Wetland Study Phase I Howth Co. Dublin

Final Report

prepared for Fingal County Council

Project No.	Rev.	Author	Reviewed By	Approved By	Issue Date
200100	13	AF	KMOC	ACr	09/03/2021

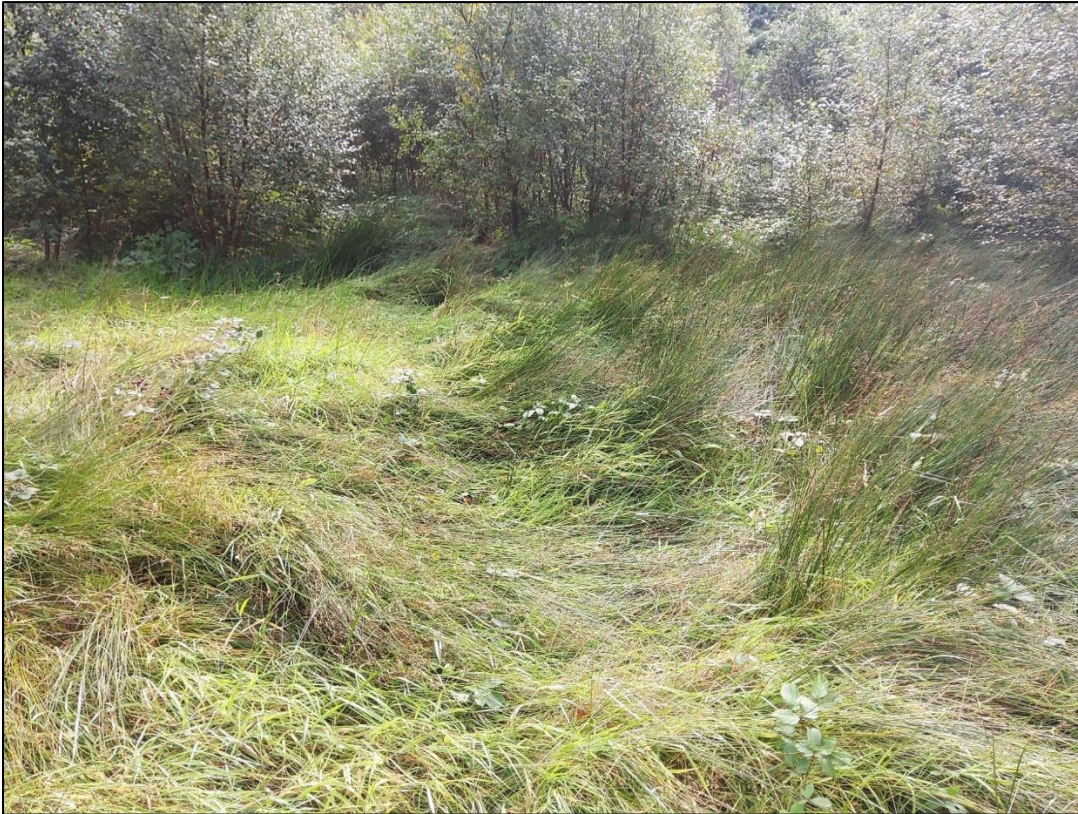
Plate 12 *Juncus effusus* – *Rumex acetosa* grassland (GL2D) in site 3. *Betula pubescens* (Downy Birch) can be seen invading the edge of the site in the background.

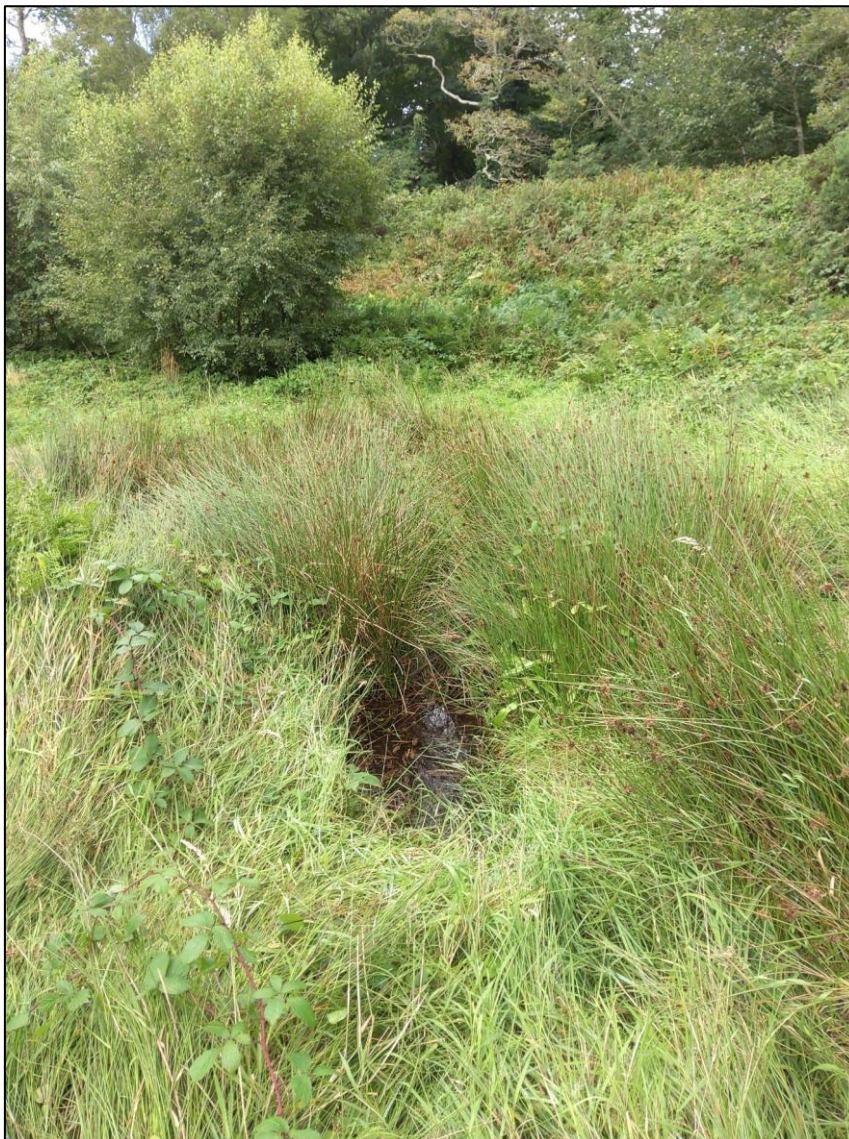
Plate 14 *Ditch running through Juncus effusus – Rumex acetosa grassland (GL2D) in site 3: a likely source of the increased drainage that this site is experiencing in recent years.*

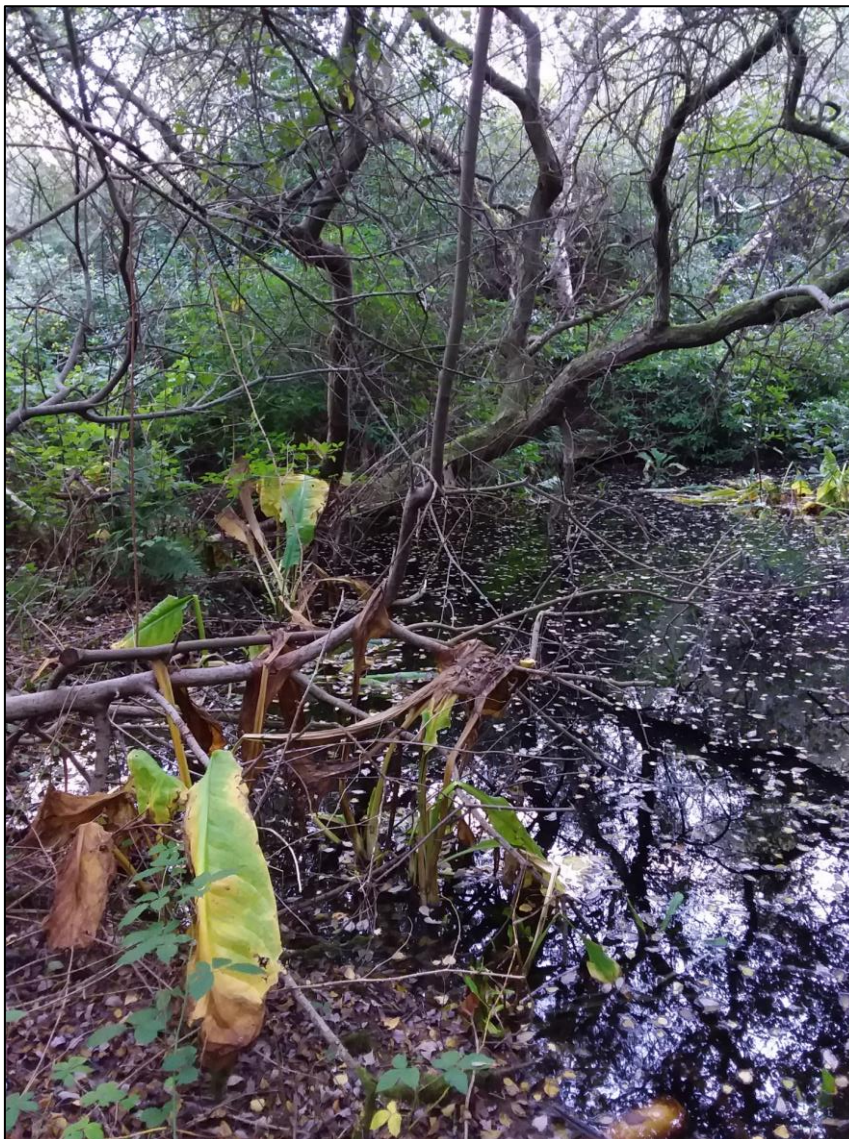
Plate 19 *Hilltop House Pond, with the invasive species Lysichiton americanus (American Skunk-cabbage).*

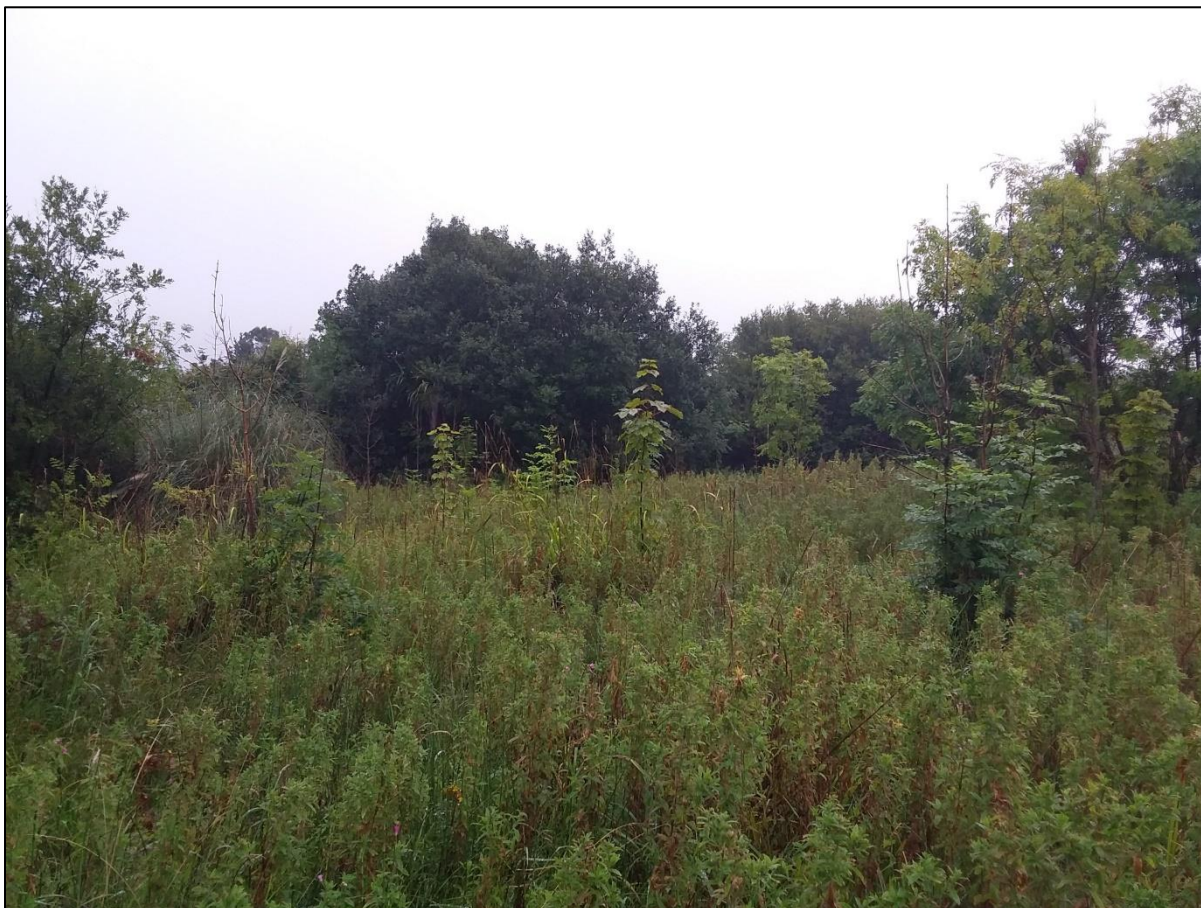
Plate 27 **Wet grassland (GS4) habitat on north side of Offington Wetland (Site 8) site, with the invasive *Acer pseudoplatanus* (Sycamore) and *Cortaderia selloana* (Pampas-grass) in the background.**

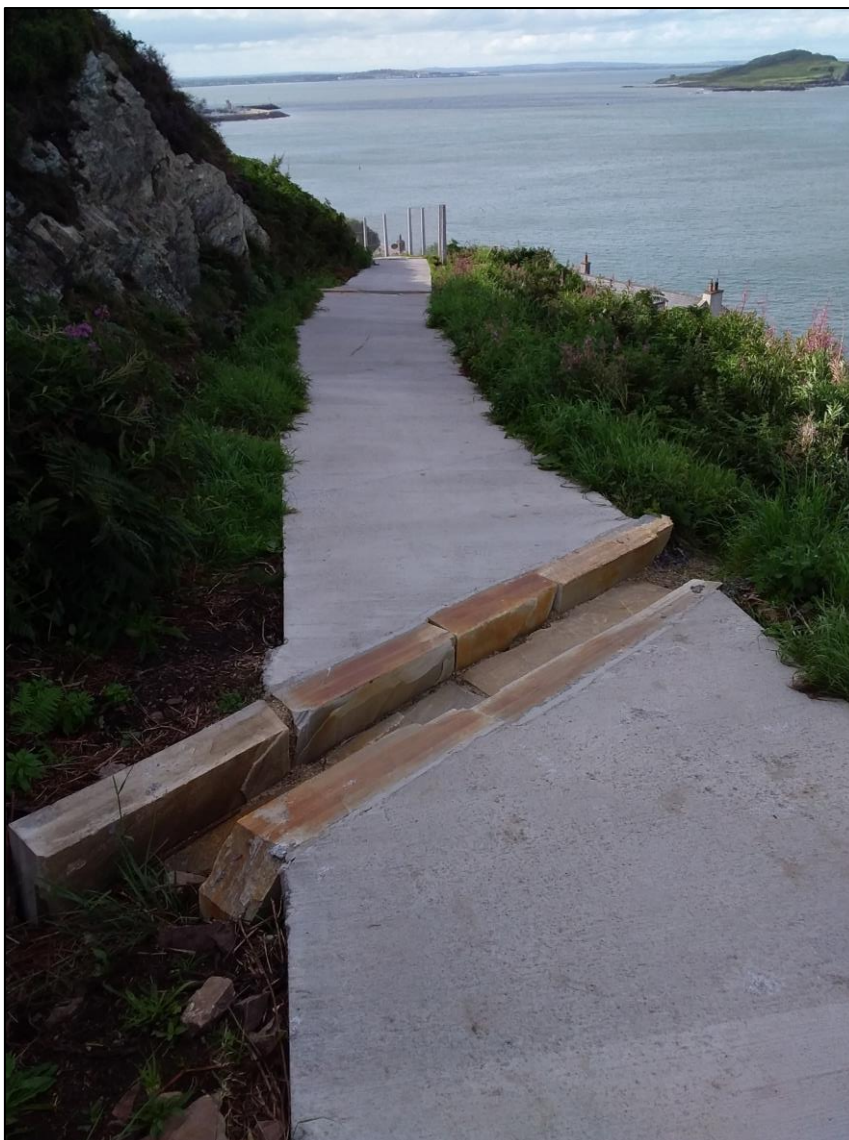
Plate 36 *Perpendicular drains installed in concretised walking pathways.*
