CULTURAL HERITAGE STUDY

Redrock/Sutton Castle, Howth

Fingal County Council

3rd December 2019

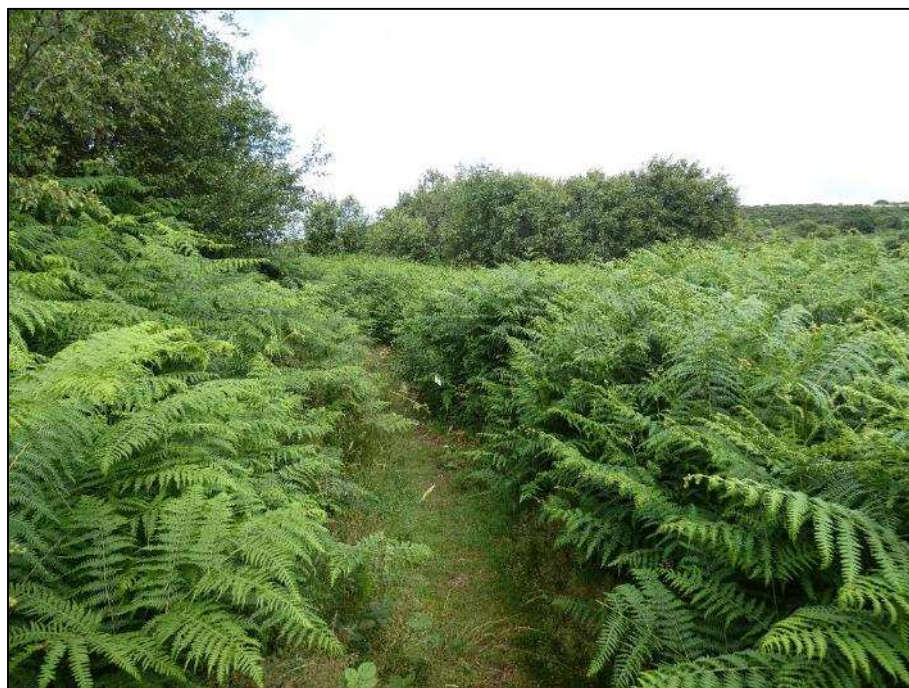
Plate 1. Nature of vegetation across site.

The study area was assessed over two days in July and October 2019, in bright and cloudy weather. The purpose of the site assessment was to identify any archaeological or architectural heritage features, or areas of archaeological potential within the site boundary. The site visit commenced at the northern end of the site. Please note that during the July visit, much of the site was covered in dense vegetation, up to 2m in height at the time of the survey, which made detailed assessment problematic (see Plate 1).

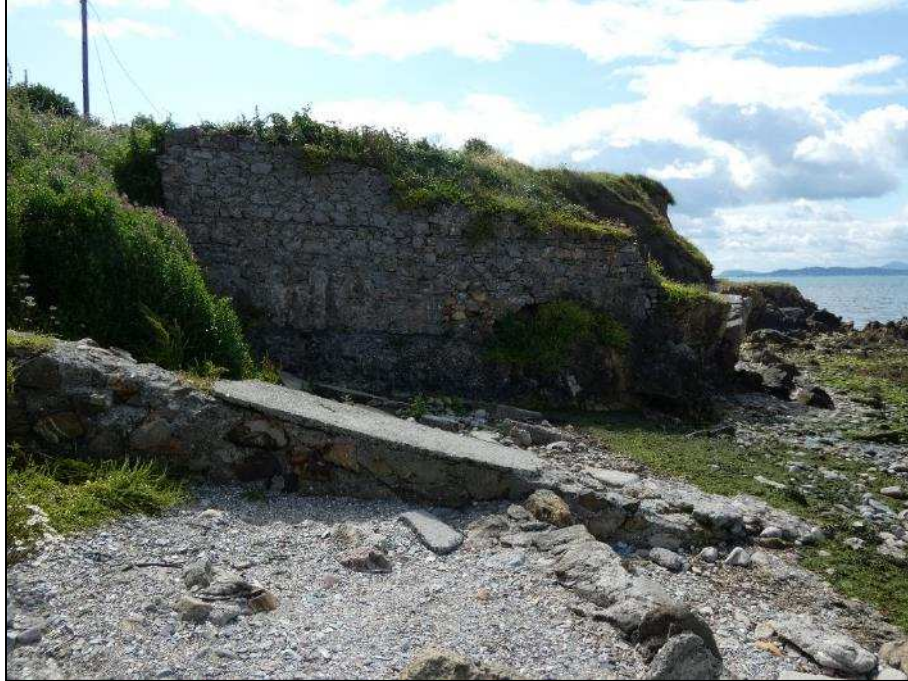
Plate 2. Bottle Quay

Bottle Quay, of eighteenth or early nineteenth century date, is located immediately to the north of the proposed development (FCAS 053---; see Plate 2). The remains of the quay comprise a rubble granite slip now covered in shuttered concrete, a rubble granite retaining walls stands to the south. A projecting quay is indicated on the 1st edition Ordnance Survey map (Figure 5).

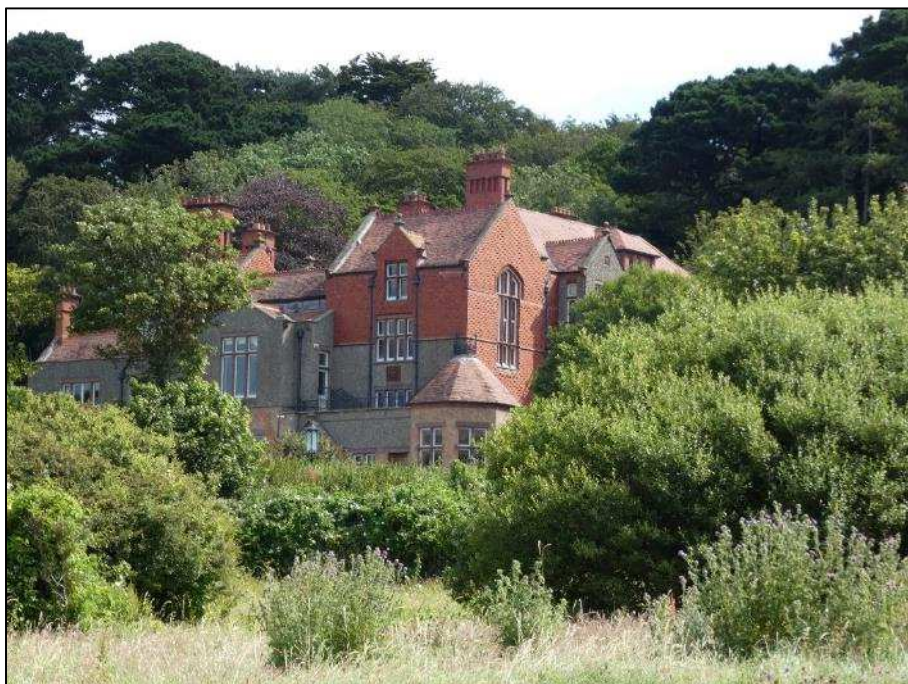
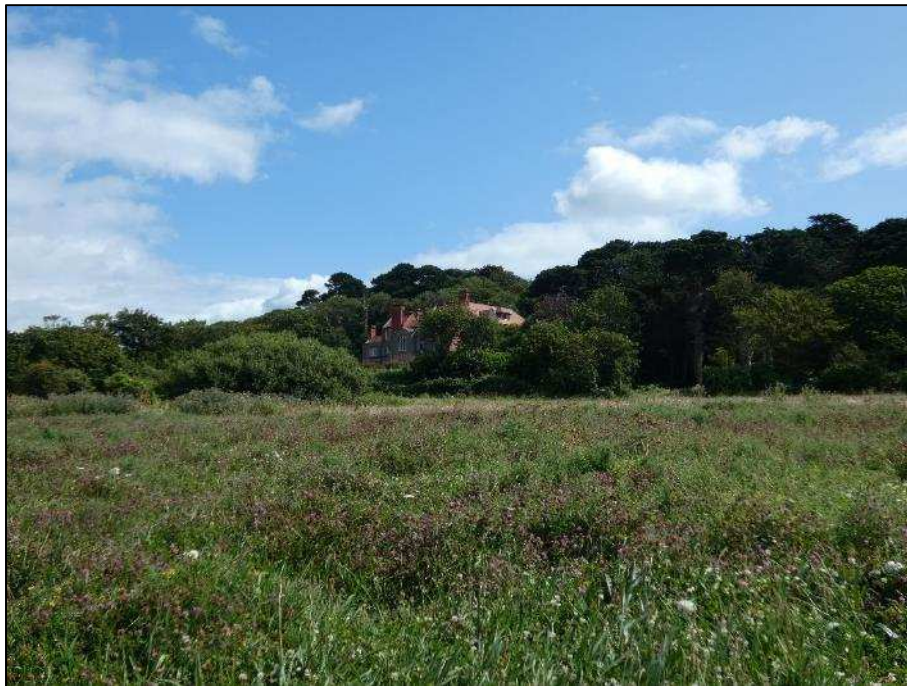
Sutton House is situated to the north of the study area and is located south of the site of an older house of the same name (NIAH 11366011; see Figures 4 and 5; see Plate 3). The house is a late nineteenth to early twentieth century house, in Arts and Crafts Style that was designed by Alfred Derbyshire. The site is bounded by mature trees (see Plate 4).

Plate 3. Sutton House

Plate 4. Sutton House and surrounding grounds

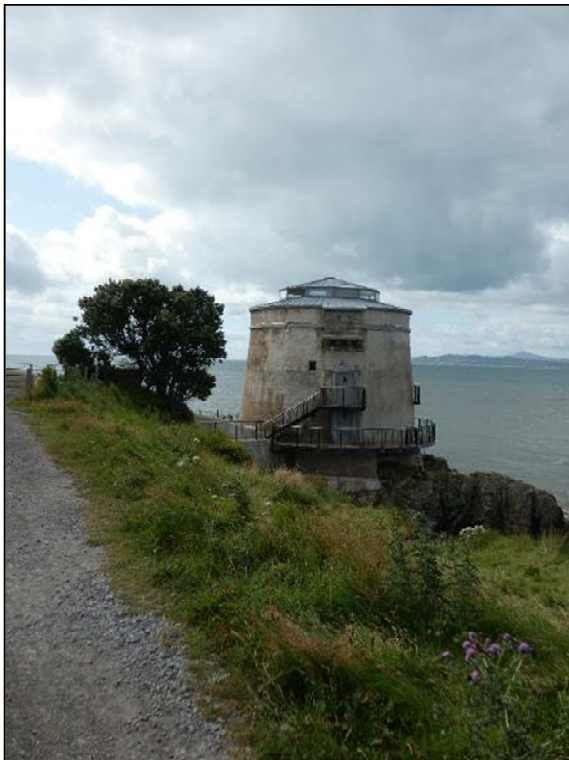
Plate 7. Martello Tower from north

The Martello Tower (RMP DU019-005/RPS/NIAH 11366017) is located on a rocky promontory to the south of the boundary stones. It was strategically located to overlook the entrance to Sutton Creek and was consequently one of the last to be disarmed. The tower was modernised in the mid-twentieth century with the addition of the timber walkway at its base and a glazed cover over the gun platform and its external walls were rendered. There is a granite machicolation over the entrance on the north-west side. The tower was subject to another phase of restoration in the early twenty-first century and is currently available to rent (see Plate 7 from north and Plate 8 from south).

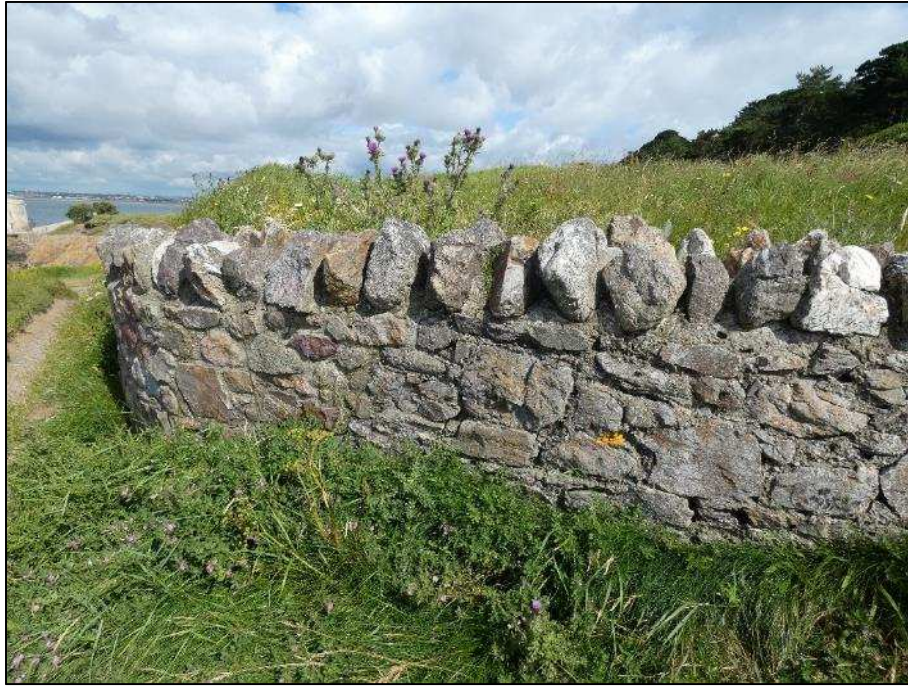
Plate 9. Rubble granite wall with rubble granite coping

To the east of the tower the pathway is bounded to the north by a rubble granite wall with rubble granite coping (see Plate 9). This wall turns north enclosing a large field in pasture. It is accessed at the east end by a wrought-iron gate supported on square profile gate piers with granite coping (see Plate 10). The piers are constructed of dressed granite blocks.

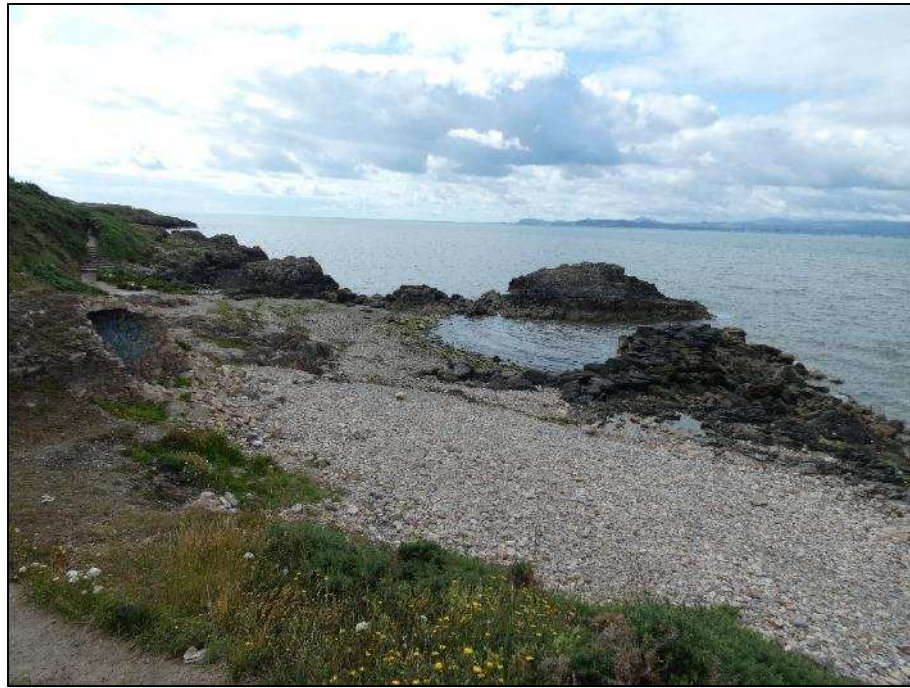
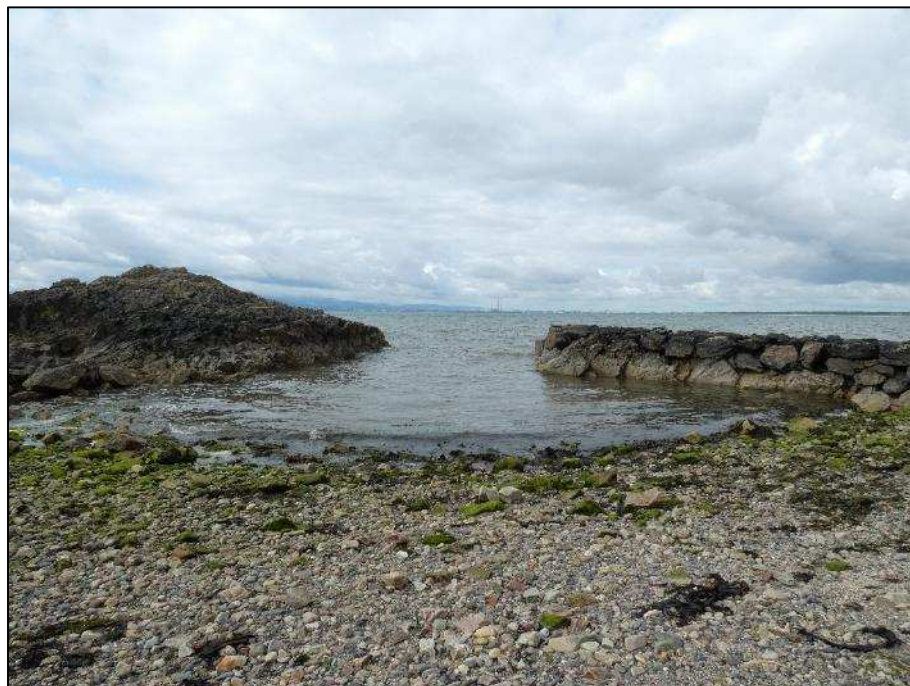
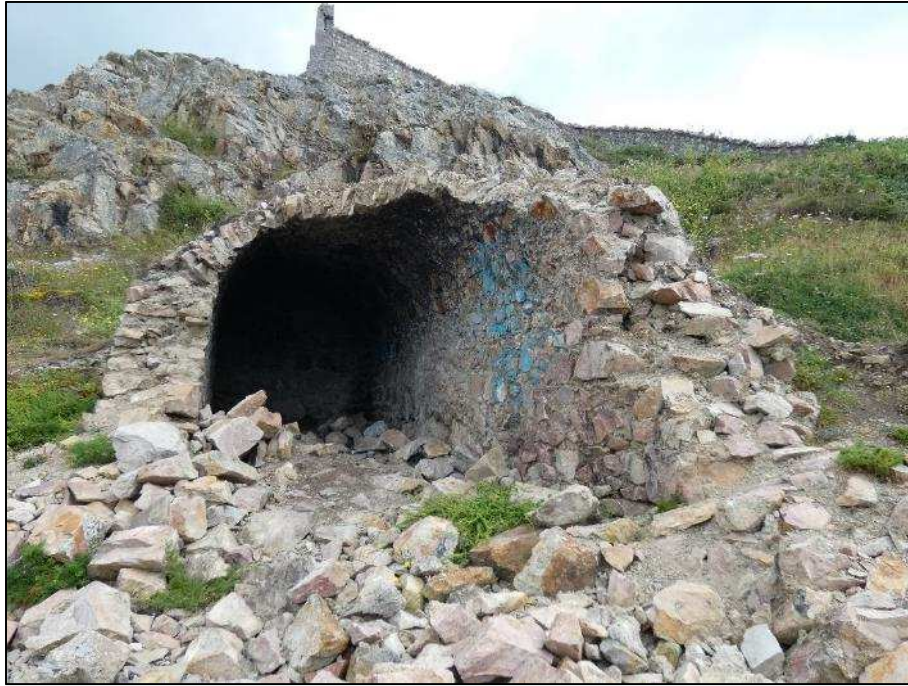
Immediately outside the southern corner of the site is a small harbour complete with a boat shed serving Candlestick House, located immediately to its north (see Plate 11). The eastern arm of the harbour comprises a natural outcrop of rock, indicated on the 1st edition Ordnance Survey map (see Plate 12 and Figure 5). The western arm of the harbour is constructed of massive irregular granite boulders but is not indicated on any of the Ordnance Survey maps for the site. A small boat house is located to the north of the harbour and comprises an arched structure with rubble granite walls, which is partially demolished at the south end (see Plate 13).

Plate 11. Small harbour with associated boat house

Plate 12. Eastern arm of the harbour

Plate 13. Boat house

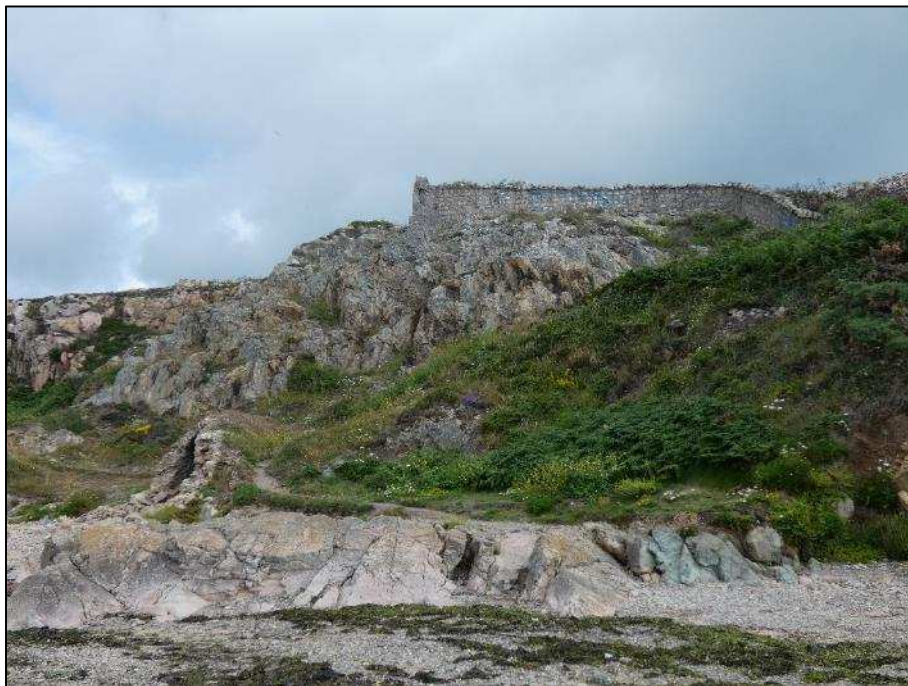
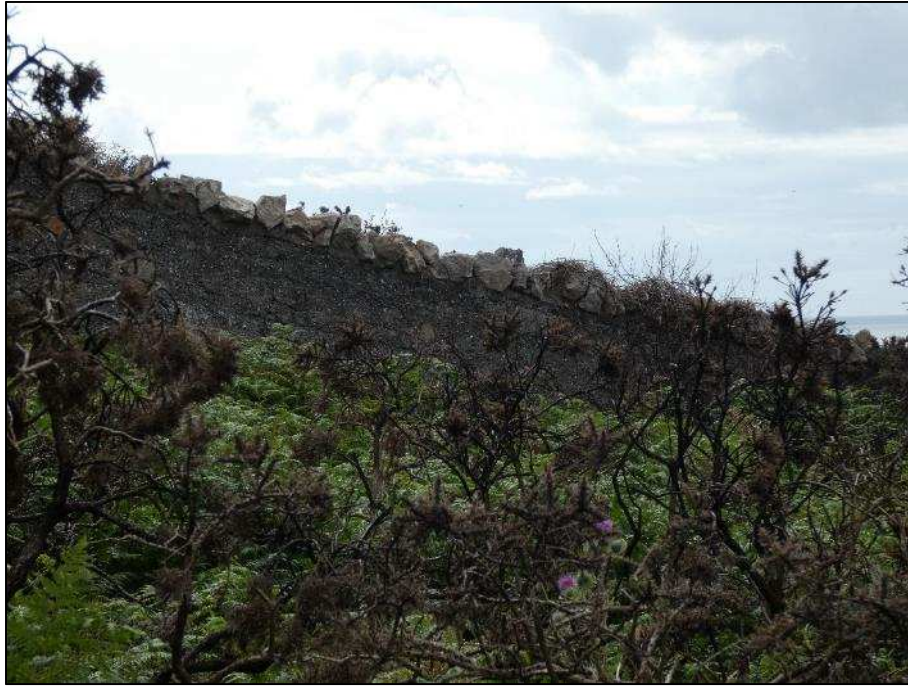
The western site boundary comprises a coursed rubble granite wall with rubble granite coping and cement pointing (see Plate 14). The wall is cement rendered on the western face in parts (Plate 15). The wall runs roughly north south up the headland, it terminates immediately to the north of the boathouse at a rocky outcrop know as 'the Candlesticks'. It forms the southern boundary of the house, marked Candlestick House on the 1st edition Ordnance Survey 6-inch map (Figure 5).

Plate 14. Coursed rubble granite wall with rubble granite coping and cement pointing

Plate 15. Close up of wall showing cement rendering

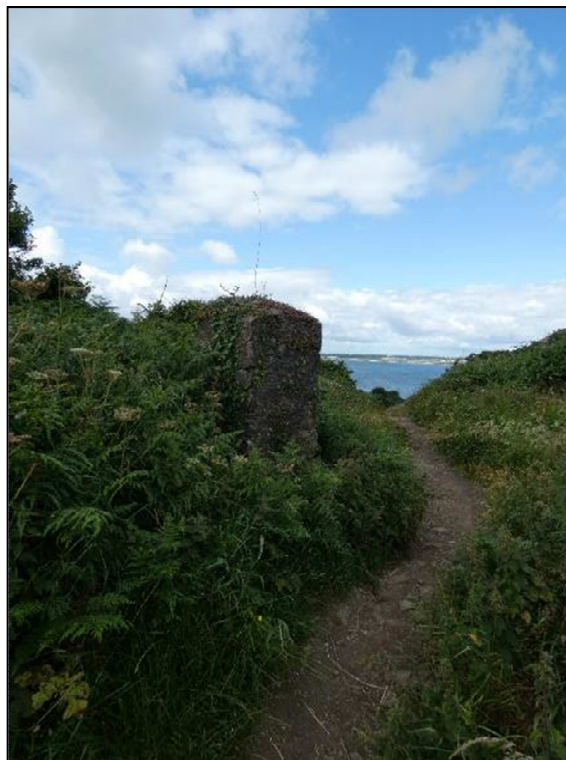
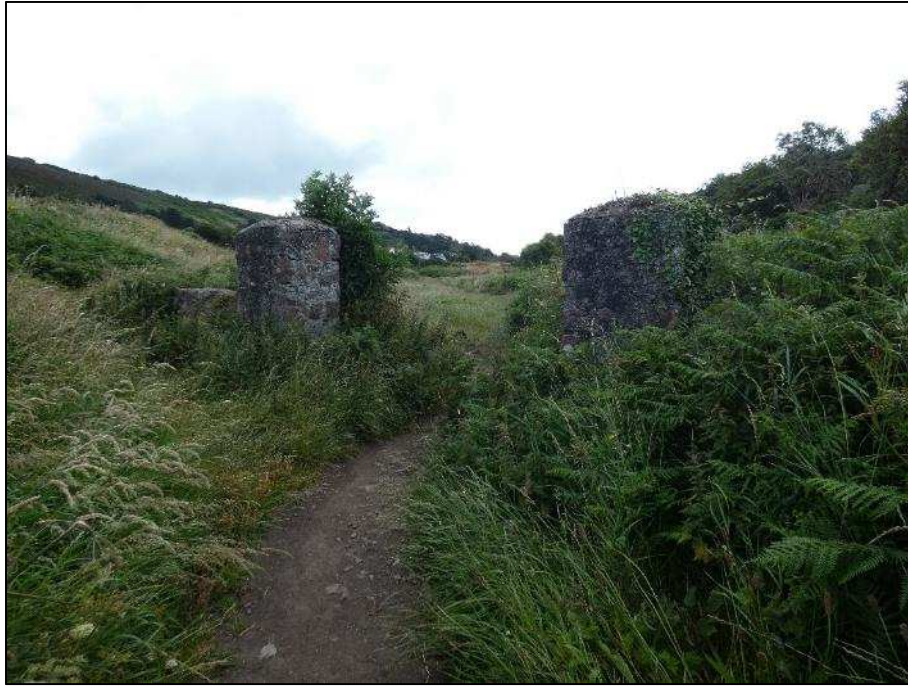
To the northeast of the harbour a pair of square profile gate piers was noted, constructed of rendered squared rubble granite (Plate 16). A cast-iron projection was noted on the northern side of the northern pier, originally used for hanging a gate. A low rubble granite wall runs north from the gate piers (Plate 17). The gateway and associated walls probably relate to the field systems that are depicted on the first and second edition Ordnance Survey mapping (Figures 5 and 6).

Plate 16. Rendered squared rubble granite gate pier

Plate 17. Piers with wall running north

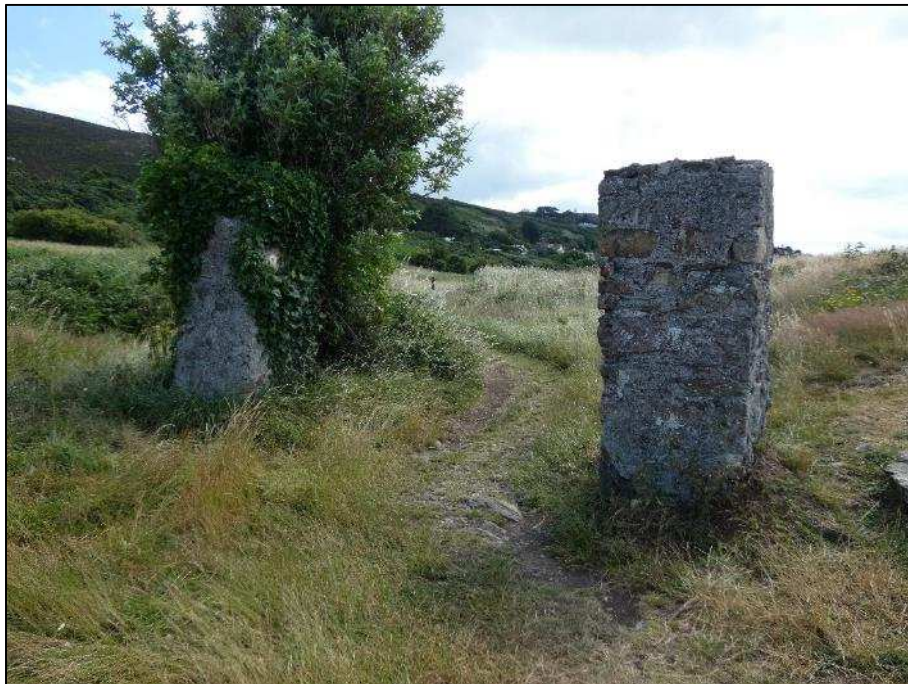
Plate 18. Pair of gate piers in the northern portion of the subject area

Another set of two gate piers were noted in the northern portion of the site, comprising a pair of square profile gate piers of rubble granite construction (see Plate 18).

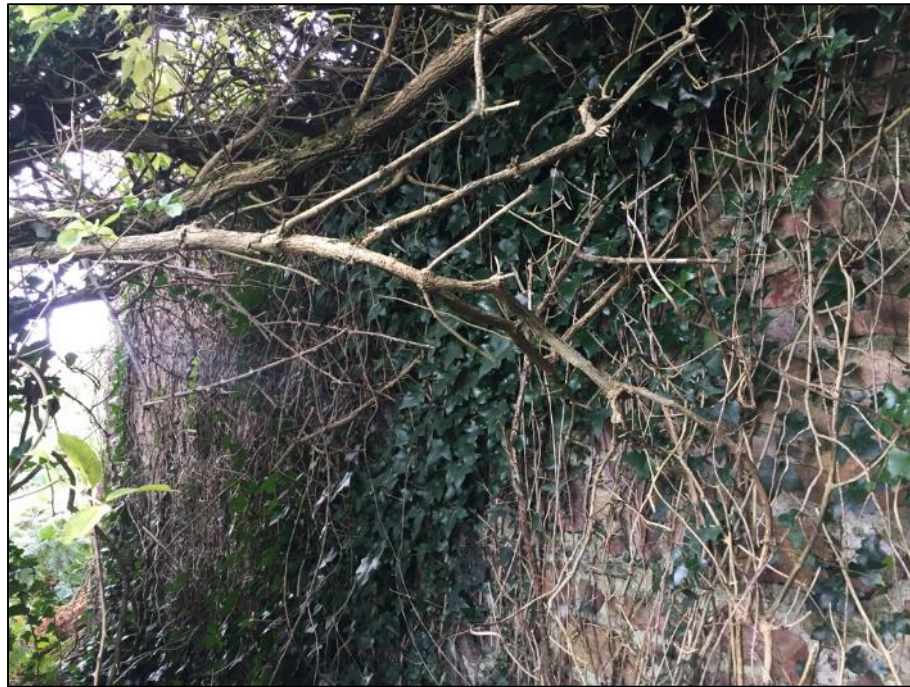
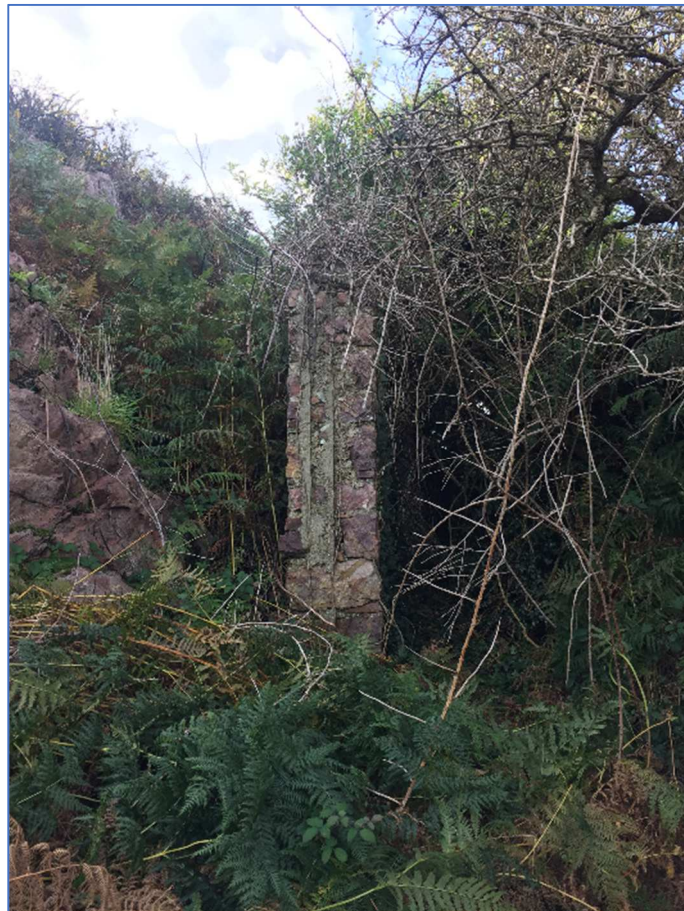
A substantial wall was noted 5m to the southeast of the squared block piers that are shown in Plates 16 and 17. The rendered rubble wall, which is predominantly constructed of the distinctive red Howth Head quartzites, extends from east to west for a distance of 7.5m (Plate 19). It then turns at a 90° angle and runs north for another 2m towards the nearby gate piers. It varies between 2.2–2.8m in height and is 0.60m in width. The structure shields the lower north-western slope of Red Rock headland (Plate 20).

Its function is unclear, but its proximity to the gate piers suggest that it may represent an aspect of the field enclosures depicted on the first and section edition ordnance survey maps (Figures 5 and 6).

Plate 19. Quartzite boundary wall running east-west facing southeast

Plate 20. Quartzite boundary wall fronting headland to southwest

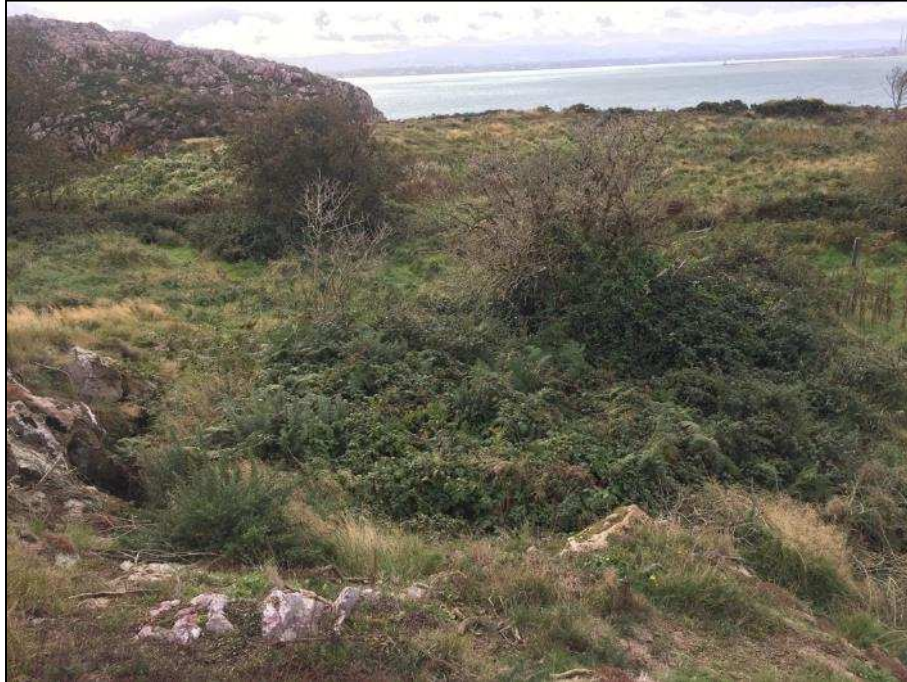
Plate 21. Possible quarry pit from quartzite outcrop facing south

A possible quarry pit was noted c. 50m to the northeast of the former field entrance that is indicated through the gate piers and wall section in Plate 17. The pit was located beside a large outcrop of red quartzite; the south-western face of the outcrop also appeared to have been worked in the past. The sub-oval pit was overgrown with dense vegetation so it was not possible to ascertain its precise form and dimensions. However, it had a diameter of c. 8.m and extended upwards for 1.9m from the ground level to the top of the outcrop.

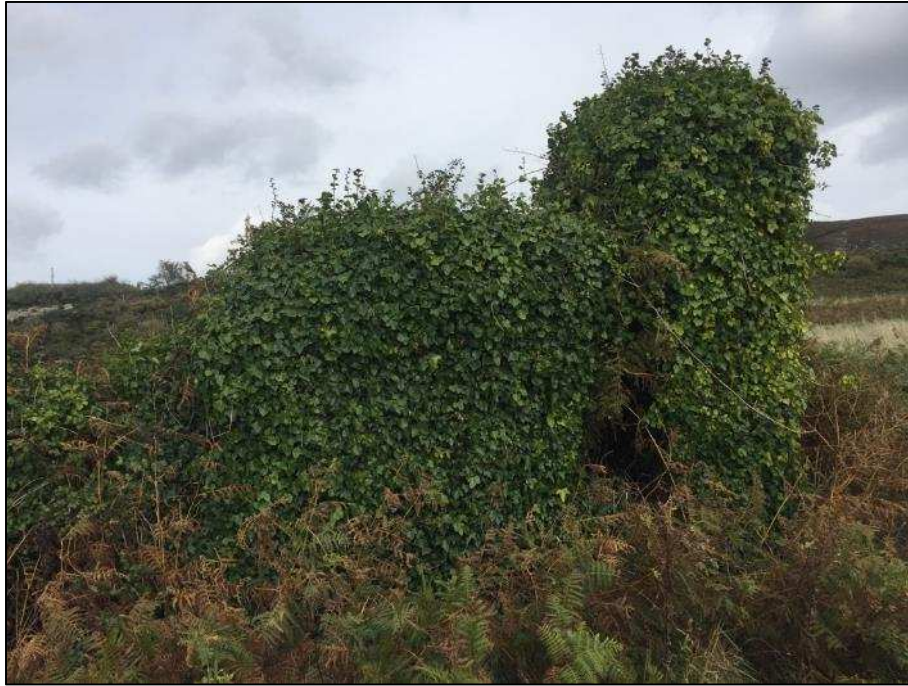
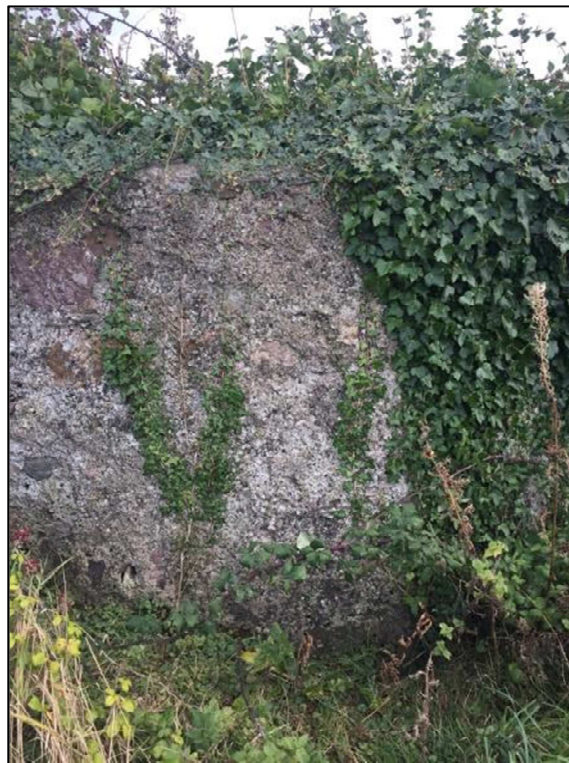
The remains of a former structure, which is depicted on the first and second editions of the Ordnance Survey mapping for the subject area (Figures 5 and 6), was sited c. 150m to the northwest of the possible quarry pit (Plates 22 and 23). The overgrown building has a sub-square shape in plan that measured 10m (NW-SE) by 5.5m (NE-SW) and incorporated an internal dividing wall. The outer walls varied between 1.6–1.8m in height. It is predominantly composed of red quartzite with occasional blocks of limestone and pieces of slate. There was evidence in places for a gravelly lime render that probably derives from sometime during the late nineteenth to early twentieth century (e.g. Plate 23).

The first edition Ordnance Survey map shows the building to the southeast of Sutton House and to the northeast of the Martello Tower (Figure 5). It adjoins a field boundary in the south-eastern section of a large sub-rectangular field and is possibly indicative of the small holding of a tenant farmer of Sutton House.

Plate 22. Eastern wall of 19th century structure facing northwest

Plate 23. Southern wall of 19th century structure

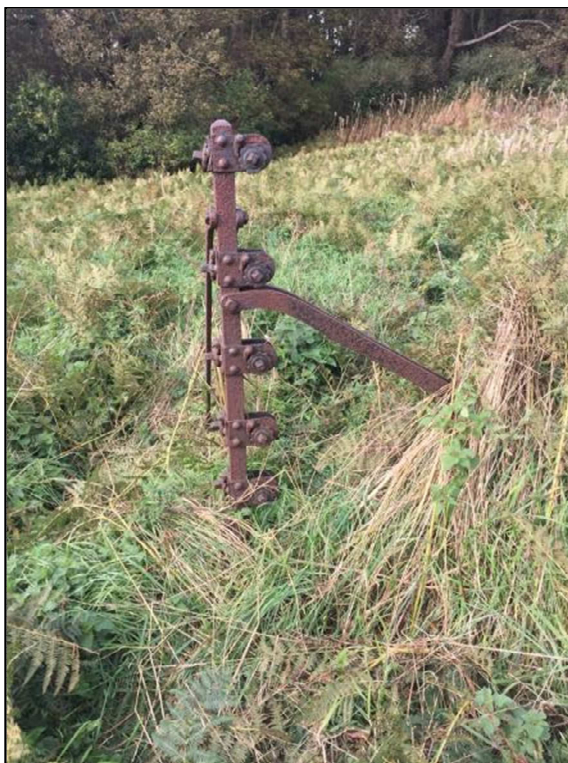
Plate 24. Wrought iron fence post

The final feature surveyed consisted of a wrought iron fence post that was located c. 50m to the northwest of the nineteenth century structure. It was 1.5m in height and incorporated two stout buttresses, in addition to six connections to affix the tensioned wire (Plate 24). Several rusty fragments of barbed wire were still in evidence along the post. There was no evidence for any associated fenceposts in the immediate vicinity; however, a number are in evidence along the former Lower Lane too.

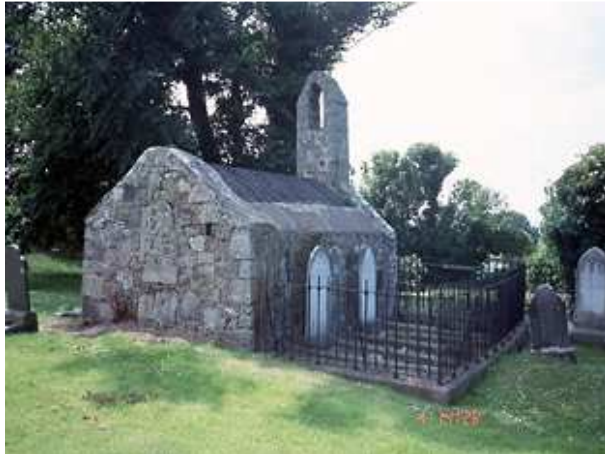
Reg. No 11358033

Name Old Saint Fintan's Private Graveyard and Church
Rating Regional
Townland Sutton South
Description Private graveyard of Bellingham family, c.1890, with pair of cut stone grave markers set behind cast-iron railings. Set adjacent to rubble granite single-cell medieval church, with bellcote over gable, now in ruins.

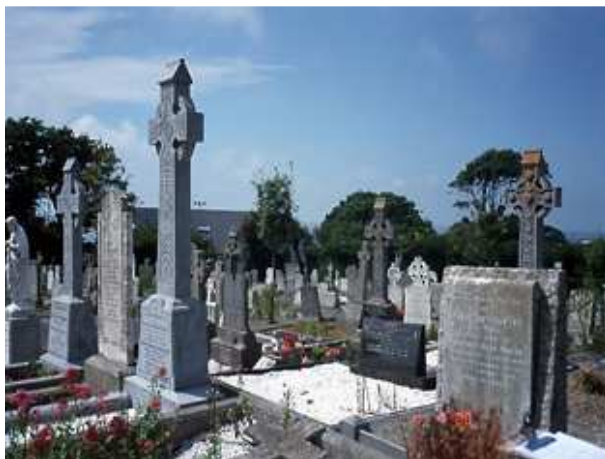
Reg. No 11358034

Name Saint Fintan's Cemetery
Rating Regional
Townland Sutton South
Description Cemetery, with various cut stone grave markers from c.1910 to present. Rubble granite and limestone boundary with castellated coping; gravel path around plots.

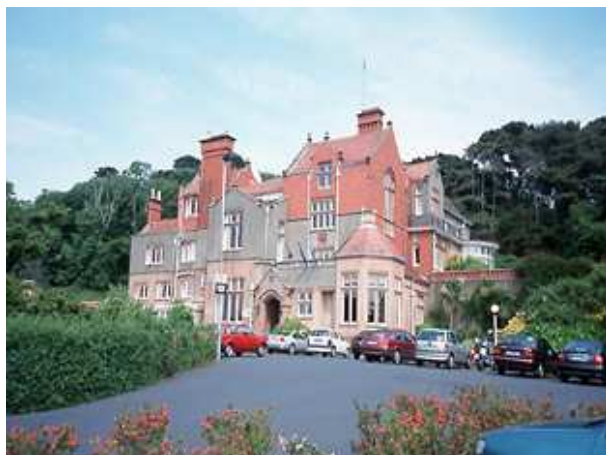
Reg. No 11366001

Name Sutton Castle Hotel
Rating Regional
Townland Sutton South
Description Detached multiple-bay four-storey Victorian Tudor style former house, c.1925, built on several terraces, and retaining original fenestration. Designed by architect Alfred Darbyshire. Single- and two-storey extension to north gable, c.1990. Now in use as hotel. Multiple span pitched roof of varying heights. Terracotta tiles and ridge tiles. Tall red brick art deco style chimneys. Cast iron rainwater goods. WALLS: Combination of yellow brick, pebbledash and terracotta tiles. Large rendered late 20th century extension to side. OPENINGS: Bi-pantile and tri-pantite timber casement windows with canted stone sills. Gothic style pointed entrance porch. INTERIOR: Retains original lobby and reception rooms.

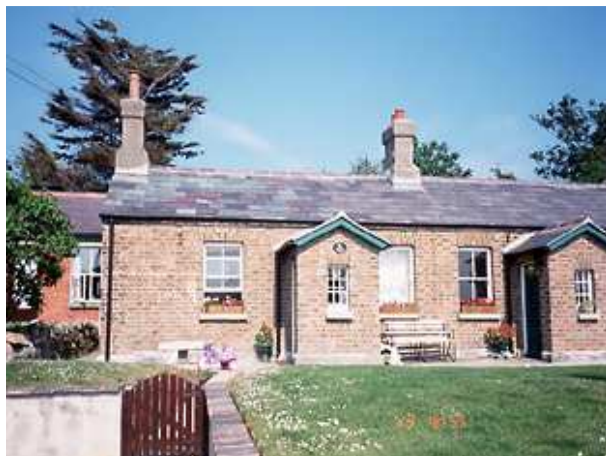
Reg. No 11366002

Name Coastguard Station
Rating Regional
Townland Sutton South
Description Terrace of six three-bay single-storey yellow brick former coastguard cottages, c.1850, with projecting entrance porches. Now in use as private dwellings. ROOF: Single span roof gabled at both ends with slate roof having terracotta ridge tiles; rendered or brick chimney to gable end with terracotta pots. WALLS: Yellow brick with cement rendered plinth. OPENINGS: Timber sash windows, granite sill. Timber tongue and grooved door.

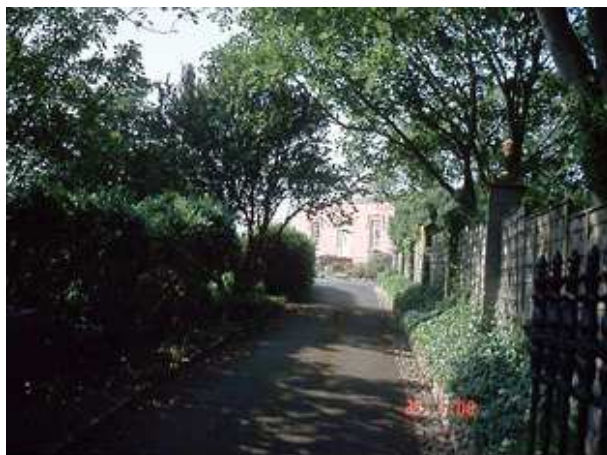
Reg. No 11366003

Name Sea Lawn
Rating Regional
Townland Sutton South
Description Detached three-bay two-storey house, c.1830, with flight of granite steps to centrally placed door. Entrance piers and screen walls with cast-iron gates. ROOF: Slate hipped roof with terracotta ridge tiles and rendered stacks. WALLS: Smooth plaster with plaster quoins and string course; decorative urns to parapet; hood mouldings over windows. OPENINGS: Original multipane timber sashes. Timber door surround with leaded side lights and fanlight; timber door.

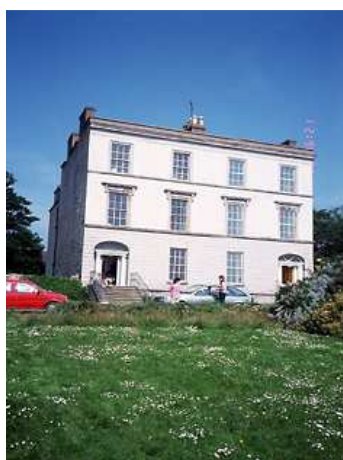
Reg. No 11366004

Name Beachfield
Rating Regional
Townland Sutton South
Description Semi-detached two-bay three-storey over raised basement double-pile houses, c.1845, with segmental-headed door openings approached by flight of steps. Single-bay three-storey returns to rear. House to right partly re-fenestrated, c.1990. House to left retaining original fenestration. ROOF: Double-pile behind nap rendered parapet; nap rendered chimney stacks; yellow clay octagonal pots. WALLS: Nap rendered; channelled to ground floor; ruled and lined to upper floors; nap rendered and cut-stone courses; exposed rubble stone and red brick construction to left side elevation; roughcast to right side elevation; nap rendered to returns; unpainted. OPENINGS: Square-headed window openings; continuous sill courses; moulded architraves; consoled entablatures to first floor; 6/6 timber sash windows; replacement uPVC windows, to right upper floors; segmental headed door openings; cut-stone Doric door cases; timber panelled doors; overlights.

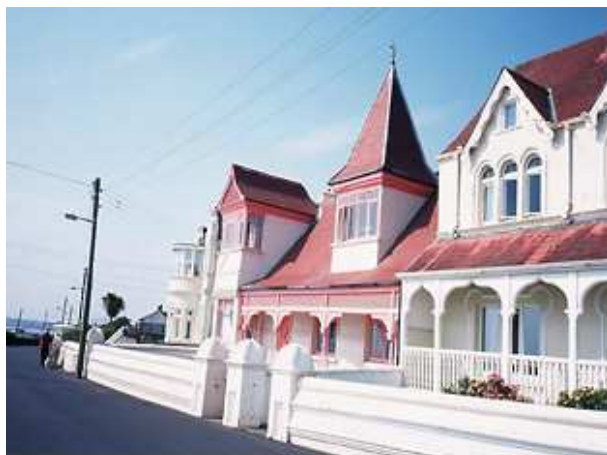
Reg. No 11366006

Name Gilmooss
Rating Regional
Townland Sutton South
Description Semi-detached four-bay single-storey house with turrets to dormer attic, c.1900. Ornate latticed veranda to ground floor. ROOF: Double pitched sprocketed red tile roof; catslide over veranda; decorative turret and gable to attic windows; corniced red brick chimney. WALLS: Smooth plaster walls with plaster decoration over windows. Ornate timber veranda. OPENINGS: Timber casement windows; original timber door; timber cornice to upper window surrounds.

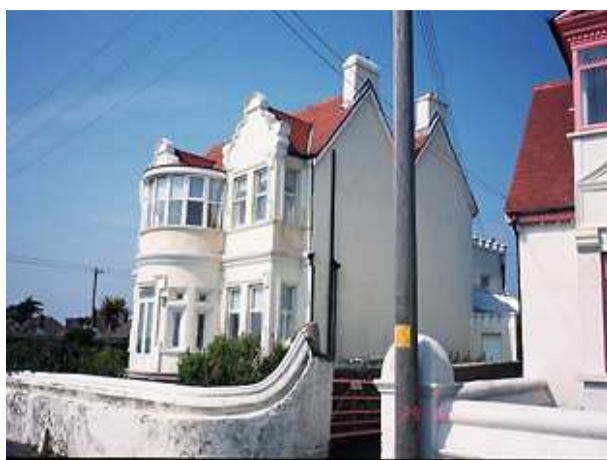
Reg. No 11366007

Name Slieverue
Rating Regional
Townland Sutton South
Description Detached double-pile three-bay two-storey house, c.1890, with full-height bowed entrance projection, flanked by Dutch gable-fronted end bays. Refenestrated, c.1990. Cast iron rainwater goods. Bow extension to side elevation. ROOF: Double-pitched and gable-fronted - behind curvilinear-gabled parapets; double-pile; terracotta tile – scalloped / fishscale: red clay ridge tiles; nap rendered chimney stacks; clay pots; cast-iron rainwater goods; flat roof to bows. WALLS: Nap rendered; string course to first floor; moulded coping to Dutch gables; painted. OPENINGS: Square-headed; continuous nap rendered sill courses; lugged architraves; replacement uPVC windows, c.1990; architrave to door opening; replacement uPVC doors, c.1990; stained glass overlight.

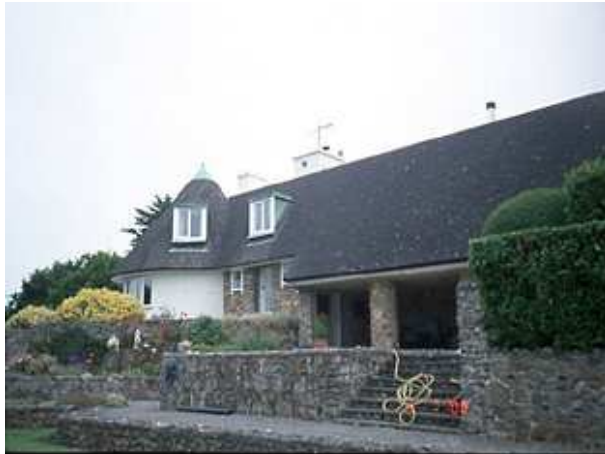
Reg. No 11366009

Description Detached multiple-bay single-storey house with dormer attic, c.1930, on an irregular plan, having circular end bay attached to north-west corner. Rubble granite faced columns supporting roof of main block, and two-storey return to rear. ROOF: Double pitched and turret roof with small clay tiles; rendered chimney stacks; copper flashing to dormer windows. WALLS: Granite walls; curricular end bay rendered. Columns of granite support the roof of the main block to a form a count. OPENINGS: uPVC casement windows and timber fixed panes; timber doors.

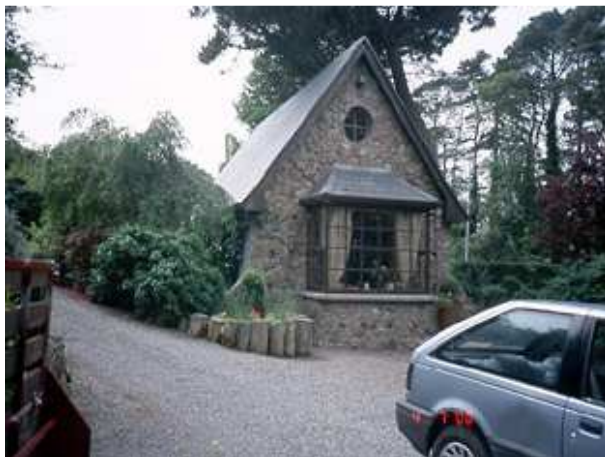
Reg. No 11366010

Description Detached single-bay single-storey gable-fronted gate lodge with dormer attic, c.1930. ROOF: Double pitched tiled roof. WALLS: Granite rubble walls. OPENINGS: Replacement timber bay window, circular timber window to gable.

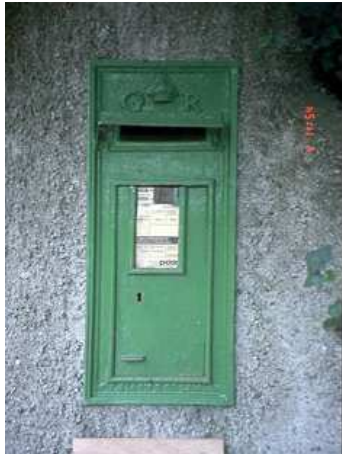
Reg. No 11366011

Name Post box
Rating Regional
Townland Sutton South
Description Wall-mounted cast-iron post box, c.1905, with 'GR' monogram, and cast by 'T.Allen & Co., London'.

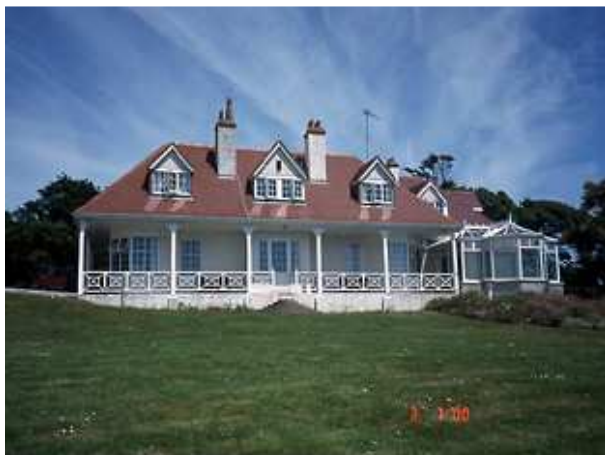
Reg. No 11366013

Name Shearwater
Rating Regional
Townland Sutton South
Description Detached four-bay single-storey house with gabled dormers to attic, c.1915, having recessed end-bay to right-hand side, timber veranda supporting roof, and single-storey clapper-board return. uPVC conservatory to recessed bay, c.1990. ROOF: Monopitched terracotta tiled roof with large overhang; two prominent stacks; monopitched hipped roof to two-storey return. WALLS: Pebble dashed. OPENINGS: uPVC replacement windows; timber glazed doors; original timber casements to clapperboard return.

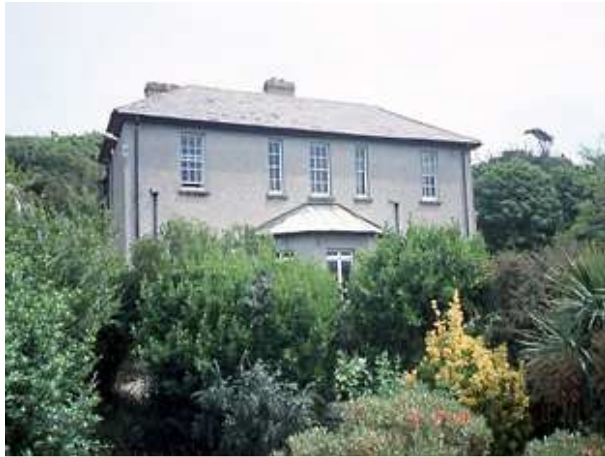
Reg. No 11366014

Name The Cliffs
Rating Regional
Townland Sutton South
Description Detached three-bay two-storey over basement house, c.1860, with single-storey central canted bay window. Returns and extensions added to rear in several phases. Outbuildings to site. ROOF: Hipped slate roof with terracotta ridge tiles; nap rendered chimney stacks with terracotta pots; cast-iron rainwater goods. WALLS: Pebble dashed with bow to right hand side and canted bay to front. OPENINGS: Square headed with timber sash windows; nineteenth century casements; granite and concrete cills; granite doorcase with fluted console brackets supporting cornice; timber raised and fielded panelled door.

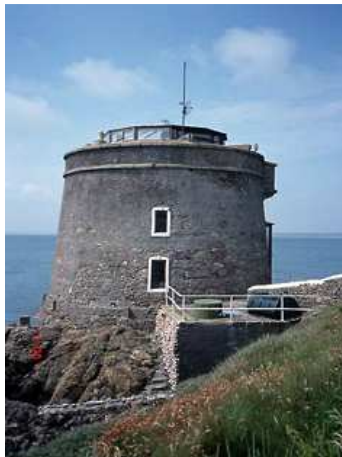
Reg. No 11366017

Name Sutton Creek Martello Tower
Rating Regional
Townland Sutton South
Description Martello tower, c.1805, granite rubble walls, on a circular plan with tapered profile, having machicolation supported by brackets over entrance door. Raised extension to roof, c.1990.

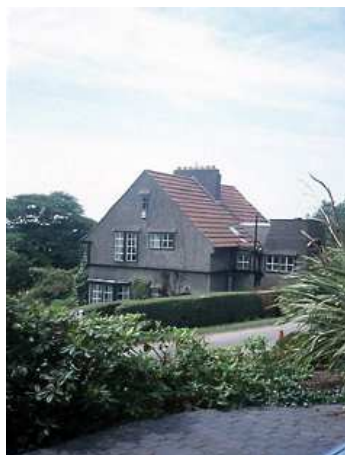
Reg. No 11367001

Name Drynan Lodge
Rating Regional
Townland Censure
Description Detached two-bay two-storey gable-fronted Edwardian style house with dormer attic, c.1910, having single-bay single-storey canted bay window to left and two-storey flat-roofed recessed end bay to right. ROOF: Gable-fronted; red clay profiled tiles; square rooflight; red clay ridge tiles; roughcast chimney stack; yellow clay pots; cast-iron rainwater goods; flat-roof to end bay behind parapet; iron/lead ridges. WALLS: Roughcast; unpainted. OPENINGS: Square-headed window openings; no sills; timber side-hung casement windows advanced from line of façade; canted bay window to left ground floor; canted oriel to end bay; round-headed door opening.

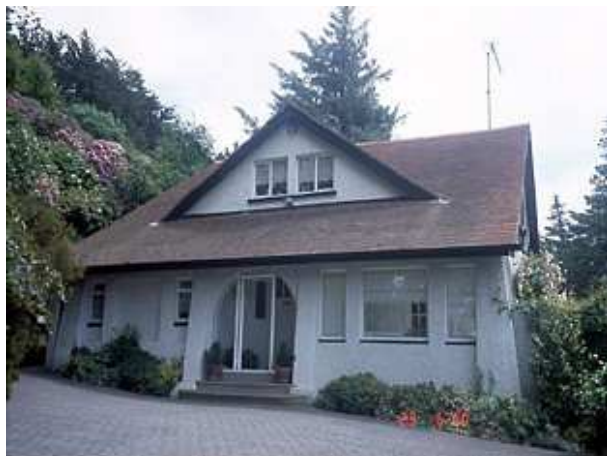
Reg. No 11367002

Name Blackberry Hill
Rating Regional
Townland Censure
Description Detached three-bay single-storey Edwardian style house with dormer attic, c.1915, with internal entrance bay to centre. Refenestrated, c.1990. ROOF: Double-pitched; gable-fronted to dormer attic window; red clay tiles; square rooflight; red clay ridge tiles; overhanging timber eaves; cast-iron rainwater goods chimney stack to rear; red clay pots. WALLS: Roughcast; painted; buttresses to front and to right corner; nap rendered 'timber-frame' dressings to right gable end having red clay tiles to apex. OPENINGS: Square-headed openings - windows to left within recessed panels; concrete sills; replacement uPVC casement windows, original glazed timber panelled door with entablature over and sidelights; round-headed open internal porch; glazed uPVC door and side lights.
