St Mary's Church of Ireland, Clonmethan, Oldtown, County Dublin: Conservation Management Plan

Prepared for the Friends of Clonmethan

18 November 2022

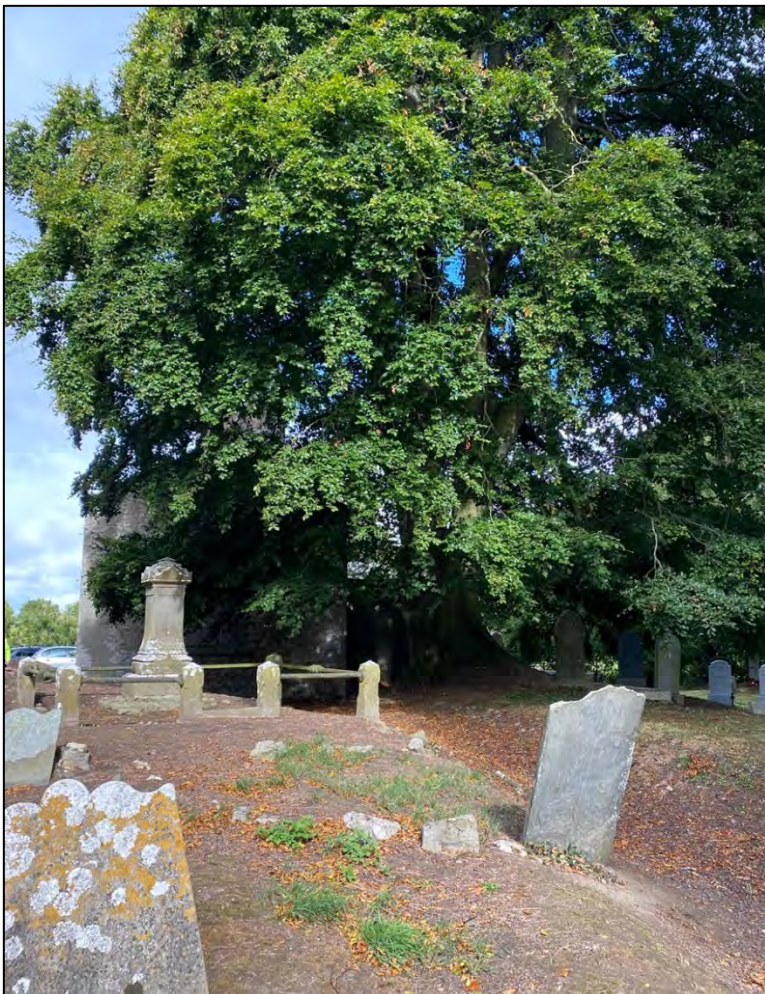
Plate 2: View of eastern part of graveyard showing soil erosion.

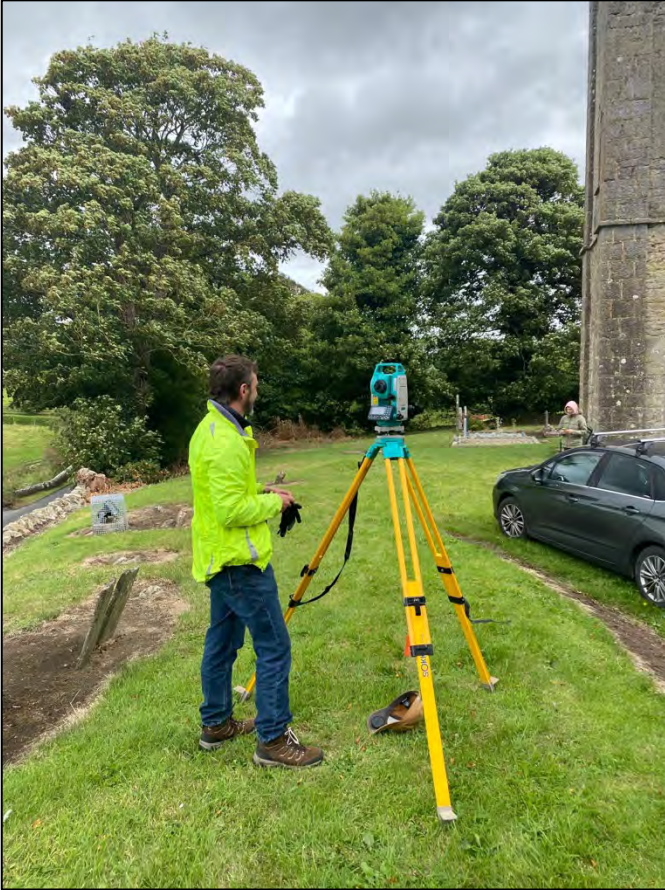
- A topographic survey of the nineteenth-century church, graveyard and enclosure wall by AMS on 19 August 2022, as part of a Heritage Week event (Figure 7 and Plate 5).

Plate 5: Topographic survey of church and graveyard, facing north=northeast.

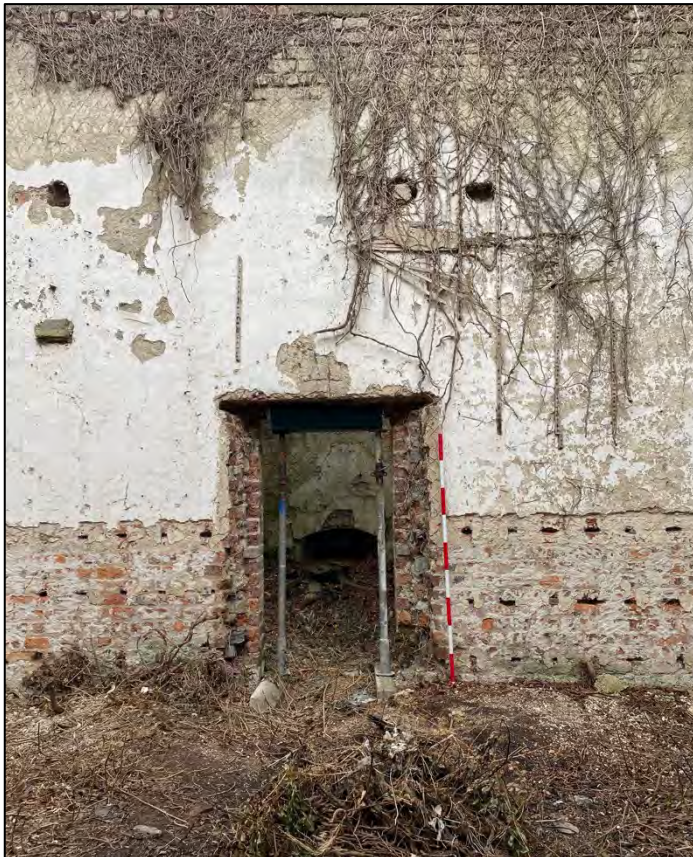
Plate 8: View northeast from nave to vestry, note propping of door.

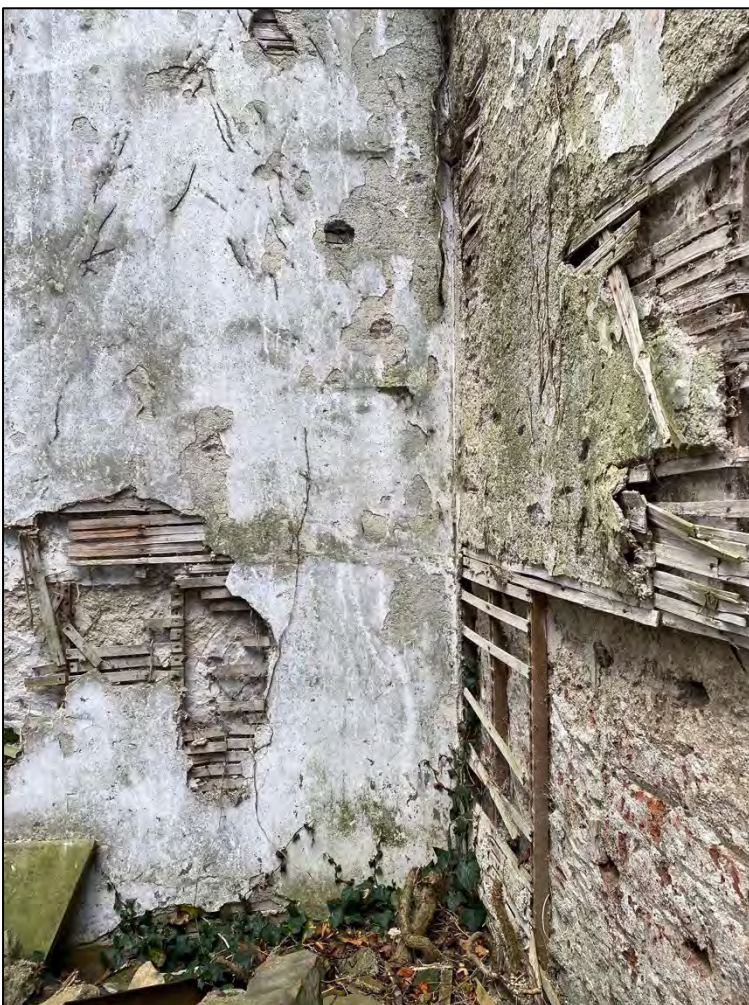
Plate 10: Timber wainscot panelling and extant render in southwest corner of nave.

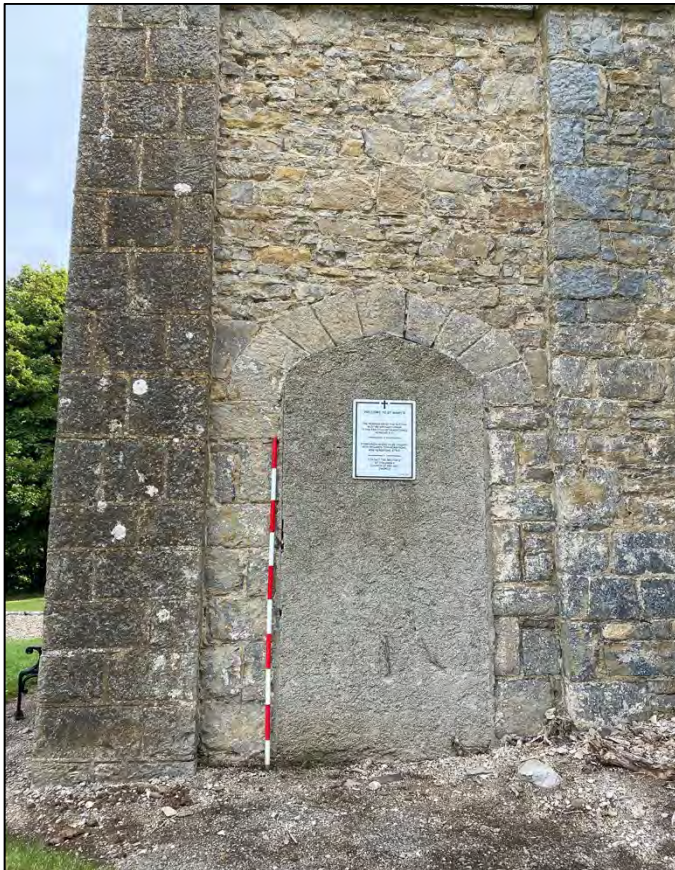
Plate 12: Blocked-up church entrance via bell tower, facing north-northeast.

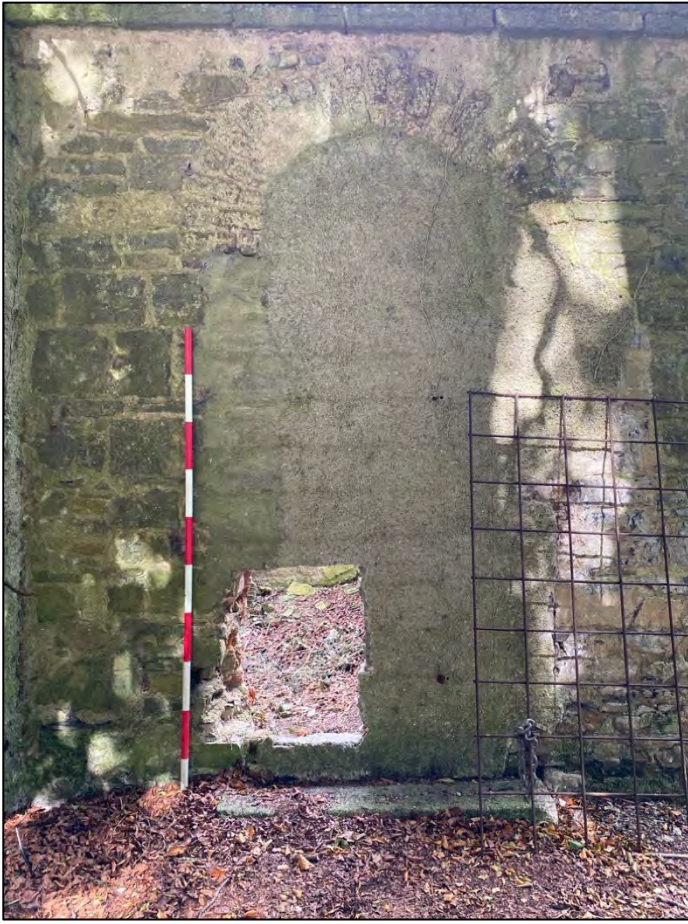
Plate 13: Blocked-up church vestry entrance, facing west-northwest.

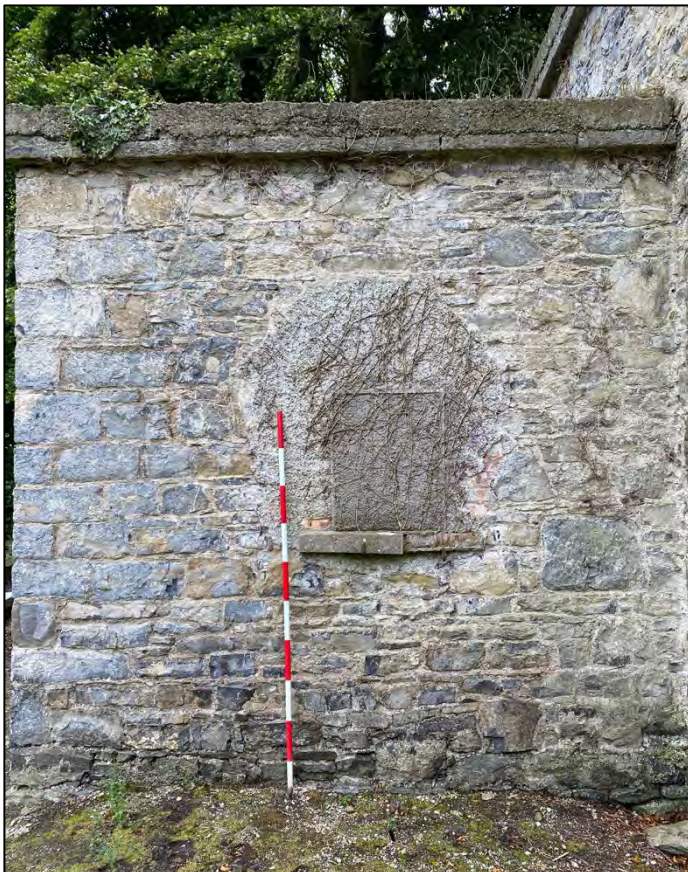
Plate 14: Blocked-up window in vestry, facing east-southeast.

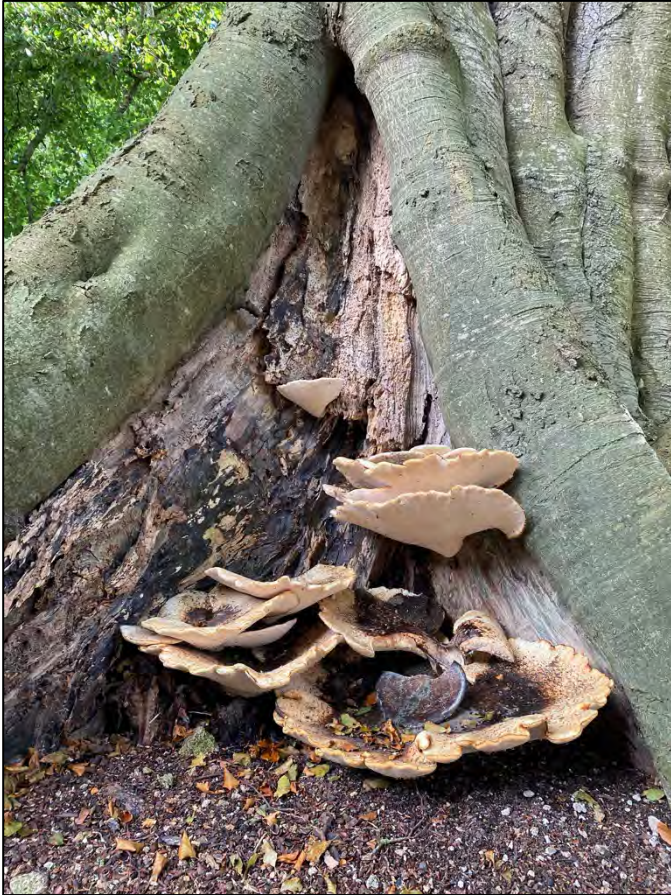
Plate 17: The basidiomycete bracket fungus *Cerioporus squamosus* on the beech tree, facing north.

A Level 2 Visual Inspection was carried out on 18 October 2022 of the mature beech tree to the east of the church (Goodwin 2022). The tree is c.26m in height, has a crown spread radius of c.10m by 13m, and a stem circumference of 5.86m (*ibid.*, 4). The crown health is excellent, with no significant disease or deadwood present, while there are nine intact buttresses at the base of the diameter stem. There is an old basal wound cavity on the lower southwestern stem, which is decayed and includes several atrophying fungal fruit bodies of the basidiomycete bracket fungus *Cerioporus squamosus* (dryad's saddle) (Plate 17).

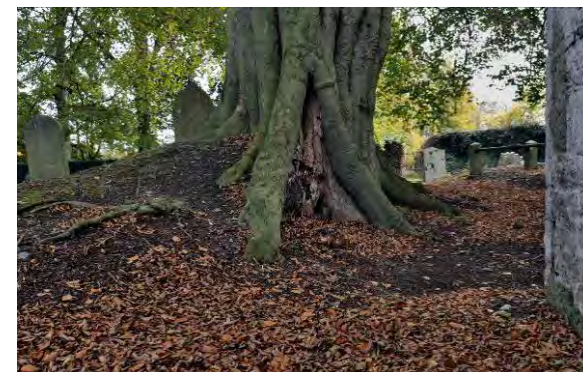
PIC.6; TREE NEAR NORTH-WEST CORNER

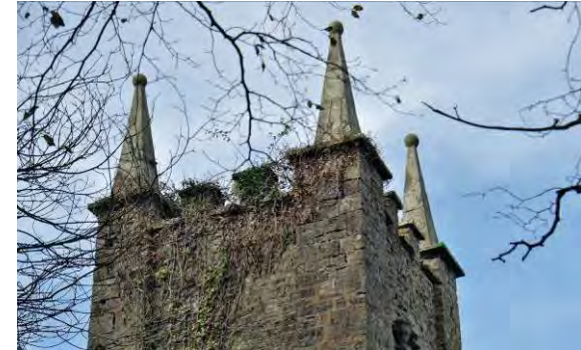
PIC.7; TOP OF TOWER.

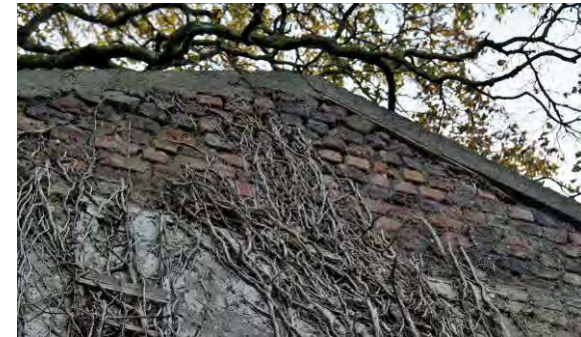
PIC.8; TOP OF EAST GABLE.

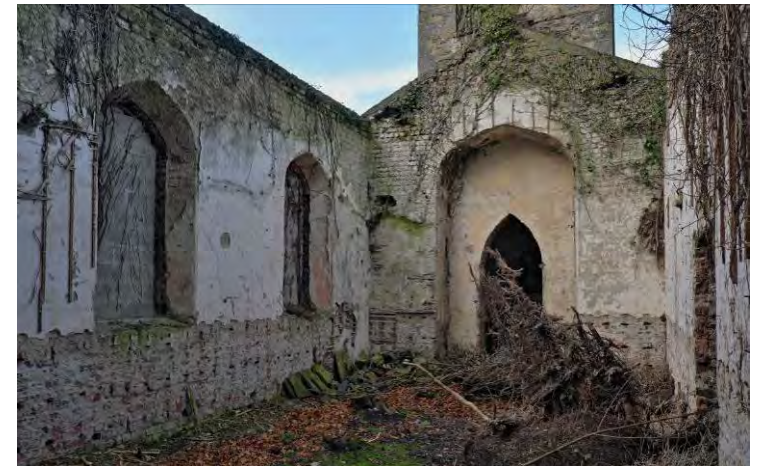
PIC. 9; INTERIOR, LOOKING WEST.

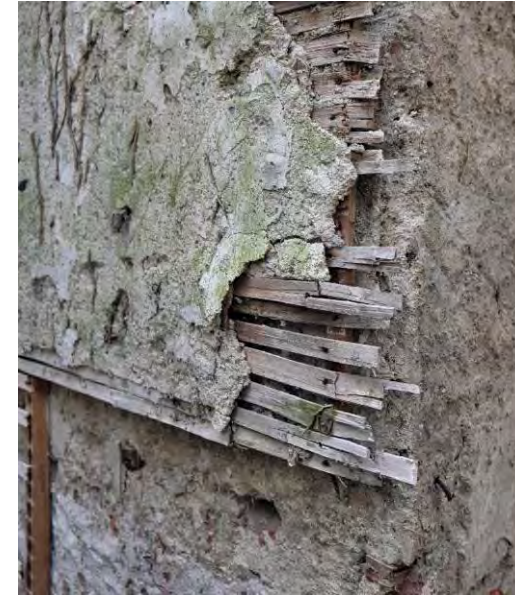
PIC.10; INTERNAL RENDER REMNANTS.

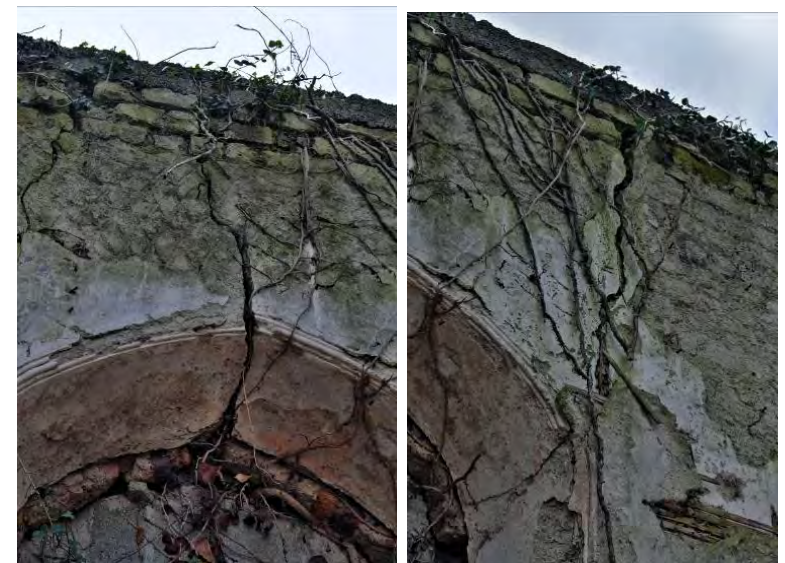
PICS 11 & 12; CRACKING IN MASONRY WALLS.

- 4.5.1 Remove all invasive growth. Note: ivy is to be removed over a period of time, as aggressive removal may damage the structure.
- 4.5.2 Engineer to check cracking referred to at 3.3.2 above. Cracks to be secured by “stitching” and re-bedding of stone.
- 4.5.3 Consideration should be given (subject to Engineer’s advice) to (a) physically connecting the fabric of nave and tower (b) provide of diagonal bracing to walls of church at corners and (c) making good to pointing of church body, if. It is not being rendered.
- 4.5.4 The missing/defective lintol between vestry and nave should be reinstated. In the immediate term, masonry over should be propped.
- 4.5.5 Tops of walling, which is capped with concrete(see) should be further protected by the application of a suitable waterproof membrane, finished with a “drip” detail.

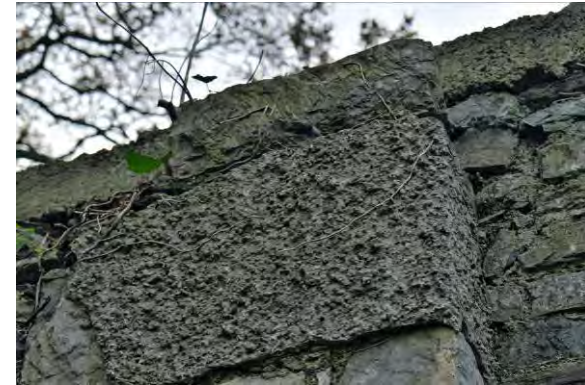
PIC.13; CONCRETE TOPPING TO STONE WALLS.

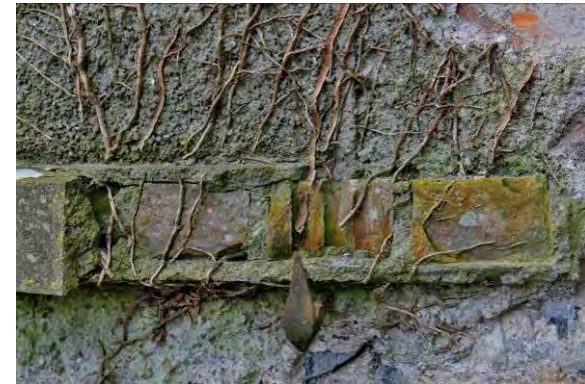
PIC.14; CEMENTITIOUS COATING TO BRICK SILL; IRON CRAMP.

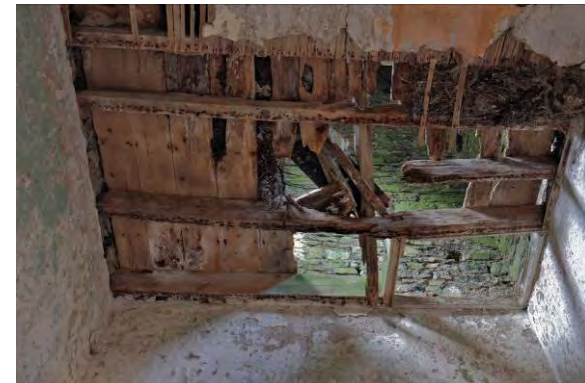
PIC.15; FIRST STAGE, VIEWED FROM BELOW

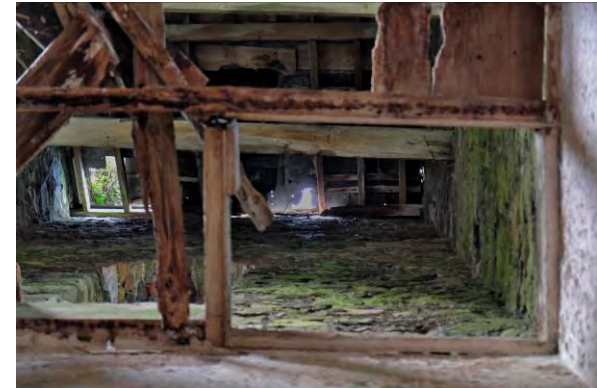
PIC. 16; (LOOKING THROUGH DECAYED FLOOR) LEAKING ROOF.

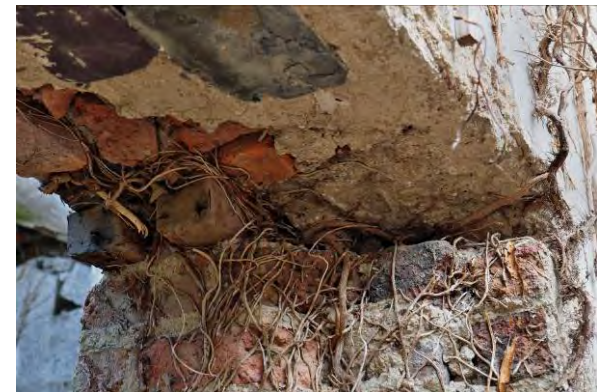
The lintol to opening from vestry to nave is missing; this is presumably have resulted from decay.

PIC. 17; LINTOL MISSING (OPE; VESTRY TO NAVE).

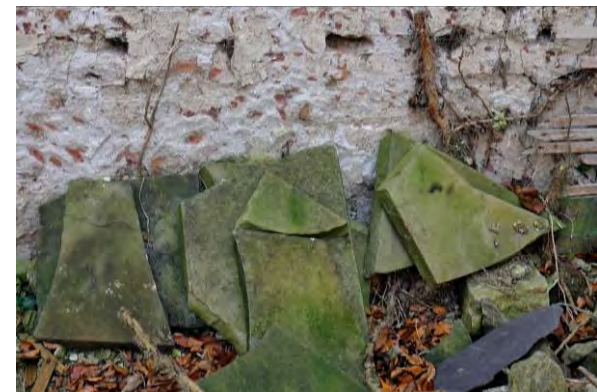
PIC. 18; FRAGMENTS OF FLOOR FLAGS?

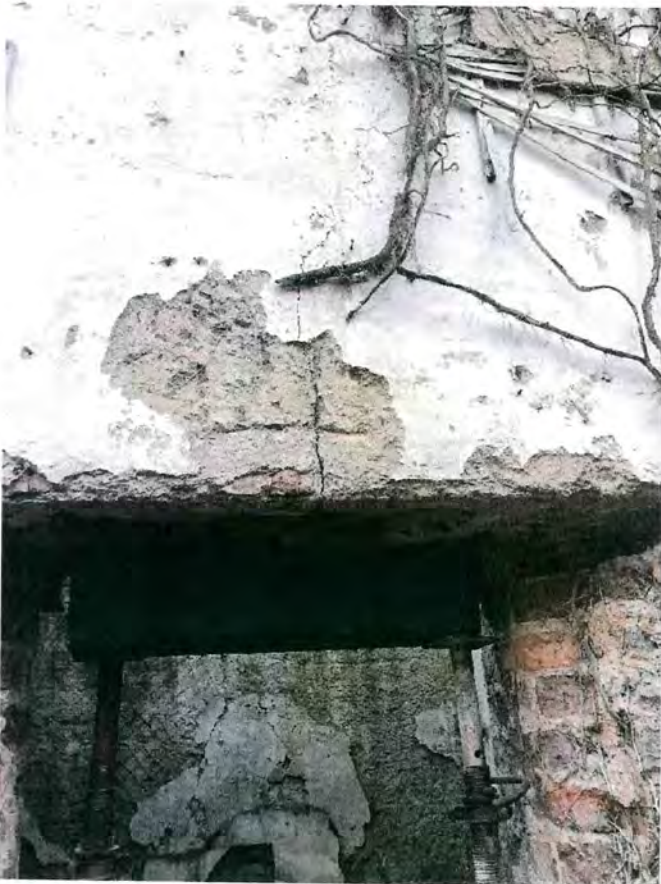
Photograph No.2

2.1.2 There is hairline cracking above the top left-hand corner of the door to the Vestry. There is also vertical cracking above the door opening. See Photograph No.2. This cracking is, most likely, associated with failure of the original lintels above this door. The original lintels consisted of timber planks which have completely perished. The masonry is currently propped. The installation of new lintels will be required in order to stabilise the existing structure at this door opening.

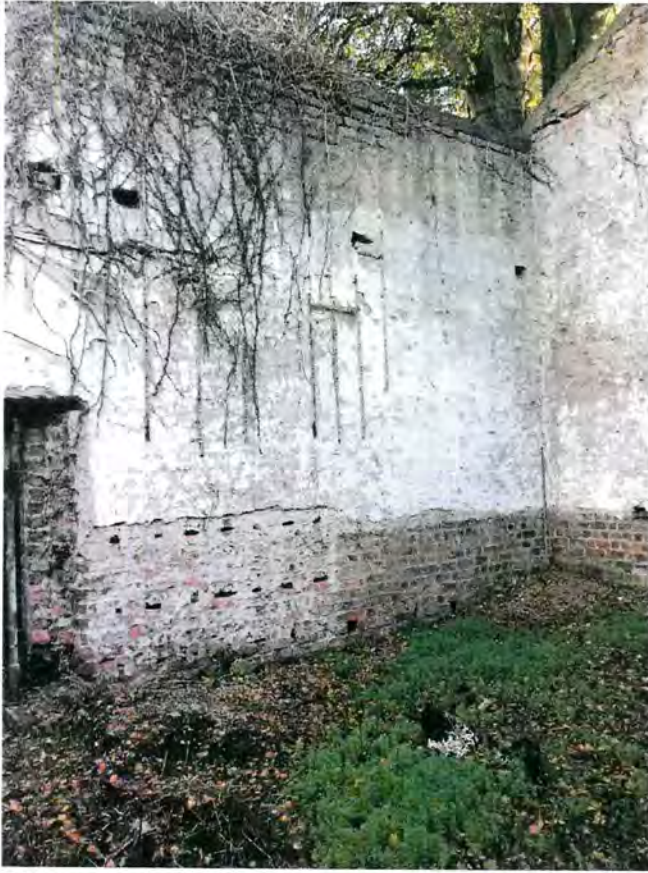
Photograph No.3

2.1.3 All vegetation should be cleared from around the structure. See Photograph No.3. The upper courses of brickwork will need to be raked out and repointed.

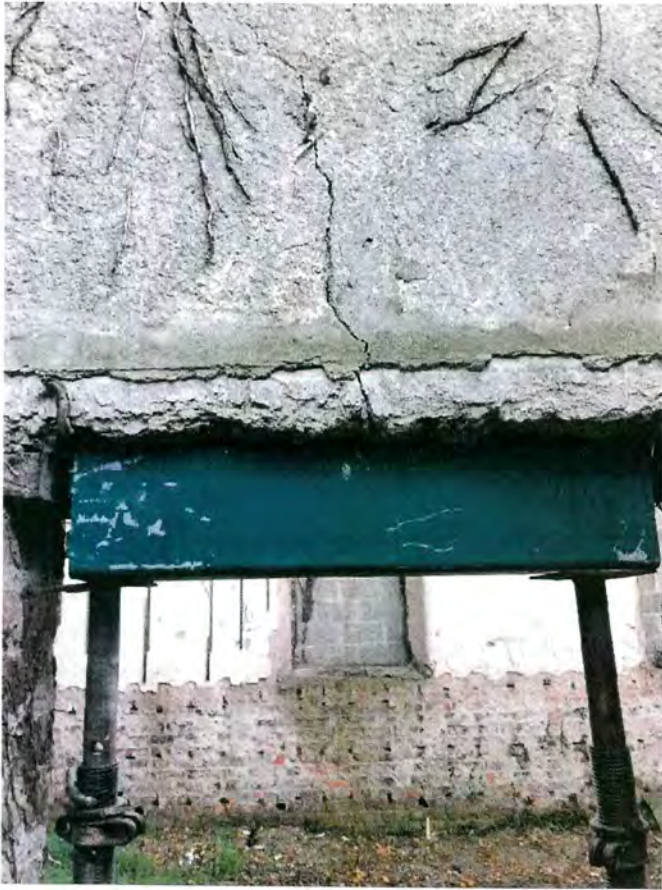
Photograph No.5

2.1.5 The vertical crack above the door to the Nave is also visible on this side of the wall. See Photograph No.5.

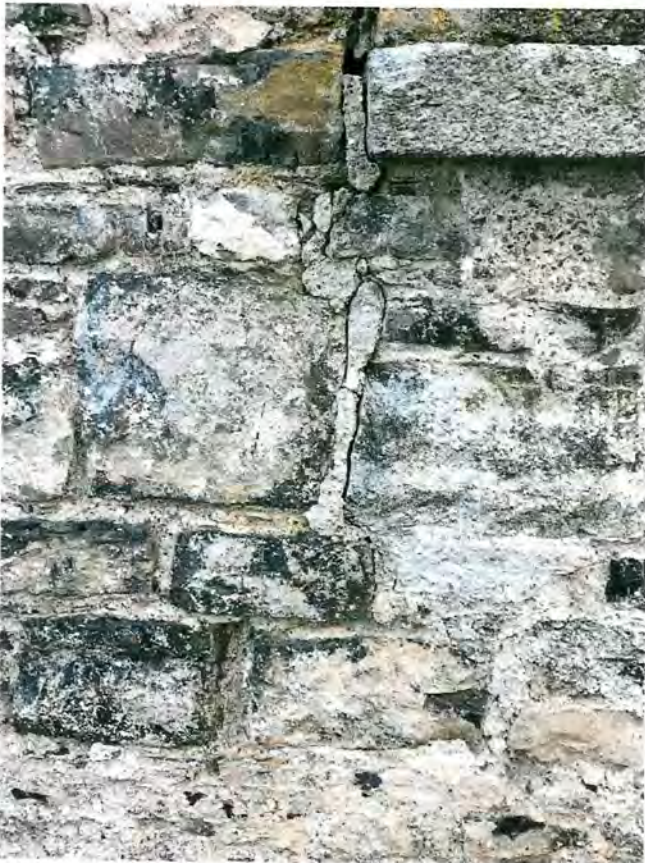
Photograph No.17

- 3.2.2 The cracking at the window opening outlined in Item 2.2.1 above (left hand side) is visible externally. See Photograph No.17. There is also cracking at the bottom left-hand corner of the window. See Photograph No.18. A gap has opened between the left side window reveal and the infill blockwork. See Photograph No.19. This gap, coupled with the cracking at the top of this window, may indicate that movement at the south-west corner of the Nave is ongoing. The remnants of a large tree/shrub are visible adjacent to this corner. It is possible that the killing of this tree/shrub and the subsequent shrinkage of the roots has led to settlement of the structure at this corner. It is possible that underpinning of the wall will be required at this corner in order to stabilise same.

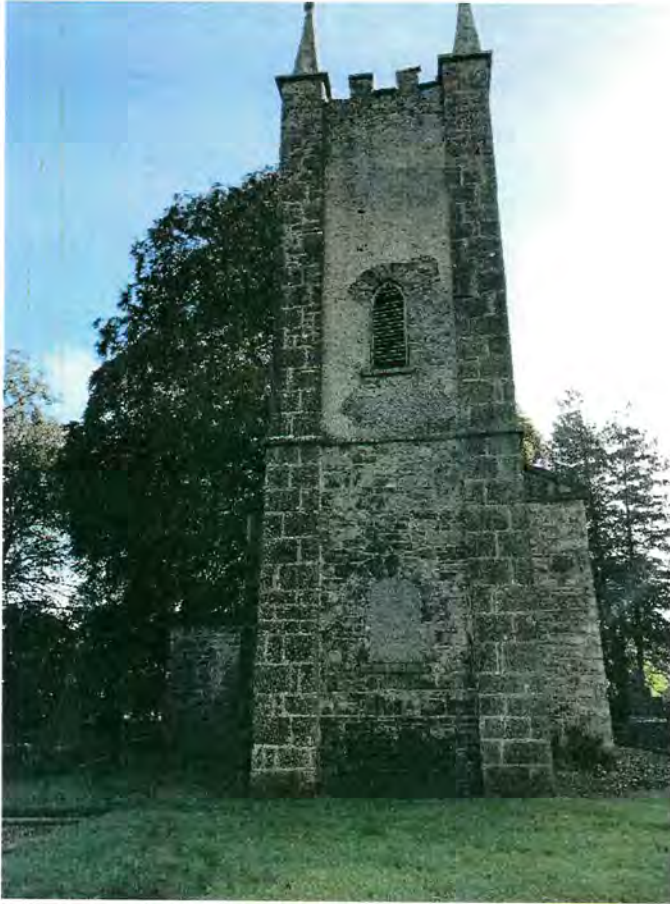
Photograph No.20

- 3.2.3 The Bell Tower appears to be in reasonable condition overall. See Photograph No.20. The stonework at the top section of the Bell Tower is in need of repointing.

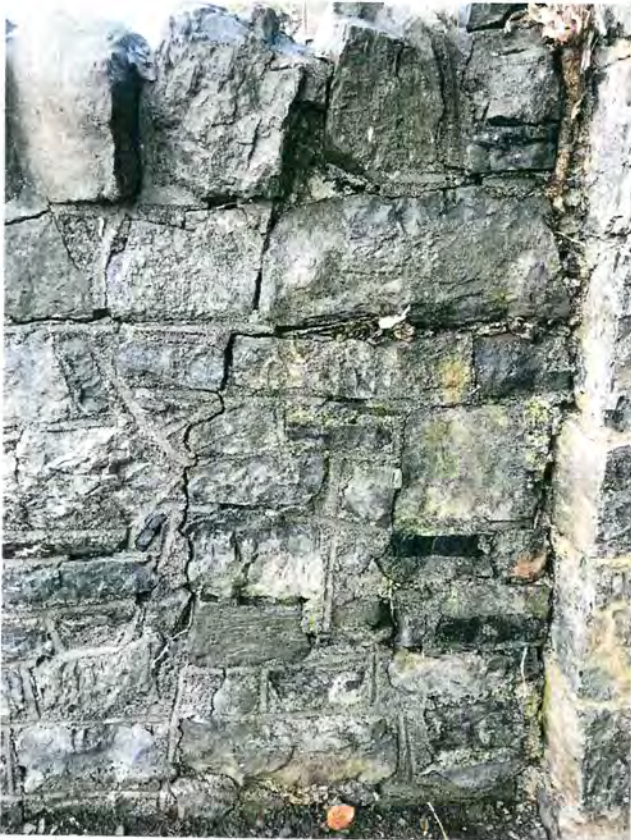
Photograph No.21

- 3.4.1 Overall, this elevation appeared to be in reasonable condition. The Bell Tower appears to be in reasonable condition overall. See Photograph No.21.
- 3.4.2 Please refer to Item 2.4.7 above with regard to the sealing of the roof of the Bell Tower.
- 3.4.3 It is reported by the Committee that a visual inspection of the upper sections of the Bell Tower was carried out from a Hoist. It is reported that the stone at the upper section of the Bell Tower is in poor condition and that the cappings and pinnacles can be moved by slight hand pressure. The stonework at the top section of the Bell Tower will need to be repointed. The cappings and pinnacles will need to be reset in place. In addition to this, all loose or dislodged masonry will need to be reset and bedded.

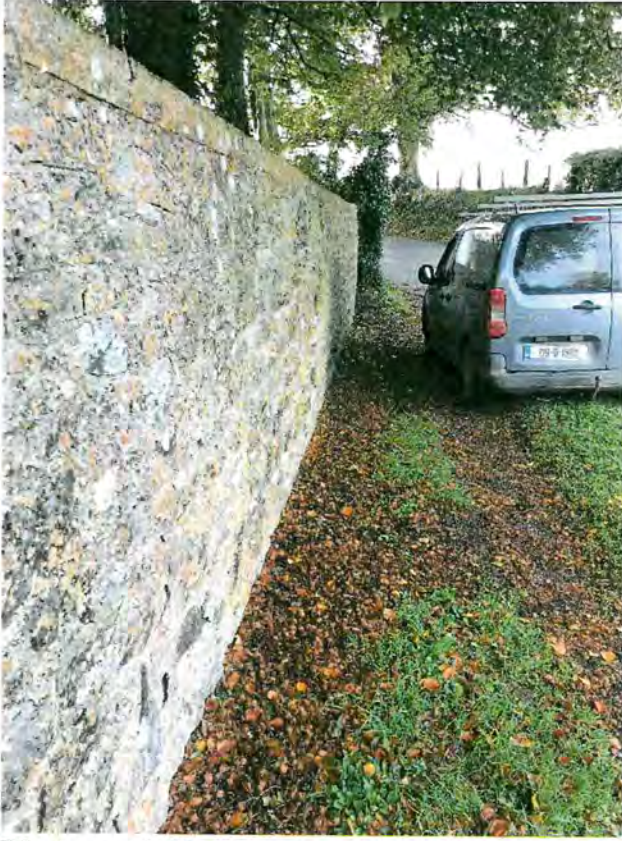
Photograph No.22

- 3.5.1 The left-hand side gate pillar has moved with associated cracking in the wall. See Photograph No.22. It is likely that the gate pillar will need to be underpinned in order to stabilise same.
- 3.5.2 The boundary wall along the right side of the front entrance is retaining a higher ground level of approximately 1.0metre. There are also mature trees growing behind this wall. Whilst the wall appears to be in relatively good condition overall, there is a noticeable outward bulge in one area of the wall. See Photograph No.23. It would appear that a section of the wall adjacent to this bulge has been rebuilt or, at least, repointed.

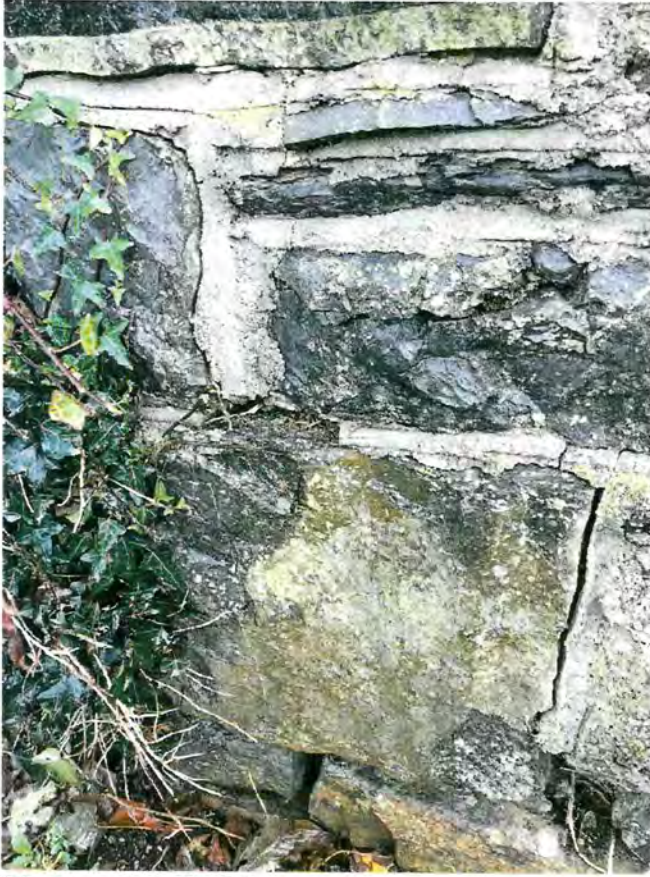
Photograph No.24

- 3.6.1 This boundary wall is retaining approximately 2.25 metres of ground. There is a sizeable crack in the wall adjacent to a tree stump. See Photograph No.24. It is most likely that the tree roots are responsible for the damage to the boundary wall. Therefore, the killing of this tree will be necessary in order to prevent further damage to the wall.
- 3.6.2 There is also cracking in the wall at the end of the site. See Photograph No.25.

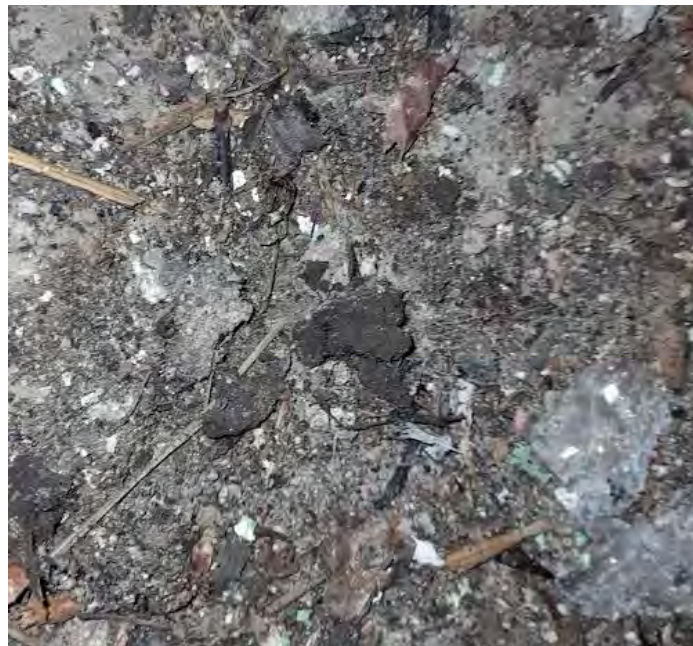
Figure 4. Small mammal droppings under belfry. Likely old bat leavings.

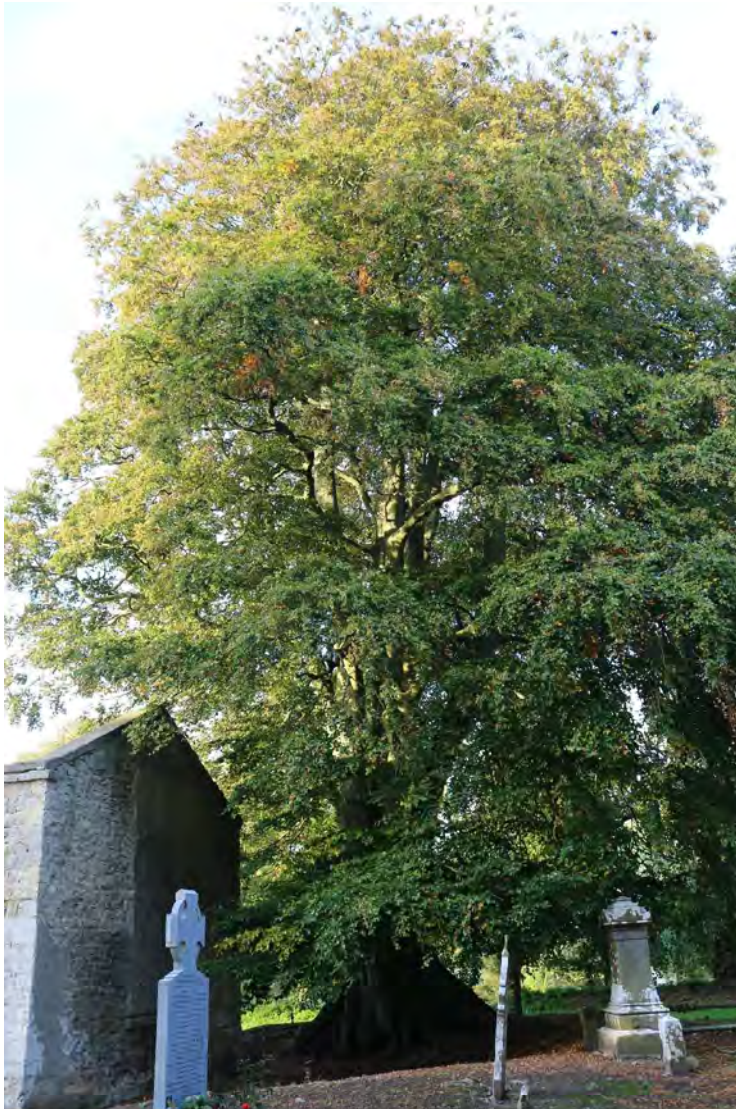
Figure 4: Excellent crown health and density

- 2.3 Crown health is excellent, with no significant disease or deadwood present. A very few, isolated and minor (small) natural dead branchlets are present in the central eastern and lowest western crown. Lower branch tips arch down to 1 - 2 m above ground level. The western crown overhangs above the (roof-less) eastern gable end of the church.

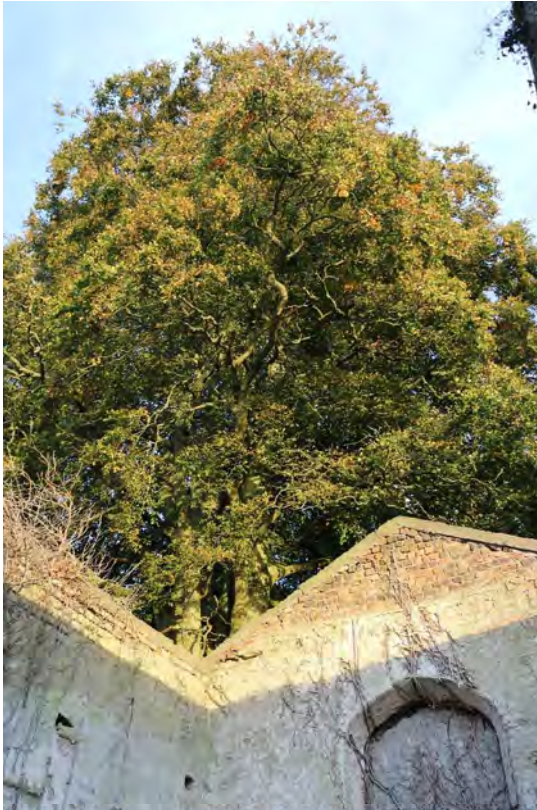
Figure 5: Western crown above eastern gable end of church.

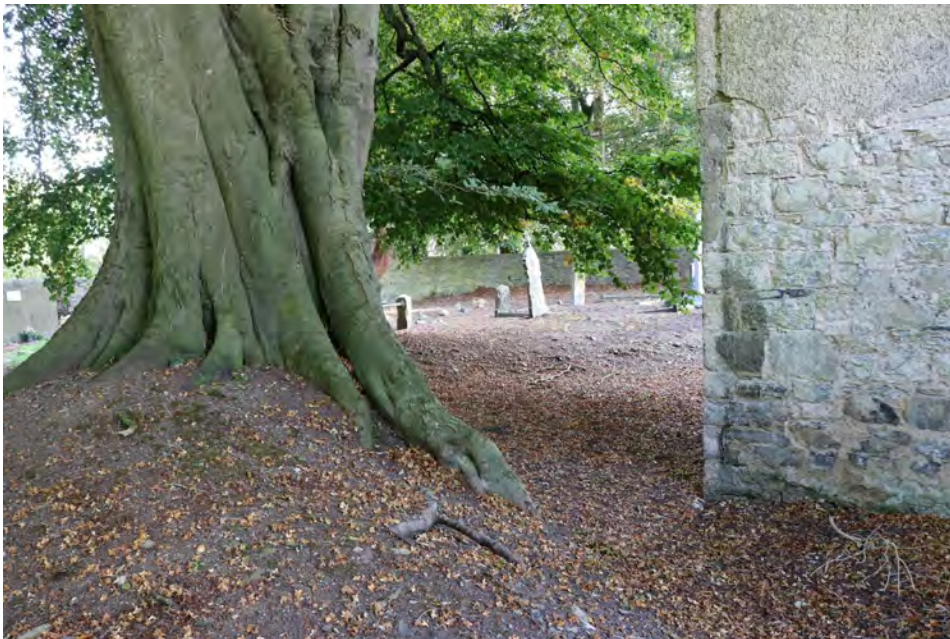
- 2.4 The ground level drops west of the tree towards the church. The stem base of the tree is centred c. 3.3 m from the adjacent (north-east) end corner of the church building. At its closest, the south-western buttresses of the tree are 2 m from the church, and c. 5 m east of the vestry. There was no damage, obvious to me, to the north-eastern corner wall of the church building.

Figure 6: Base of tree beside north-eastern corner of church.

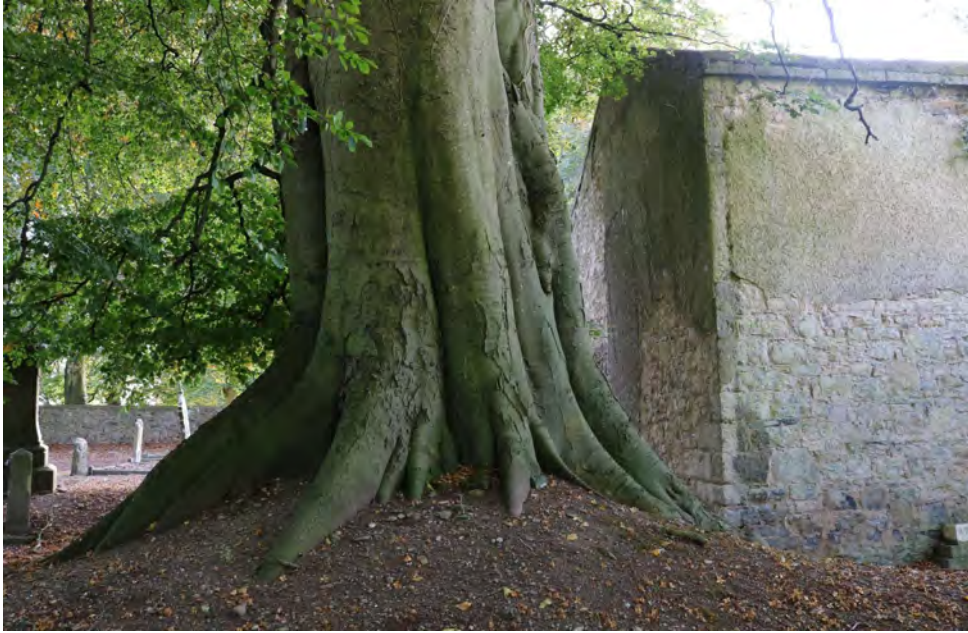
Figure 7: Northern side lower stem – exceptionally large circumference, live and intact.

2.5 At the base of its large diameter stem there are c. nine buttresses, all live and intact. The lower stem circumference is almost entirely live and intact, other than for one old basal wound on the south-western lower stem. This old, long-standing wound cavity between two south-western buttresses is c. 1.4 m in length and c. 50 cm at its widest point at ground level. The exposed wound surface within is decayed, with several atrophying fungal fruit bodies of *Cerioporus squamosus*. Around the edges of this old wound cavity is strong healthy occluding woundwood.

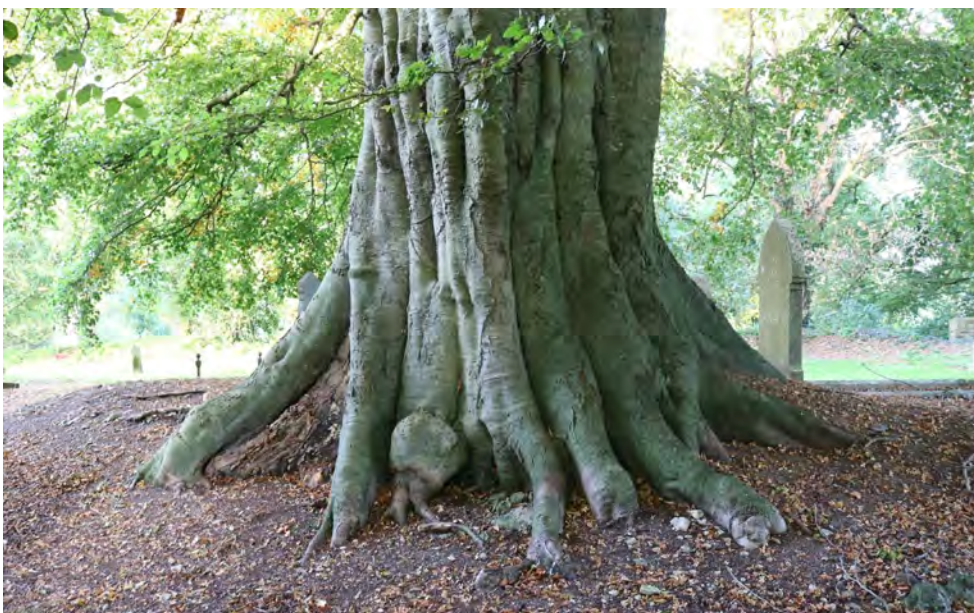
Figure 8: Southern side of lower stem; intact buttresses and old SW basal wound cavity.

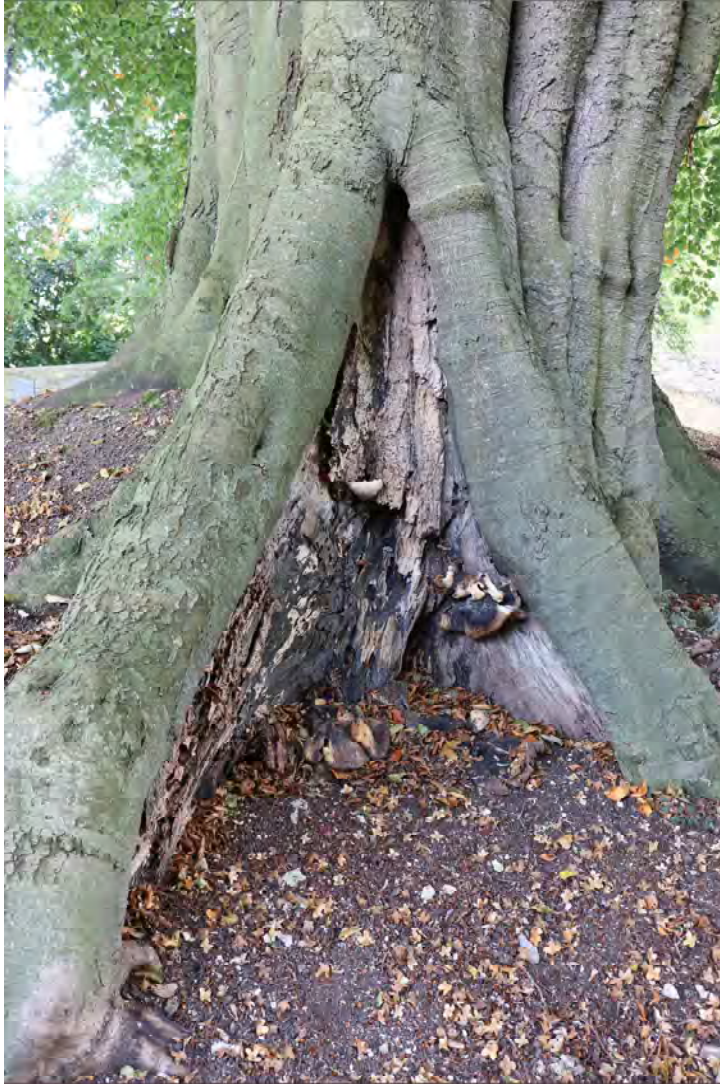
Figure 9: Old wound cavity in south-western stem base; old exposed wood naturally decaying. Over many decades the cavity is being occluded and 'reinforced' by strong woundwood edges on the buttresses either side.

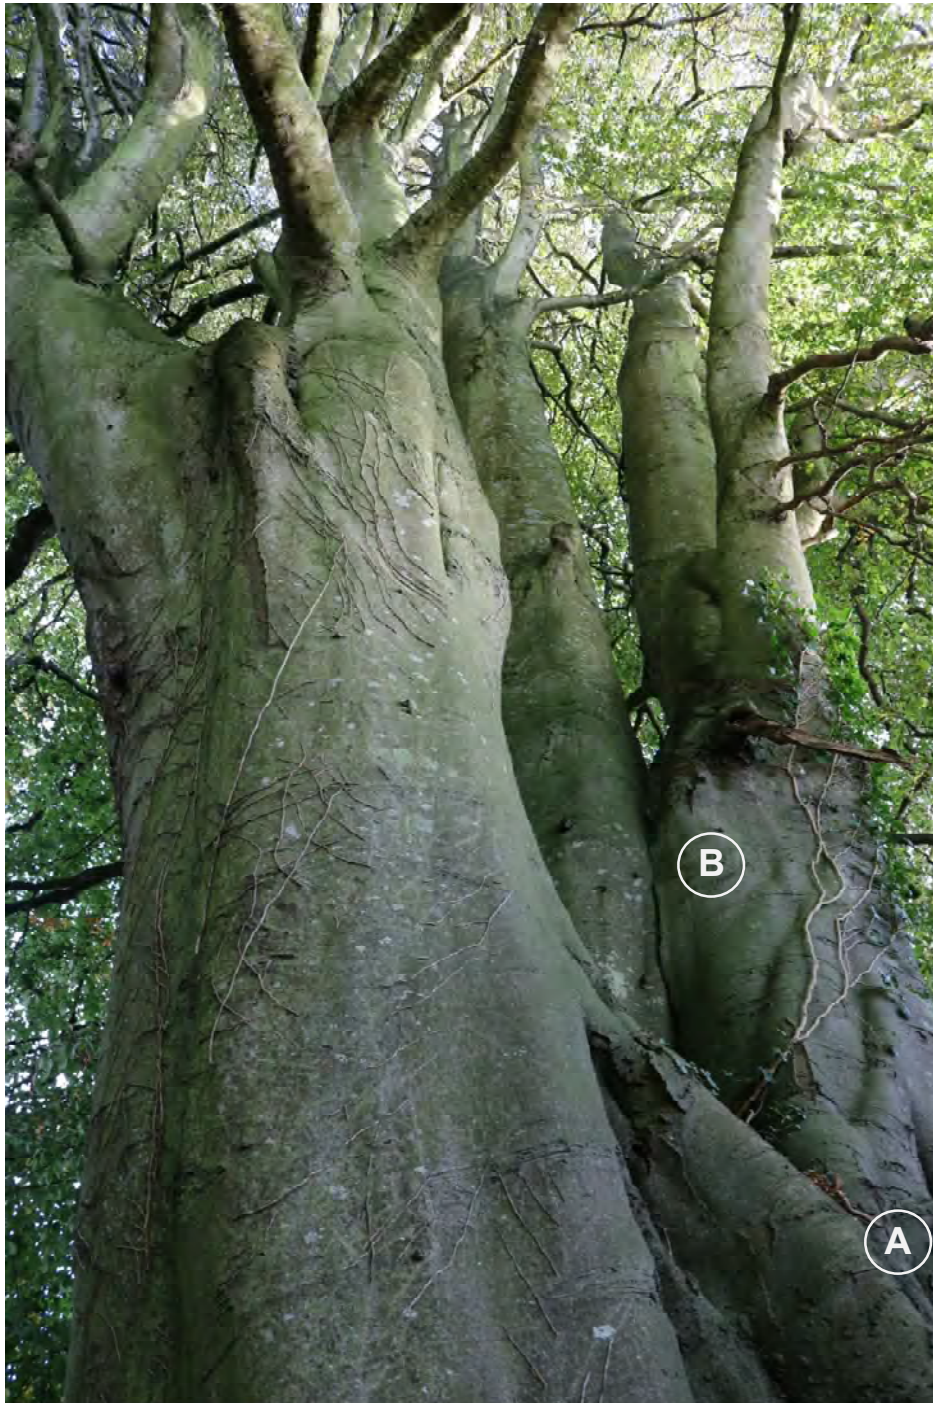
Fig 11: (A): main lower stem junction (fork); (B) southern co-dominant limb fork

2.7 The main stem forks at c. 2.5 – 3 m, and its southern co-dominant stem forks again at 3 - 4 m height (Figure 11, above). These main fork unions appear relatively stable; effectively welded by large rounded columns of adaptive wood growth descending from the junctions. The southern co-dominant limbs are basally appressed but appear effectively welded by a strong, long-standing cambial column on the southern side of the fork junction (Figures 12 & 13, below). No splits, cracks or necrotic inclusions were apparent in the fork unions. There was no recent storm damage (branch or limb fracture failures) apparent.

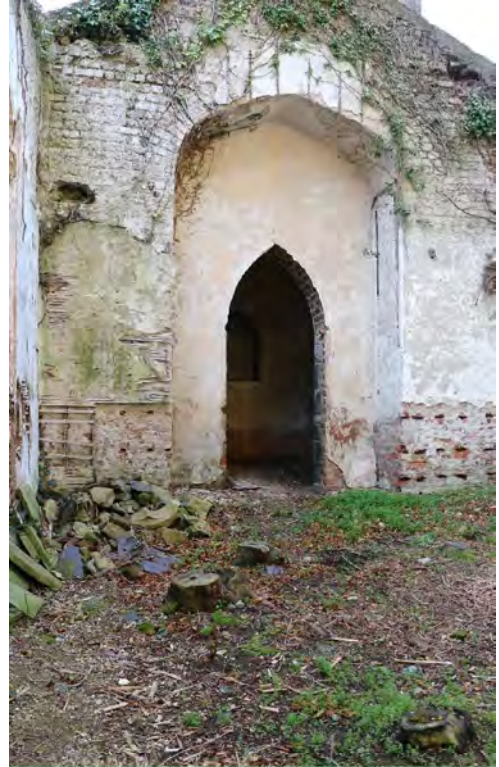
2.8 The other trees in the walled graveyard (not inspected), include a small mature cypress in the south-eastern corner, and a line of early-mature sycamore and ash along the northern boundary with the neighbouring field. Inside the church (nave) are several stumps of semi-mature sycamore trees felled in the past. These were with reasonable certainty self-seeded (after loss of the church roof). They appear chemically treated (effectively killed) and are not re-sprouting.

Fig 15: Sycamore stumps within church

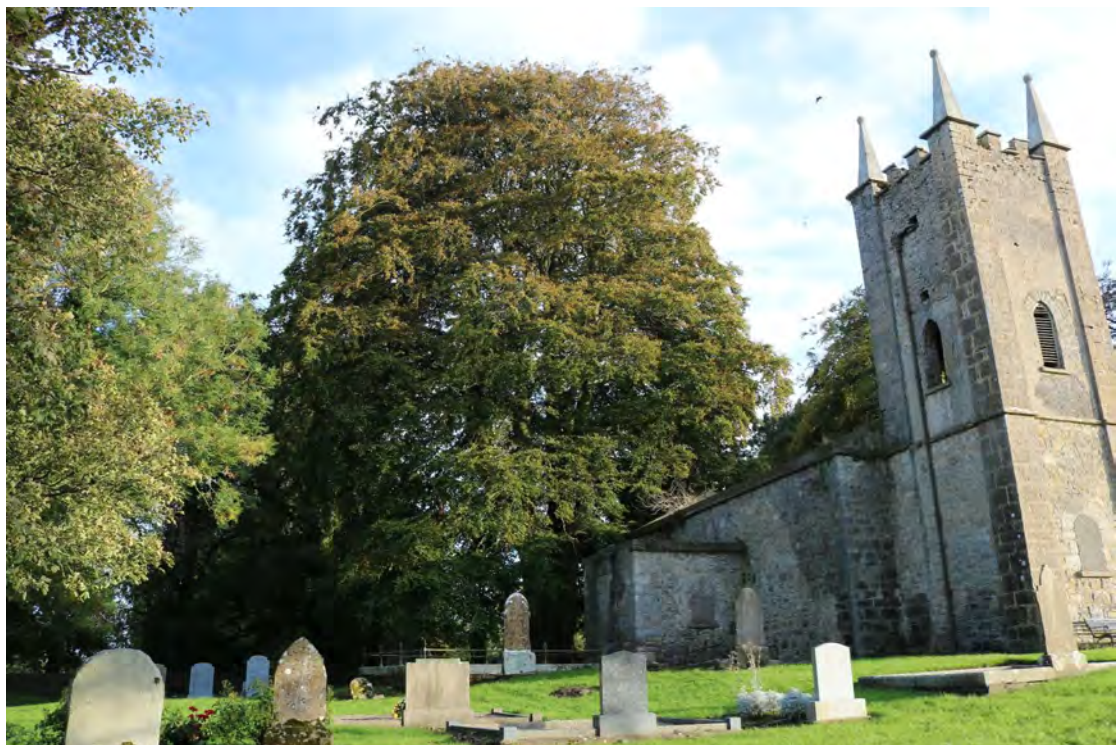
Figure 19: Subject tree: a prominent and defining feature.

- 3.10 Its fine form, impressively large size and defining prominence make this a tree of exceptional heritage value.

- 3.9 On current evidence, pruning would be of no benefit. Some minimal selective pruning (specified by an arboriculturist) and expertly executed by suitable contractors should be not unduly detrimental to the appearance or condition of the tree, if it were required for clearance from the outer eastern wall of the church building. Any significant cutting back of the main crown, however, would merely cause physiological stress, xylem (vascular) dysfunction and damage, and thereby increase vulnerability to serious disease and mortality. Similarly, any significant excavation, soil contamination, or machinery tracking in proximity to the tree would be irreparably damaging and could be potentially destabilising.
