Wetland Study Phase I Howth Co. Dublin

Final Report

prepared for Fingal County Council

Project No.	Rev.	Author	Reviewed By	Approved By	Issue Date
200100	13	AF	KMOC	ACr	09/03/2021

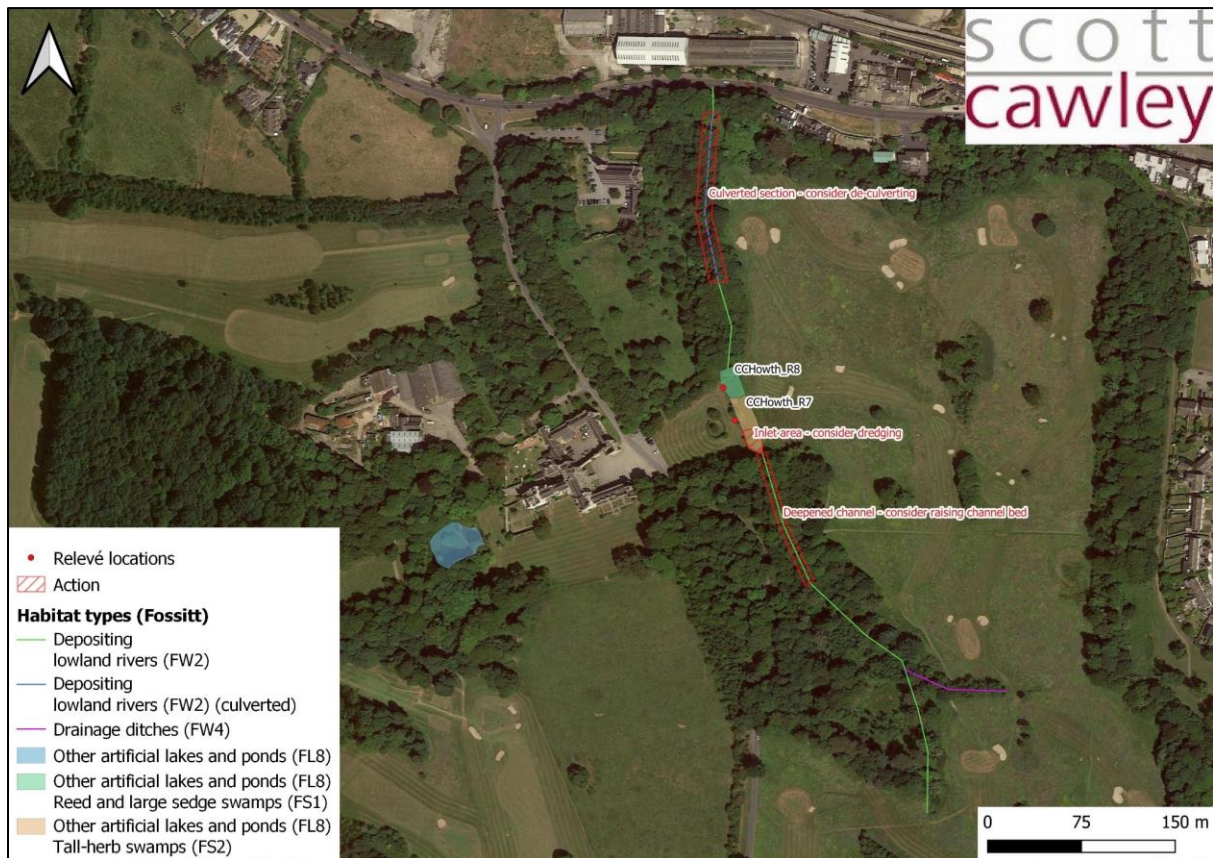
Figure 17 Bloody Stream and Hawth Castle ponds (Swan Pond in the west and Black Jack's Pond in the east) (Site 10).

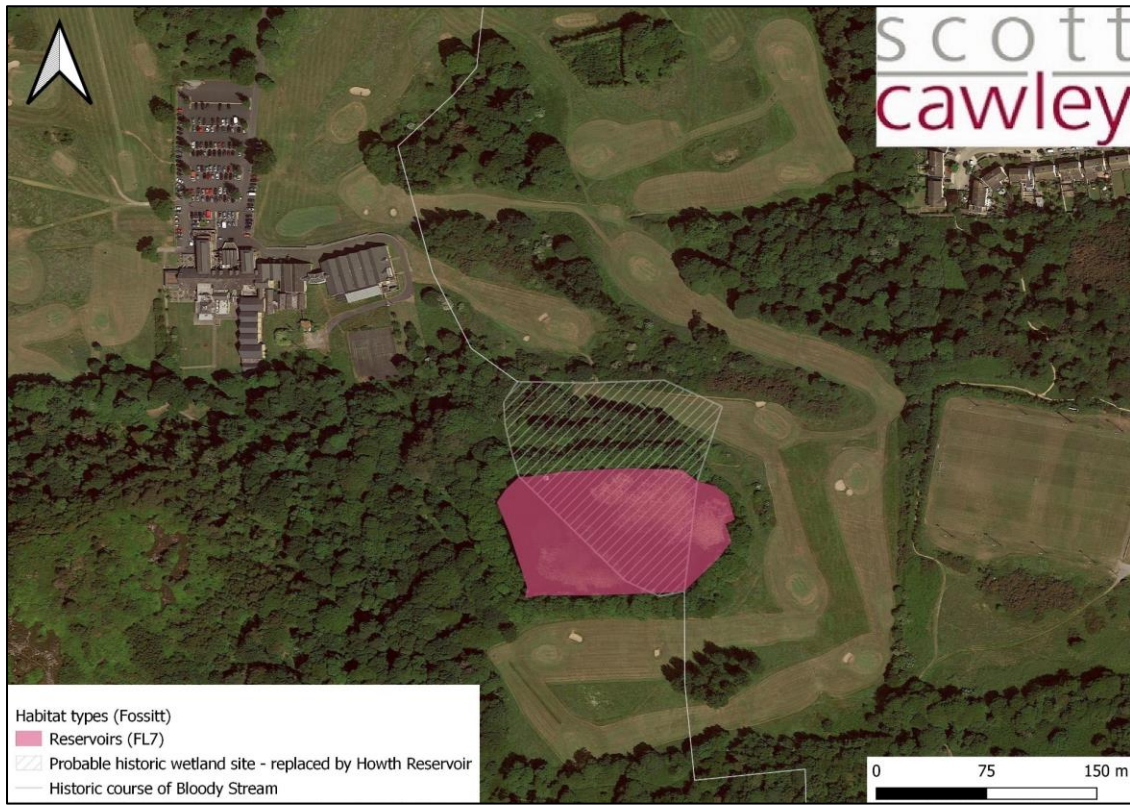
Figure 18 Howth Reservoir (Site 10) – also including former course of Bloody Stream and probable former wetland (“Ballykill Bog”) site prior to construction of Howth Reservoir (from historic 25 inch maps from 1888-1913).

1. Install water level logger to confirm degree of water level fluctuation in reservoir. This is important to better understand maximum potential release of uncontrolled water in event of sluice failure.
2. Perform inspection of sluice mechanism to confirm invert level of reservoir.

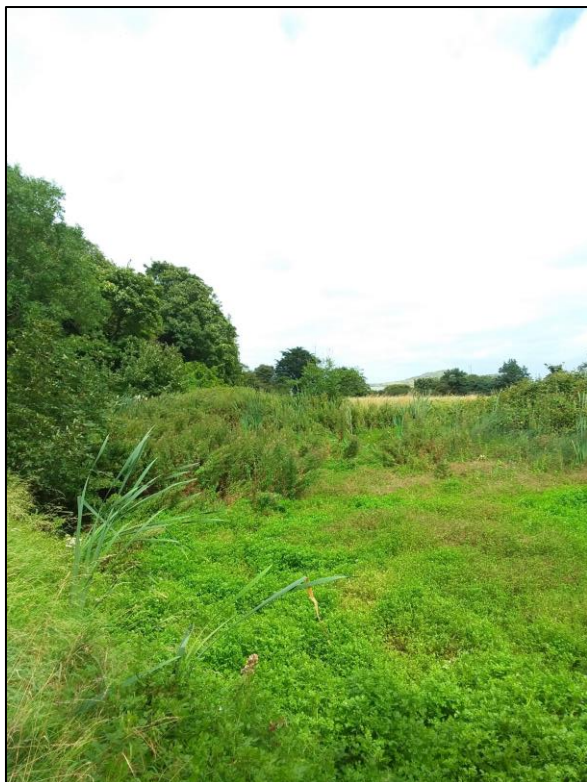
The most notable vegetation in this site can be found in the associated ponds, in particular, Black Jack's Pond. This pond contains both reed and large sedge swamps (FS1) and tall-herb swamps (FS2) vegetation. The FS1 vegetation is largely dominated by *Typha latifolia* (Bulrush). This is most comparable to the *Phragmites australis* – *Typha latifolia* swamp community (FW3B), although this *Typha*-dominated form (with no *Phragmites australis* (Reed) present) needs to be updated as a new swamp community (P. Perrin, pers. comm., November 2020). The FS2 vegetation is largely dominated by *Epilobium hirsutum* (Great Willowherb) and *Nasturtium officinale* agg. (Water-cress). The vegetation communities within the pond include the *Eleocharis palustris* – *Agrostis stolonifera* marsh/fen (FE3C) community (relevé CCHowth_R8). This marsh community is quite varied in herbaceous grass, sedge and forb species, which may include *Eleocharis palustris* (Common Spike-rush), *Agrostis stolonifera* (Creeping Bent), *Mentha aquatica* (Water Mint), *Helosciadium nodiflorum* (Fool's-water-cress), *Nasturtium aquaticum* agg. and *Juncus articulatus* (Articulated Rush). Also in this pond and on its margins, *Holcus lanatus* – *Lolium perenne* grassland (GL2C) occurs (relevé CCHowth_R7), which is a relatively species-poor community of low conservation value, often dominated by *Holcus lanatus* (Yorkshire Fog), *Agrostis stolonifera* (and *Lolium perenne* (Perennial Ryegrass) in the more improved examples, not found here), along with *Ranunculus repens* (Creeping Buttercup) (NBDC, 2020). The relatively frequent *Apium nodiflorum* – *Rorippa nasturtium-aquaticum* agg. aquatic community (FW2E) also occurs in the pond.

Plate 32 *Black Jack's Pond, just east of Howth Castle (location of Relevés CCHowth_R7 & CCHowth_R8).*

2. Consider dredging the entire pond. This would facilitate a more suitable target depth of water for particular species, shelving within pond, and would also increase attenuation capacity. There is an estimated 1 m of sediment in the downstream (northern) end of the pond.
3. Remove fallen trees from impoundment walls to prevent structural damage of pond.
4. **Considering repairing the breach on eastern side of pond impoundment wall. This would raise pond water levels by 1m (if considered desirable).**
5. **Repair sluice in impoundment wall to complement recommendation 4 above. Calibrating the sluice would enable the pond to attenuate higher inflows. Similar rehabilitation of the two downgradient dam walls would allow targeted water depths in the stream intervals which could be used to promote different wetland plant species/vegetation.**

3. Some undermining of stream banks upgradient of pond. Reinforcement works not considered urgent; however, a biannual inspection and maintenance programme is recommended.

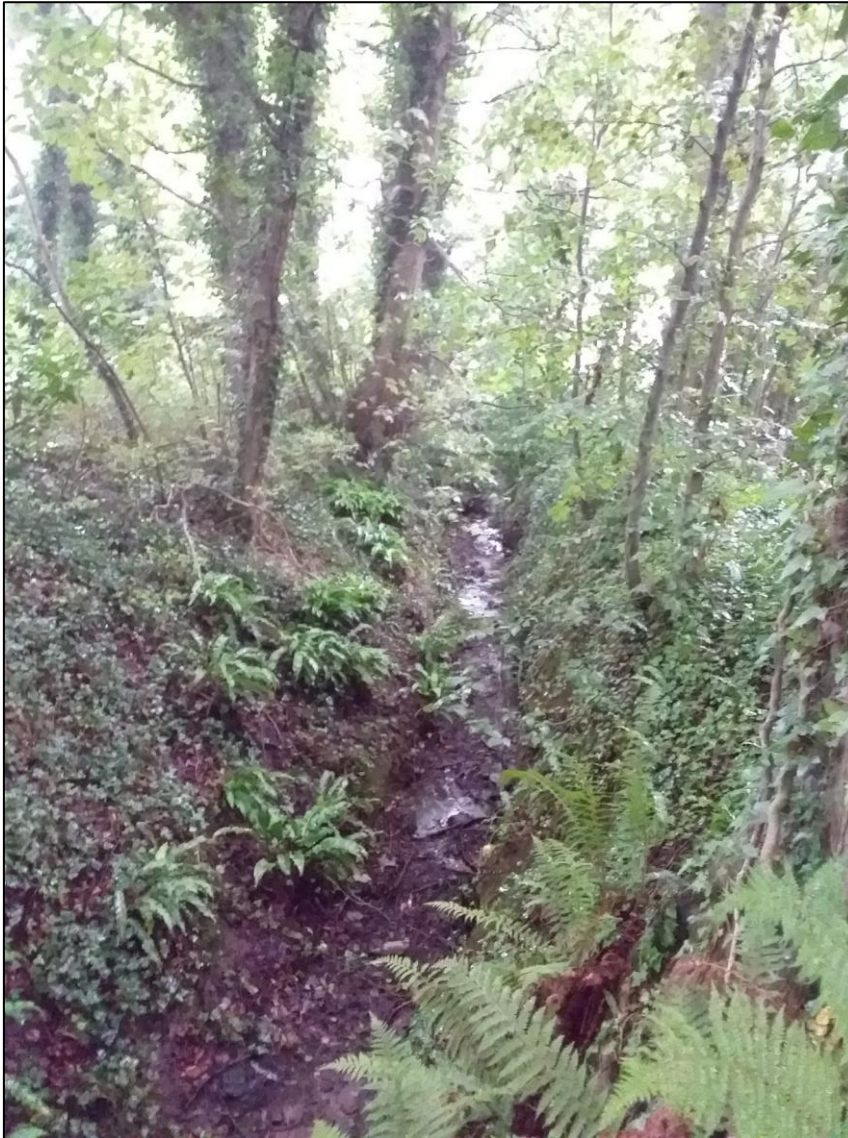
There is more or less no existing wetland stream vegetation within the Bloody Stream FW2 habitat (nor indeed in the associated FW4 drainage ditches) itself, unlike most of the other streams on Howth Head, which indicates how poor the condition of this stream is currently.

Plate 33 *Bloody Stream, just south of Black Jack's Pond – deepened stream course, with little or no wetland vegetation present. Dry woodland vegetation occurs on the stream banks.*

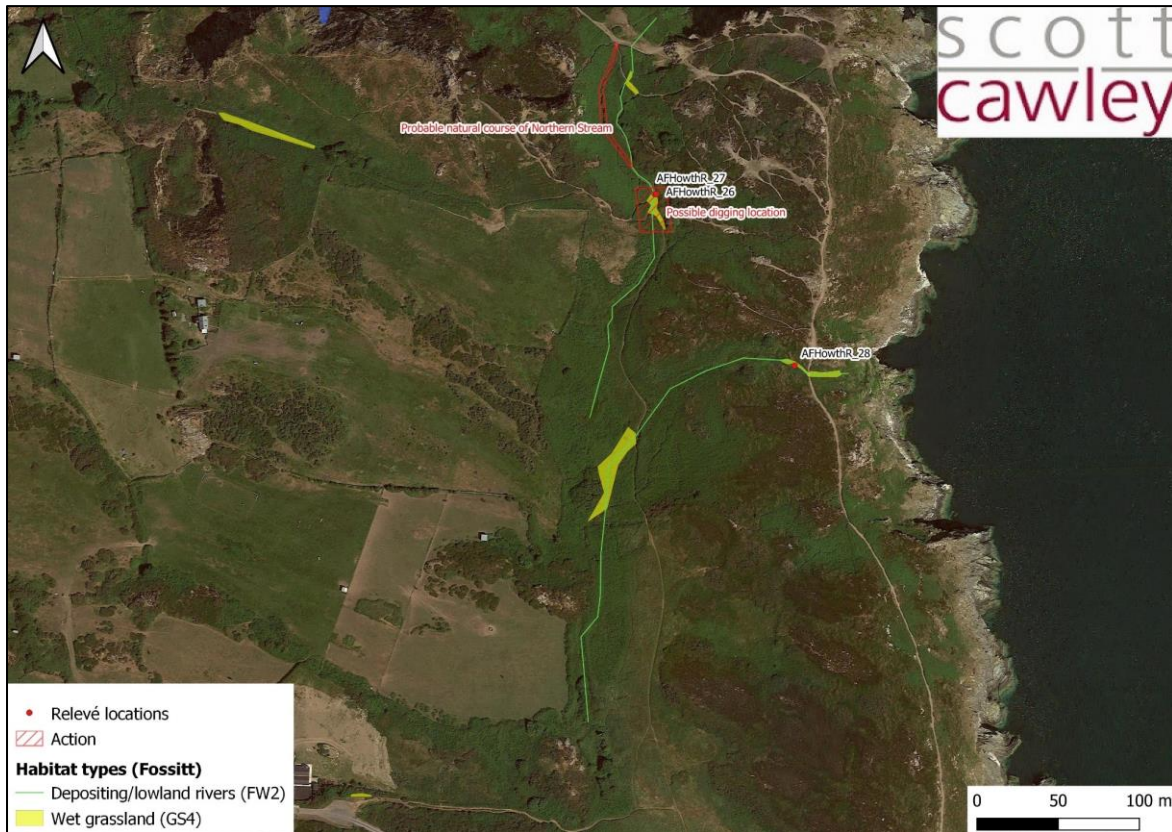
The wetland vegetation in this site is predominantly made up of wet grassland (GS4), which indicate the flow of the streams throughout the site. Much of this wet grassland is drying out (perhaps indicating disruptions/changes to water flow rate and direction) and is represented by *Holcus lanatus* – *Lolium perenne* grassland (GL2C), which is a relatively species-poor community of low conservation value, often dominated by *Holcus lanatus* (Yorkshire Fog), *Agrostis stolonifera* (Creeping Bent) and *Lolium perenne* (Perennial Ryegrass), along with *Ranunculus repens* (Creeping Buttercup), *Trifolium repens* (White Clover), *Cerastium fontanum* (Common Mouse-ear), and in this area, often a significant presence of *Epilobium*

Scrub and *Pteridium aquilinum* encroachment on the streams is a primary threat, whilst in the other scattered areas of wet grassland, diversion of upstream water sources (e.g. for the pasture fields to the west) is a threat. Eutrophication caused by upstream water inputs from pasture fields may also potentially threaten these wetlands.

Figure 20 Eastern Stream, Northern Stream and wet grassland habitats at the Nose of Howth (Site 11).

1. **Consider feasibility of digging holes/ponds in areas of wet grassland vegetation in order to better access the water table (see Figure 20).**
2. **Intermittent physical cutting of scrub (e.g. dense *Rubus fruticosus* agg.) (in winter and all cuttings should be removed from the site) and *Pteridium aquilinum* (cutting twice per year, at start and end of summer and all cuttings should be removed from the site) along portions of the short stream in order to improve the species-richness of the stream bank and other wetland vegetation in this area. No herbicide should be used for this purpose. Also physical removal of scrub from the sources of both streams would be advisable, in order to better ascertain their sources.**

3. Install culvert or raised path/boardwalk section to prevent stream bed and bank erosion where streams cross walking pathway.
4. Consider diverting Northern Stream flow away from walking pathway and into the narrow valley to the immediate west of the pathway.

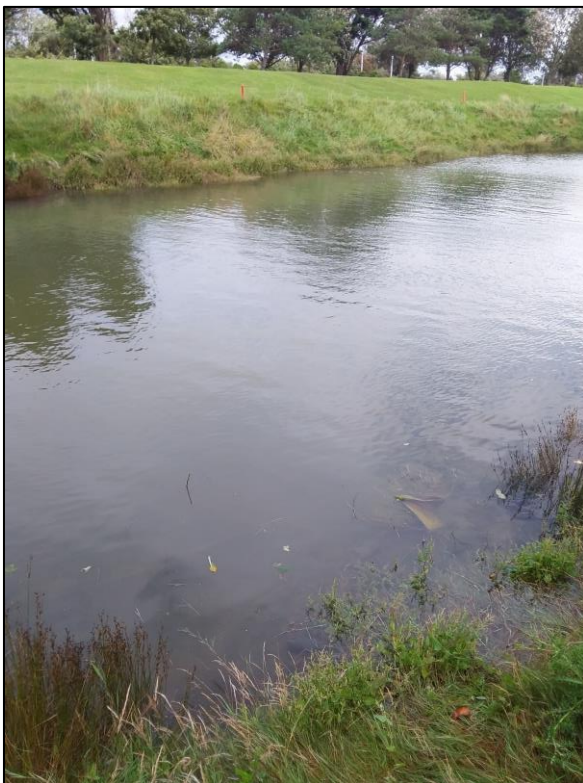
The south-westernmost pond in the site contains, unlike the other three, a pronounced brackish water influence, and as a result, a salt-marsh type of vegetation has developed in it. Although artificial, the pond water and vegetation mimics that of a lagoon. Two salt-marsh vegetation communities were present in the relevés, namely, *Festuca rubra* – *Agrostis stolonifera* saltmarsh (SM4A) and *Festuca rubra* – *Plantago maritima* saltmarsh (SM4D). However, salt-marsh habitat was not mapped or assessed further for this study.

Plate 37 Brackish pond in Sutton Golf Club (site 12), with salt-marsh/lagoon vegetation.

1. **Consider constructing new and larger ponds near to existing ponds (and/or connecting existing ponds via channels) to increase available wetland habitat. Consider creation of further artificial lagoon-type habitat utilising brackish water influence.**
2. Consider dredging of existing ponds if/when they become choked with organic sediment.
3. Monitor the ponds on an ongoing basis in terms of surface water quality.

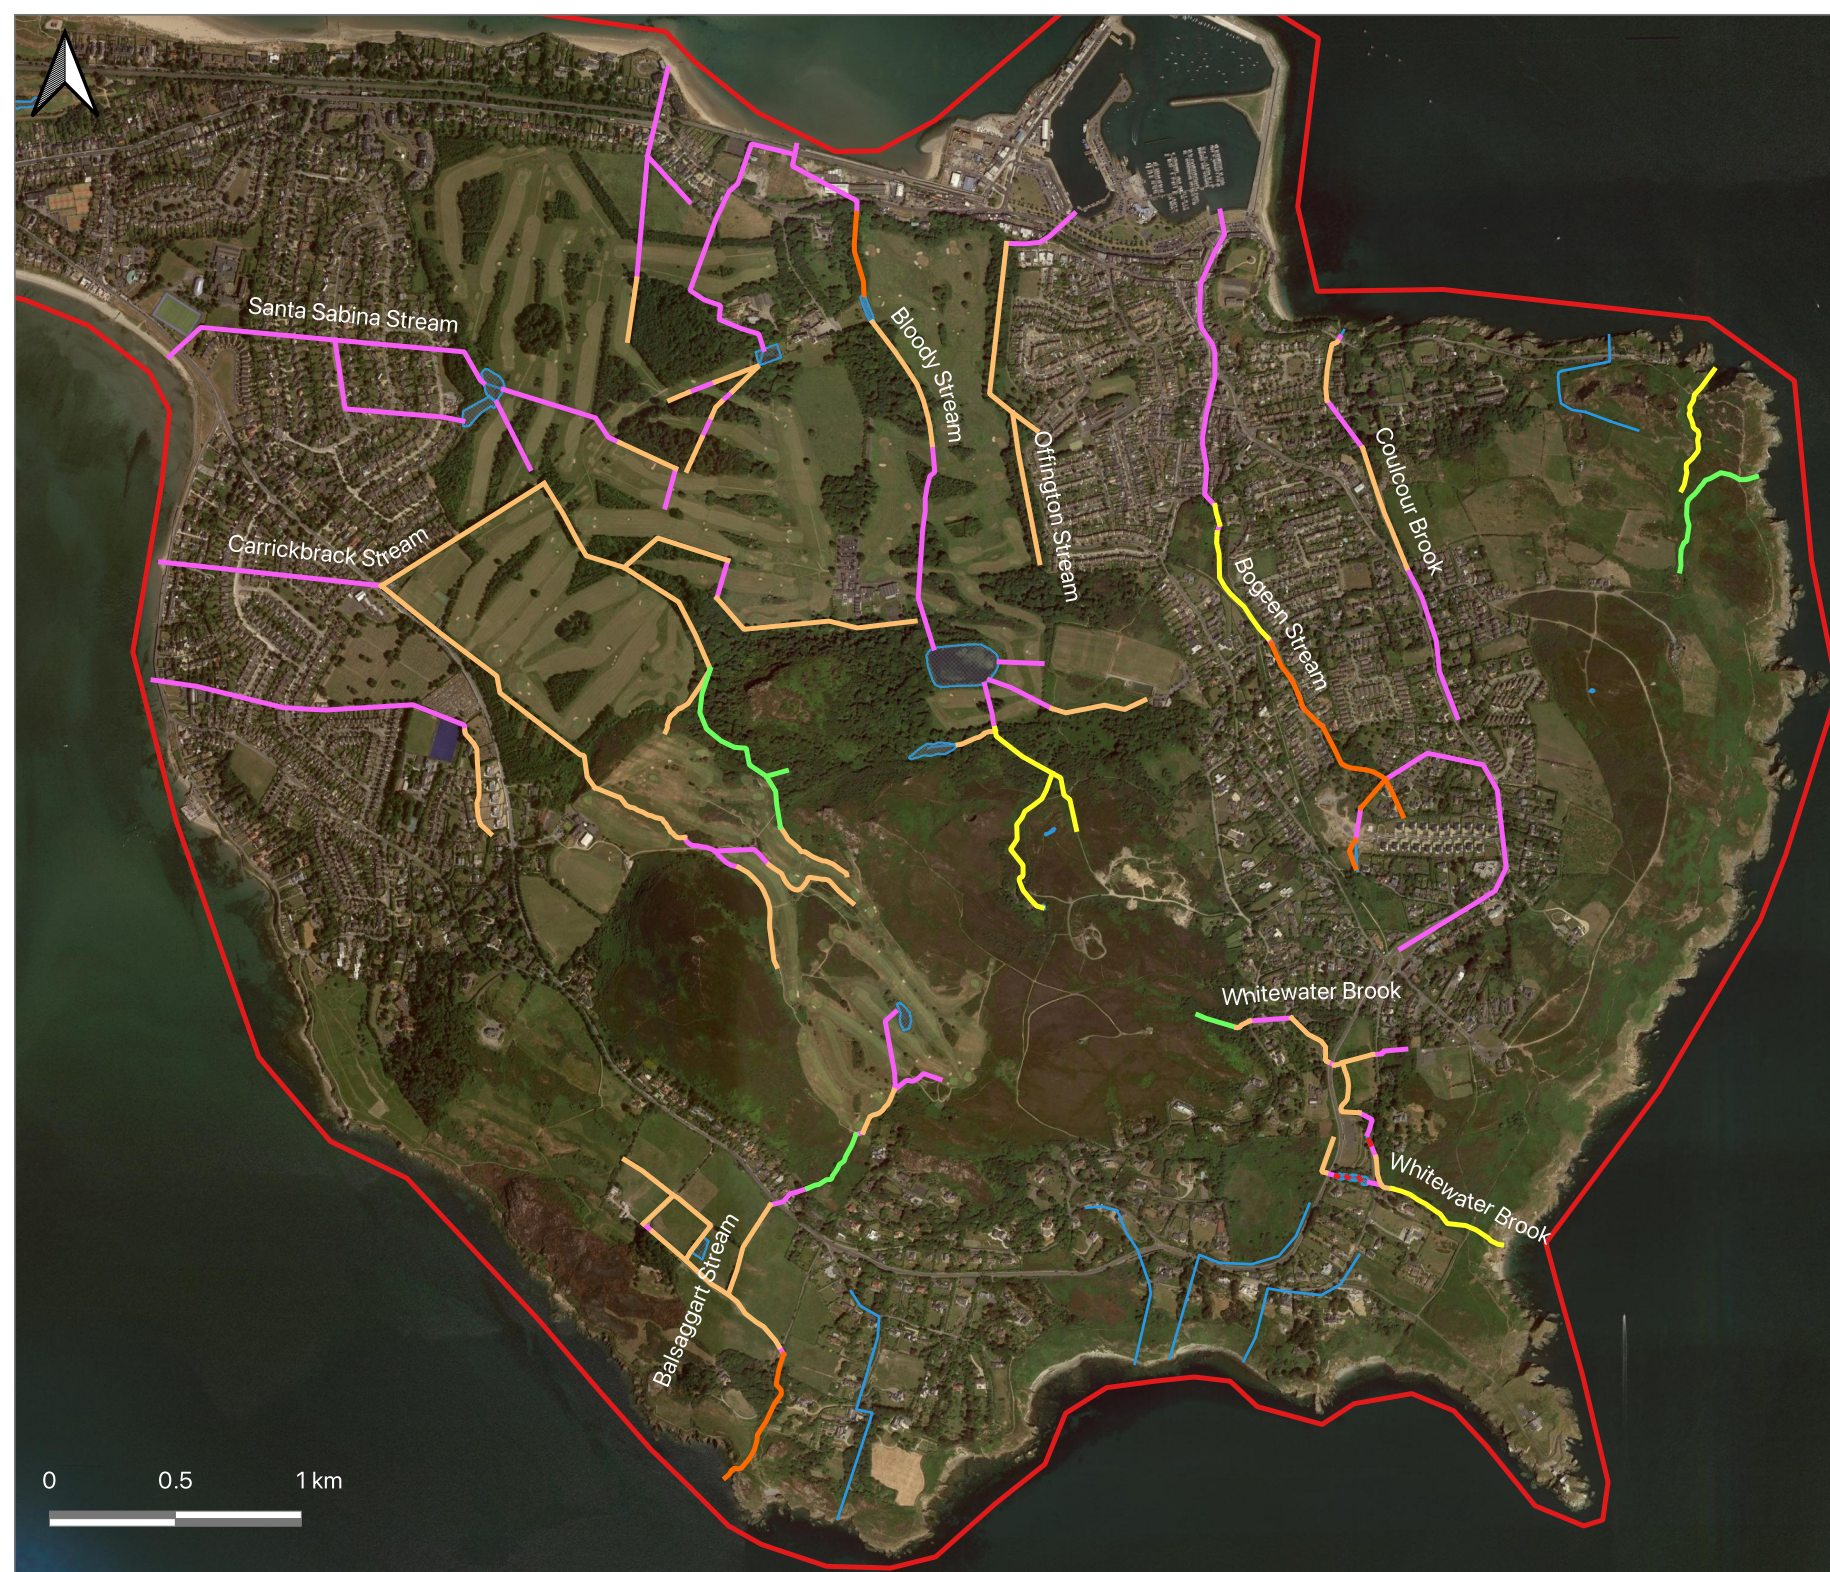
The total score was used to categorise each discrete watercourse segment (Table 2) and these have been colour-coded to provide a graphical representation of stream naturalness across Howth in Figure 8. Given the propensity of long culverted sections in the area these have been given their own separate category, though they are considered to correlate with 'severely modified'. No 'pristine' streams, i.e. having no artificial modification, exist on Howth. Four sections of stream channel are classified as semi-natural, with these occurring primarily in the higher areas where no development works have taken place.

Figure 8:	Naturalness (HMS) Map
Date:	January 2021
Project:	1779
Author:	COR
Scale:	1: 30,000
Client:	Fingal County Council
Project:	Hydrology of Howth Wetlands
Location:	Howth, Co.Dublin

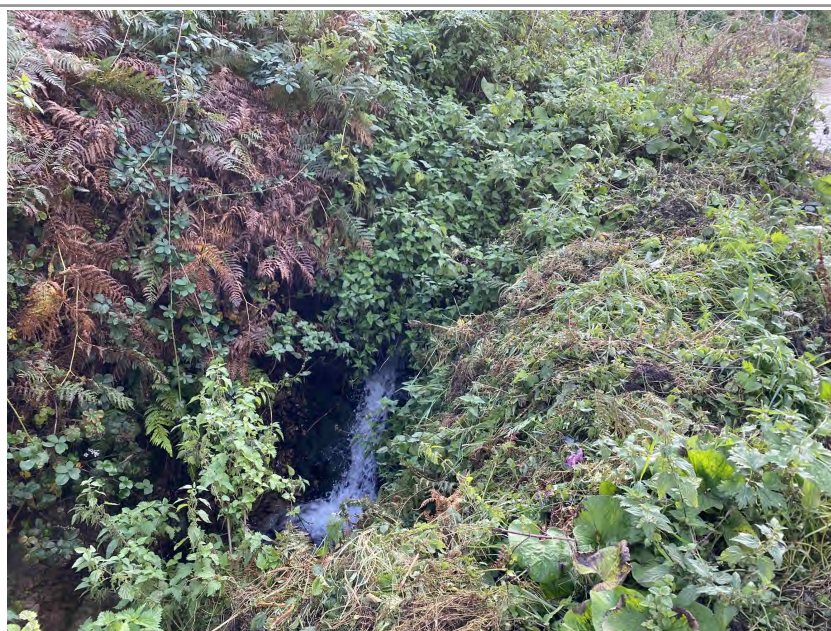
Bedrock	Cambrian greywacke (majority of catchment)	Proximity of Structural Fault	Mapped as passing over two SW-NE faults
Subsoil	Quartzite till / Sandstone gravels / Limestone gravels	Soil	Shallow, well-drained acidic mineral
Exposures	Lower half of catchment is urbanised. Some exposed bedrock on western side of stream adjacent to Dungriffin Villas.

Channel Length	1,400 m	Catchment to Outfall	97 ha
Channel Dimensions	Gray's Lane: bed width = 0.5 m, bank height 1 m, bank top width 3 m. Dungriffin Villa's: bed width = 0.75 m, bank height 2 m, bank top width 4 m.		
Water Levels	87.03 - 84.44 mOD along Gray's Lane; 80.31 - 50.07 mOD between Dungriffin Road and Balglass Road; Inaccessible from Balglass Road to outfall.		
Gradient	Gray's Lane = moderate; Dungiffin Road - Harbour = steep		
Primary Inflows	Outfall from Thormanby Woods (Site 1) via 600 mm diameter culvert; IL = 87.25 mOD; flow = c. 10 l/s. Stormwater network along route.		
Drainage Description	<p>As the stream flows through the Gray's Lane area it is culverted beneath the entrance to several residences. These culverts are composed of a variety of structure types and orifice sizes, generally set within cast/block headwalls. It is unclear if these culverts contribute to flood risk. Upgradient of Dungriffin Road the stream flows along a constructed stone channel within private gardens, which includes a number of small weirs and pools.</p> <p>Vegetation varies from maintained grass verges and scrub in fenced off areas.</p> <p>Downstream of Dungriffin Road the channel steepens significantly and the profile changes accordingly. Bank vegetation changes to gorse and bracken. Bed substrate becomes coarser, composed of angular cobbles and boulders.</p> <p>The channel enters a short culvert crossing Dungriffin Villas adjacent to the Irish Water compound, where flow was estimated as 50 l/s. At the transition of Balglass Road to Main Street the stream enters a culvert which carries flow along Main St. to the outfall point. This culvert inlet was not observed due to heavy scrub cover. The stream has reportedly surcharged in the past at iron manhole covers along Main Street following intense rainfall.</p>

Proportion Culverted	50%		
Outfall	Howth Harbour just east of Howth Yacht Club clubhouse, submerged during high tide.		
Hydrochemistry	Dungriffin Villas: C = 459 µS/cm; T = 14.8 °C; pH = 8.0*; ORP = 281 mV; DO = 81%*.		
Pressures	Potential flooding due to channelisation of flow in upgradient catchment area (Thormanby Woods) and variety of culvert crossings.		
Measures	Consider removal of scrub and planting maintained grass banks where stream passes through Gray's Lane. Clean all culvert inlets and outlets of vegetation and include same in regular inspection programme.

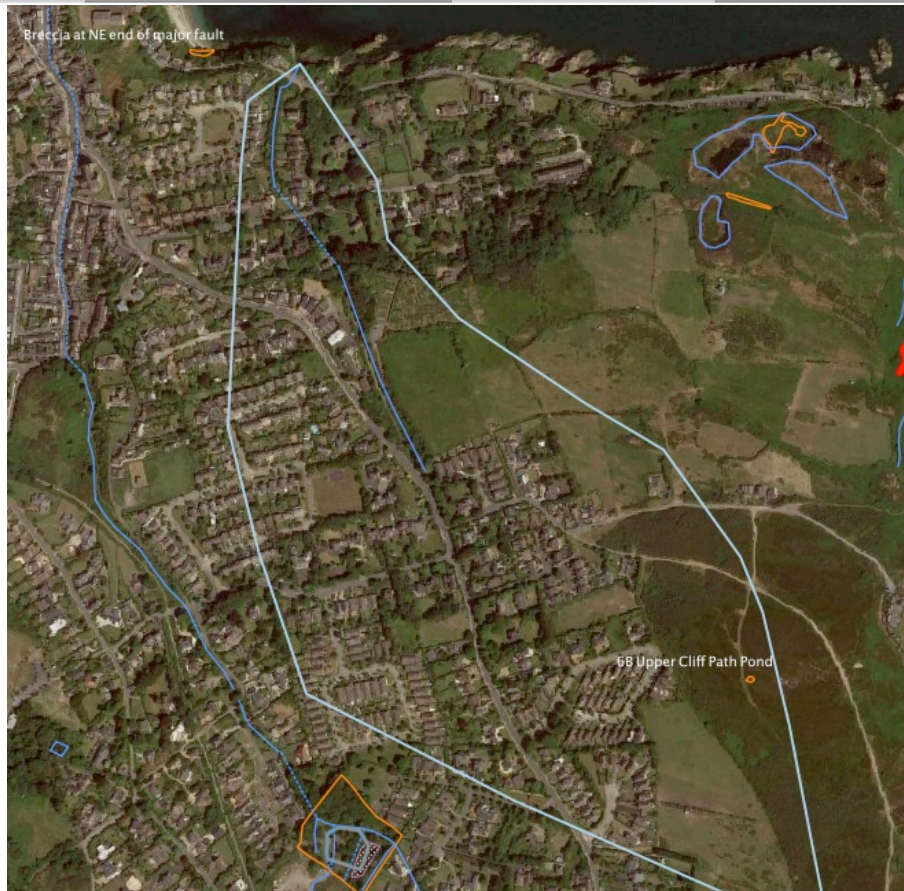
Site 4A - Coulcour Brook

Bedrock	Cambrian: mixed (Elsinore)	Proximity of Structural Fault	Southwest-northeast faulting terminates as breccia observed northwest of stream outfall.
Subsoil	Limestone till / Quartzite till / Limestone gravels	Soil	Shallow, well-drained acidic mineral
Exposures	Steep north-facing cliff face at outfall shows clean orange/brown greywacke, massive structure. Heavily weathered and deformed bedrock west of outfall. Overburden at coastal cliff is a 5 m thick, gravelly clay till, resembles conglomerate.		
Channel Length	600 m	Catchment to Outfall	47 ha (natural) though much runoff is captured by mains stormwater network.
Channel Dimensions	Channel is largely inaccessible along its entire route.		
Water Levels	Top of Cowbooter Lane = 69.72 mOD.		
Gradient	Same gradient as Cowbooter Lane. Gradient shallows out for a short distance upgradient of Balscadden Road.		
Primary Inflows	Fed by diffuse runoff from exposed hilltop in Upper Cliff Road area, stormwater network serving roads and hardstanding may outfall to stream (unconfirmed).

Drainage Description	<p>The upper catchment boundary is not easy to delineate. Runoff passes through the Upper Cliff Road area of houses before entering open channel at top of Cowbooter Lane.</p> <p>Close to where it passes the allotments the stream is culverted from the eastern to western side of Cowbooter Lane from where the culvert continues behind a stone wall as far as Nashville Road.</p> <p>Between Nashville Road and Balscadden Road stream flows through rear gardens of private residences.</p>		
Proportion Culverted	25%, between lower Cowbooter Lane and Nashville Road.		
Outfall	Inaccessible. Stream is culverted beneath Balscadden Road prior to coastal outfall through narrow gorge in steep cliff.		
Pressures	No significant pressures identified.		
Measures	Consider clearing scrub from channel and planting riparian margin.

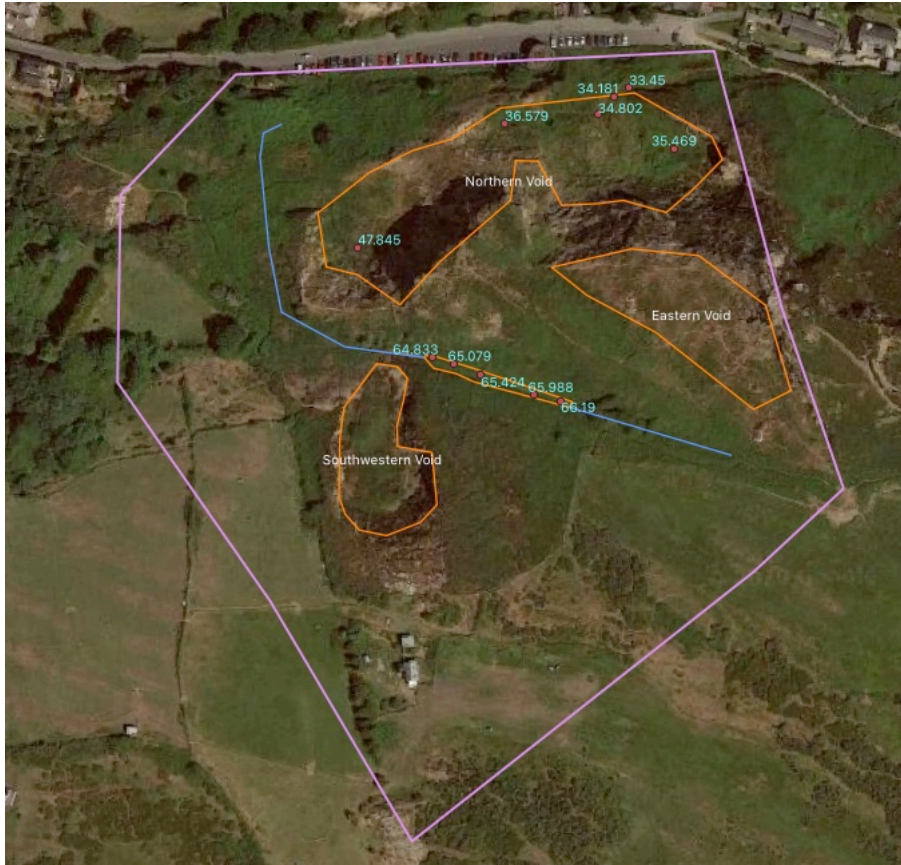
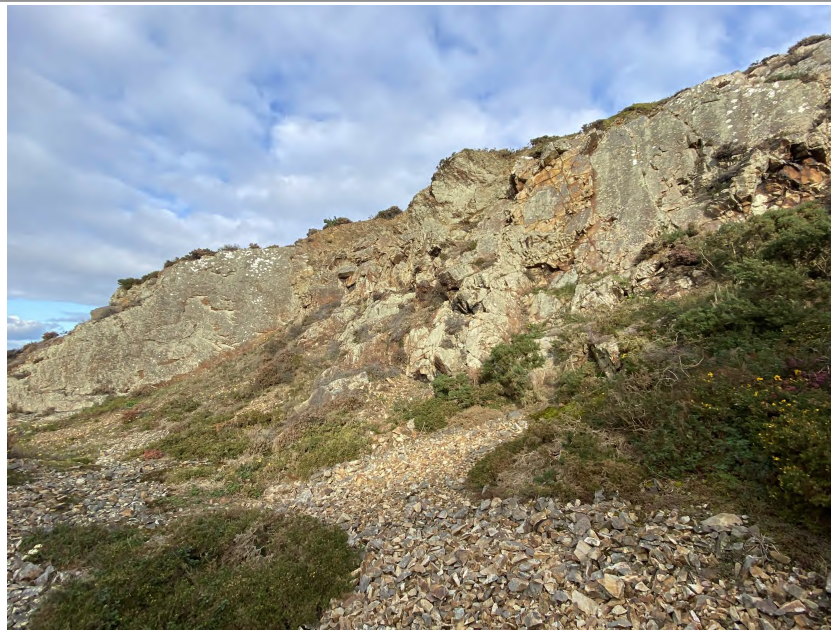
Site 5 - Kilrock Quarries

Bedrock	Cambrian: Polymict melange (Elsinore)	Proximity of Structural Fault	500 m southwest
Subsoil	Lacking across much of the area. Where present pockets of quartzite till (east) and limestone gravels (west).	Soil	Shallow, well-drained acidic mineral to south and east; deep, well-drained limestones to west
Exposures	Quartzite and greywacke bedrock exposed across entire area.

SW Catchment	Coast	Upgradient catchment	Difficult to delineate. Potentially 3 ha.
Historical Drainage Pattern	The massive structure and low permeability of greywacke at Kilrock, combined with the raised landscape position of historical excavations, means it is unlikely that previous activities caused a significant alteration to natural drainage patterns. Historical maps appear to indicate some form of quarry compound or processing facility in the flat area south of the eastern void. No significant quarrying since publication of 25" OSI map.		
Water Levels	Some localised areas of ponding were noted on depressed areas within the pit floors. Water levels in these ponded areas are relieved by lower ground at the mouth of each void. A linear surface water channel was surveyed in the east-west valley running through the quarry area. Water levels were recorded as 66.19 - 64.83 mOD, falling from east to west.

Current Inflows	Direct precipitation to the voids.		
Current Drainage Pattern	<p>The eastern void is raised relative to surrounding ground and is unlikely to have any groundwater catchment.</p> <p>Similarly, the northern void is raised relative to Balscadden Road and fields to the south. No significant seeps were observed on the 10 m high exposed faces within the northern void, with bedrock here massive in structure. Overburden cover is less than 100 mm. Small topographically enclosed depressions are saturated (presumed to be rainwater) and may display some ponding. Some minor seepages were observed closer to the western end of the northern void. Soils and organic matter washed into these areas have degraded to podzols and peats.</p> <p>The southwestern void is a north-facing horseshoe-shaped depression. The c. 10 m high faces and 5-8 m high gravel spoil heaps at the open northern end protect this void from the elements, when compared to the much more exposed northern pits. The floor of this void appears to be lower than that of peripheral fields. Hence rainfall infiltrating the field surfaces may re-emerge in the faces of this southwestern void. No seeps were observed in the eastern and western faces which are massive in structure. The southern face is less steep and displays some weathering and fracturing; some small groundwater seeps were noted in this southern face though significant gravel spoil at the toeslope obscured closer inspection.</p>

Current Outflows	Any waters in the southwestern void leave at the open north end and enter the east-west stream. This stream enters a small overgrown valley that wraps around the western perimeter of the area and is assumed to enter a culvert beneath Balscadden Road. This stream also restricts potential for infiltration and subsequent re-emergence of groundwater in the northern void.		
Hydrochemistry			
Pressures	This void is largely undisturbed.		
Measures	Clean gorse and scrub on quarry floors to aid identification of groundwater seeps.

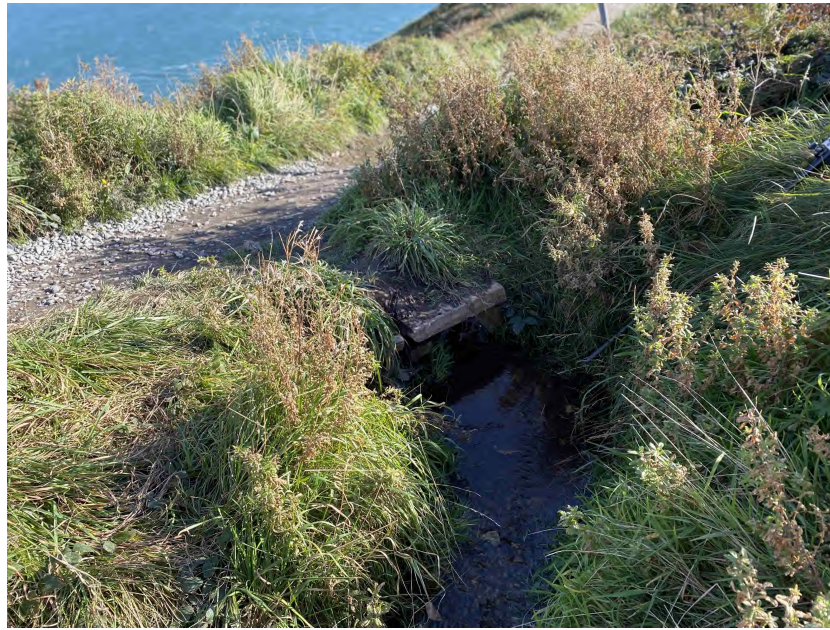
Site 6A - Nose of Howth Eastern Stream

Channel Length	360 m	Catchment to Outfall	7.5 ha
Channel Dimensions	Small profile, in places 300 mm wide with no significant banking.		
Water Levels	40 - 80 mOD.		
Gradient	Shallow, steepening towards outfall.		
Inflows	The stream appears to rise from a site of ruins located 150 m east of Cannon Rock Cottage and within a horseshoe-shaped depression at the base of a raised bedrock exposure. A well is indicated at this location on 25" OSI maps. There appears to be a 2 m diameter, 2 m deep topographically enclosed depression that may be a shallow well but significant scrub prevented closer inspection. Historic 50 mm cast iron pipework in close proximity reinforces this somewhat though the destiny of this infrastructure is unclear.		
Drainage Description	The stream runs through a shallow valley which drains a relatively small catchment in the northeast corner of the peninsula. This is a typical example of the many small catchments on East Mountain which drain to the coast. 100 m north of the shallow well feature streamflow was estimated as 1 l/s as it passed northwards over a 1 m high, 300 m wide weirtop. The channel then runs through or around a small area of birch trees before turning east where it flows freely over the path. This can promote erosion though the hard rock and small stream dimensions mean that this is unlikely to be a significant issue at this location.

Proportion Culverted	< 1%		
Primary Outflow	The stream is culverted beneath the lower cliff path via a 200 mm PVC pipe and at 2 l/s outfalls to the sea through a steep, narrow gorge on an east facing cliff.		
Hydrochemistry			
Issues	Source of stream is not well understood. Erosion and sediment mobilisation where stream crosses public walking trail. There are no significant sources of contamination in the area. Some grazing of horses in the catchment but this is very low intensity.		
Measures	Scrub clearance to facilitate closer inspection of potential stream source. Install culvert or raised path section to prevent stream bed and bank erosion.

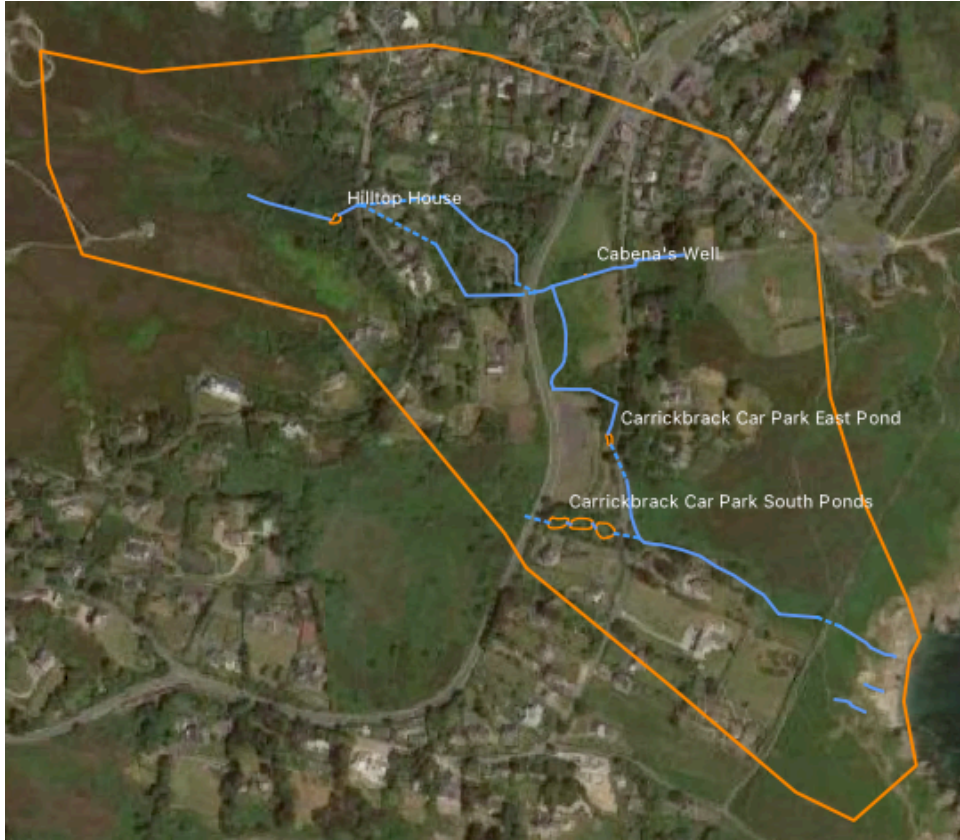
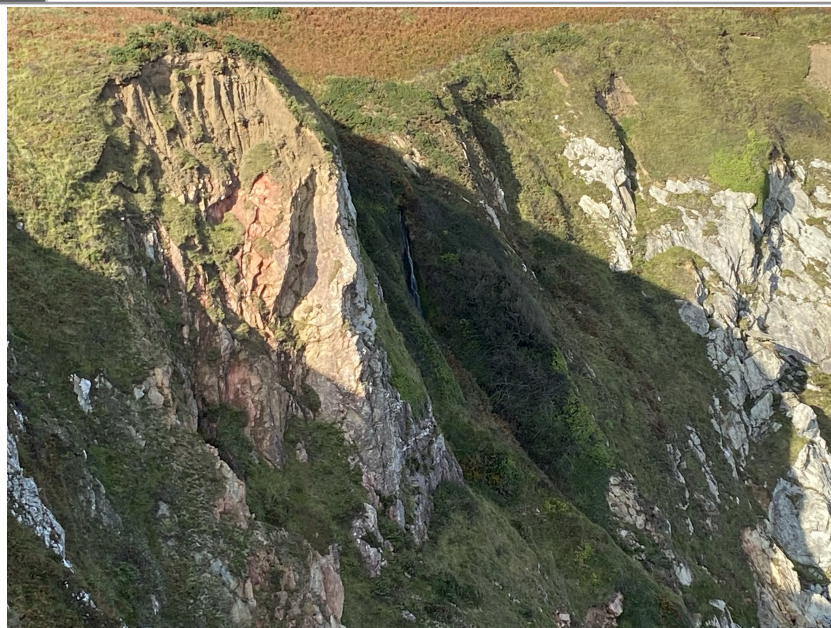
Site 7A - Whitewater Brook

Bedrock	Cambrian: Mixture (Elsinore); Mudstone/Greywacke (Gaskins Leap)	Proximity of Structural Fault	Parallel anticline, 250m south
Subsoil	Quartzite till	Soil	Shallow, well-drained acidic mineral
Exposures	Primary exposure on high cliff face at outfall. Bedrock pink/red where fresh collapse. 5 m clay till coverage on bedrock, undermined by recent rock collapse.

Channel Length	1,000 m	Catchment to Outfall	43 ha
Channel Dimensions	Bed width = 0.5 m, bank height = 0.3 m, bank top width = 0.5 m. Bank height increases significantly in the lower catchment.		
Water Levels	109.7 mOD on Tweedy's Lane; 108.2 mOD north of Carrickbrack car park		
Gradient	Upper catchment valley = shallow; Windgate Road-Carrickbrack Road = steep; Carrickbrack Road-Carrickbrack car park = shallow; downgradient of Carrickbrack car park = steep.		
Primary Inflows	Surface runoff from exposed Cambrian bedrock on upper catchment, road runoff, tributary along Tweedy's Lane from Summit tanks.		
Drainage Description	Small dendritic network drains minor valleys on elevated ground which converge to a single inflow at Hilltop House. Between Windgate Road and Carrickbrack Road the stream flows through a grassland field used for grazing horses. This field was not surveyed but it appears the stream is not livestock proofed in this section. Downgradient of Carrickbrack Road the stream enters a natural wet depression and subsequently a small artificial pond. The channel between Carrickbrack car park and the outfall is inaccessible.

Proportion Culverted	Road crossings only, i.e. negligible.		
Outfall	Steep gorge which terminates in a cascade over coastal cliff immediately north of Dungriffin Promontory to Whitewater Brook Cove. Access to the outfall is possible but difficult.		
Hydrochemistry			
Pressures	Between Windgate Road and Carrickbrack Road significant poaching of stream bed and bank erosion caused by grazing horses. Potential direct defecation from grazing horses. Significant dumping of garden waste in stream on eastern side of Thormanby Road.		
Measures	Restrict animal access from stream as it flows between Windgate Road and Carrickbrack Road. Also check animal access in fields in vicinity of Cabena's Well. Provision of a metered animal drinker if stream is only potable water source for animals. Consider a pilot riparian margin scheme (e.g. wildflower) to protect stream from sediment and nutrient enrichment. Consider improving access path down to beach where Whitewater outfalls. Implement measures to prevent dumping of garden waste.

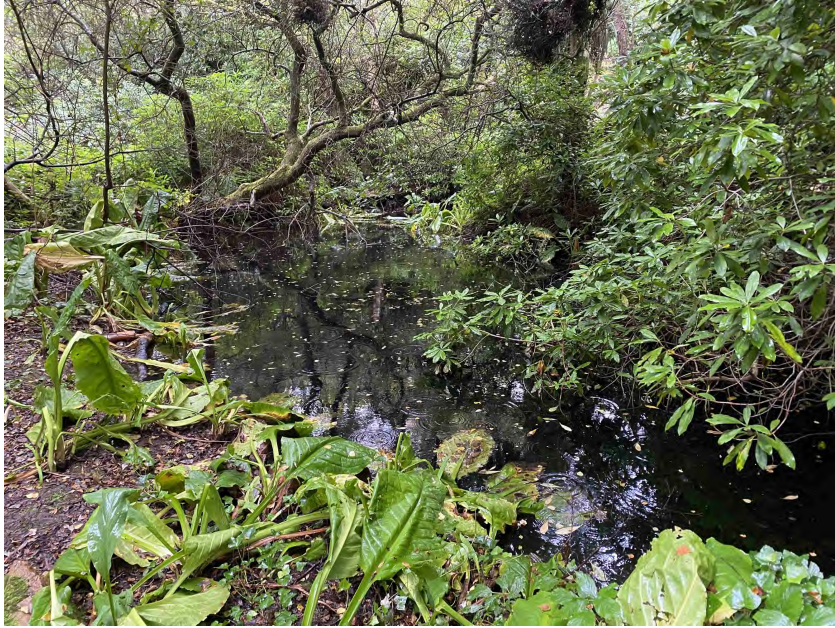
Site 7B - Hilltop House

Bedrock	Cambrian: Mixture (Elsinore)	Proximity of Structural Fault	Anticline, 750m south
Subsoil	Quartzite till	Soil	Peaty
Exposures	Cambrian bedrock on raised ground 250 m northwest		
SW Catchment	Whitewater Brook	Upgradient catchment	4.5 ha
Water Levels	c. 141 mOD		
Depth	Estimated 1 - 1.5 m.		
Inflows	Runoff generated in two small raised valleys to the west converge a short distance upgradient of the pond. This flow enters a 150 mm pipe which outfalls to the southwestern end of the pond. Flow estimated on 08/10/20 as 1 l/s.		
Drainage Pattern	Pond appears to have been excavated in a low-lying woodland area as part of a landscaped garden walk. The woodland appears to have been in place for a long time (c.100 years) and there are no contamination sources in the upgradient catchment. On 28/09/20 and 16/10/20 water was confined to the pond. On 08/10/20 and following heavy rainfall water covered much of the low-lying woodland floor.

Outflows	No level control on pond. A 150 mm PVC pipe installed in berm on western side of Windgate Road releases water that accumulates in the woodland, this subsequently entering a road drainage gully. In this regard the woodland floor provides attenuation storage.		
Hydrochemistry			
Pressures	None in terms of flow or water quality. Invasive species evident. Illegal dumping.		
Measures	Sample water quality entering pond as it is one of the few wetland features with no upgradient pressures. Potential site for the local authority to take in charge; consider protection from future development. Additional measures pending outcome of botanical survey and importance.

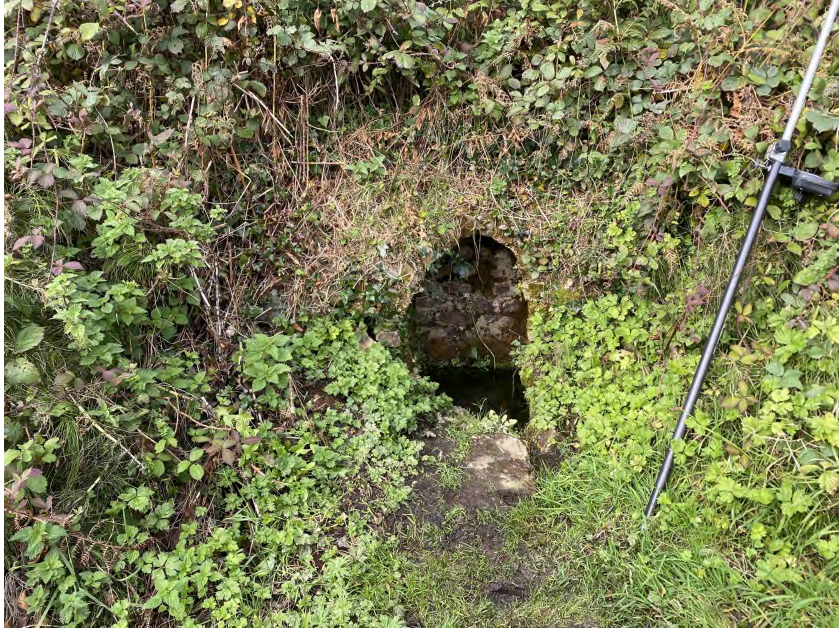
Site 7C - Cabena's Well

Bedrock	Cambrian: Mixture (Elsinore)	Proximity of Structural Fault	Anticline 500m south
Subsoil	Quartzite till	Soil	Shallow, well-drained acidic mineral
Exposures	None. Floor of well chamber may be exposed bedrock.		
SW Catchment	Whitewater Brook	Upgradient catchment	n/a
Drainage Pattern	Well is marked on 25" OSI map. Water in the well likely comes from rainfall infiltrating through overburden and flowing on top of the impermeable bedrock.		
Water Level	111.82 mOD		
Depth	200 mm		
Current Inflows	No discrete inflow		
Current Outflows	Outflow to nearby Whitewater Brook, 0.3 l/s.		
Hydrochemistry	C = 392 µS/cm; T = 11.8 °C; pH = 7.3*; ORP = 260 mV; DO = 58%*.		
Pressures	Horses grazing in adjoining field; upgradient construction (e.g. Irish Water compound); future development

Measures	<p>Raise path here and at nearby stream crossing to prevent mobilised sediment from path entering well chamber.</p> <p>Retrieve sample to establish baseline.</p> <p>Ensure legislative setback being adhered to.</p>

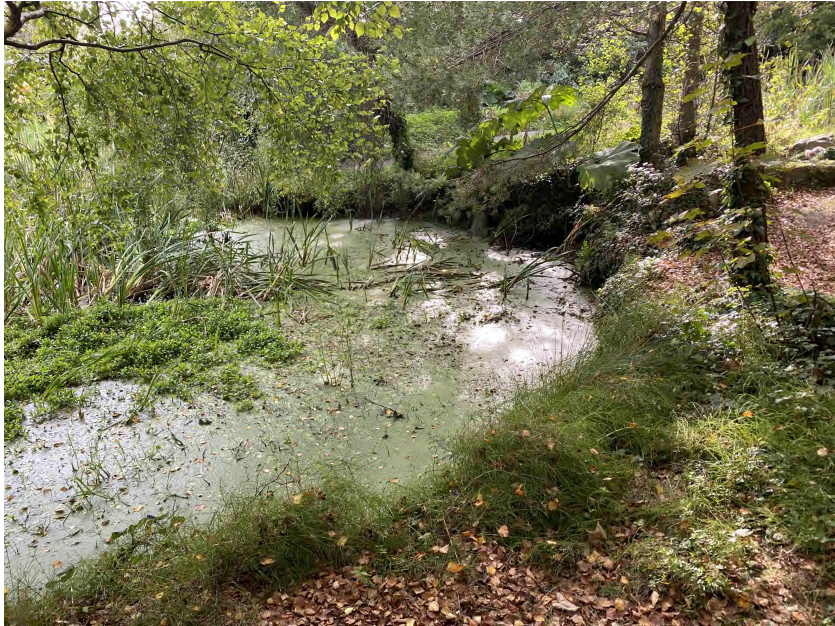
Site 7E - Carrickbrack Car Park (South)

Bedrock	Cambrian: Greywacke (Hippy Hole)	Proximity of Structural Fault	300 m south
Subsoil	Quartzite till	Soil	Shallow, well-drained acidic mineral
Exposures	None		
SW Catchment	Whitewater Brook (tributary)	Upgradient catchment	3 ha
Drainage Pattern	Three ponds arranged in sequence with interconnecting weirs, fed by a small catchment on the western side of the Carrickbrack Road, possibly road runoff.		
Water Levels	(1) 96.60 mOD (2) 95.42 mOD (3) 94.13 mOD		
Depth	(1) 0.4 m (2) 0.3 m (3) 0.5 m		
Inflows	Box culvert beneath Carrickbrack Road, width 0.6 m, height 1 m, flow 2 l/s.		
Outflows	Flat top weirs form the outfall from each pond, which cascades directly into the subsequent pond. Outfall from Pond 3 is a 200 mm PVC pipe, which is culverted beneath Thormanby Road and subsequently enters the main channel of the Whitewater Brook.

Hydrochemistry	C = 469 µS/cm; T = 12.6 °C; pH = 7.7*; ORP = 285 mV; DO = 79%*.		
Pressures	Growth of surface algae suggests nutrient inputs.		
Measures	<p>Catchment survey and water quality testing to determine source of nutrient enrichment.</p> <p>No scope to adjust water levels.</p> <p>Include inlets and weir overflows on all ponds in regular inspection programme to ensure structures are free of heavy vegetation or other potential blockages.</p> <p>Consider dredging of Pond 1.</p> <p>Remove fallen trees from Pond 3.</p>

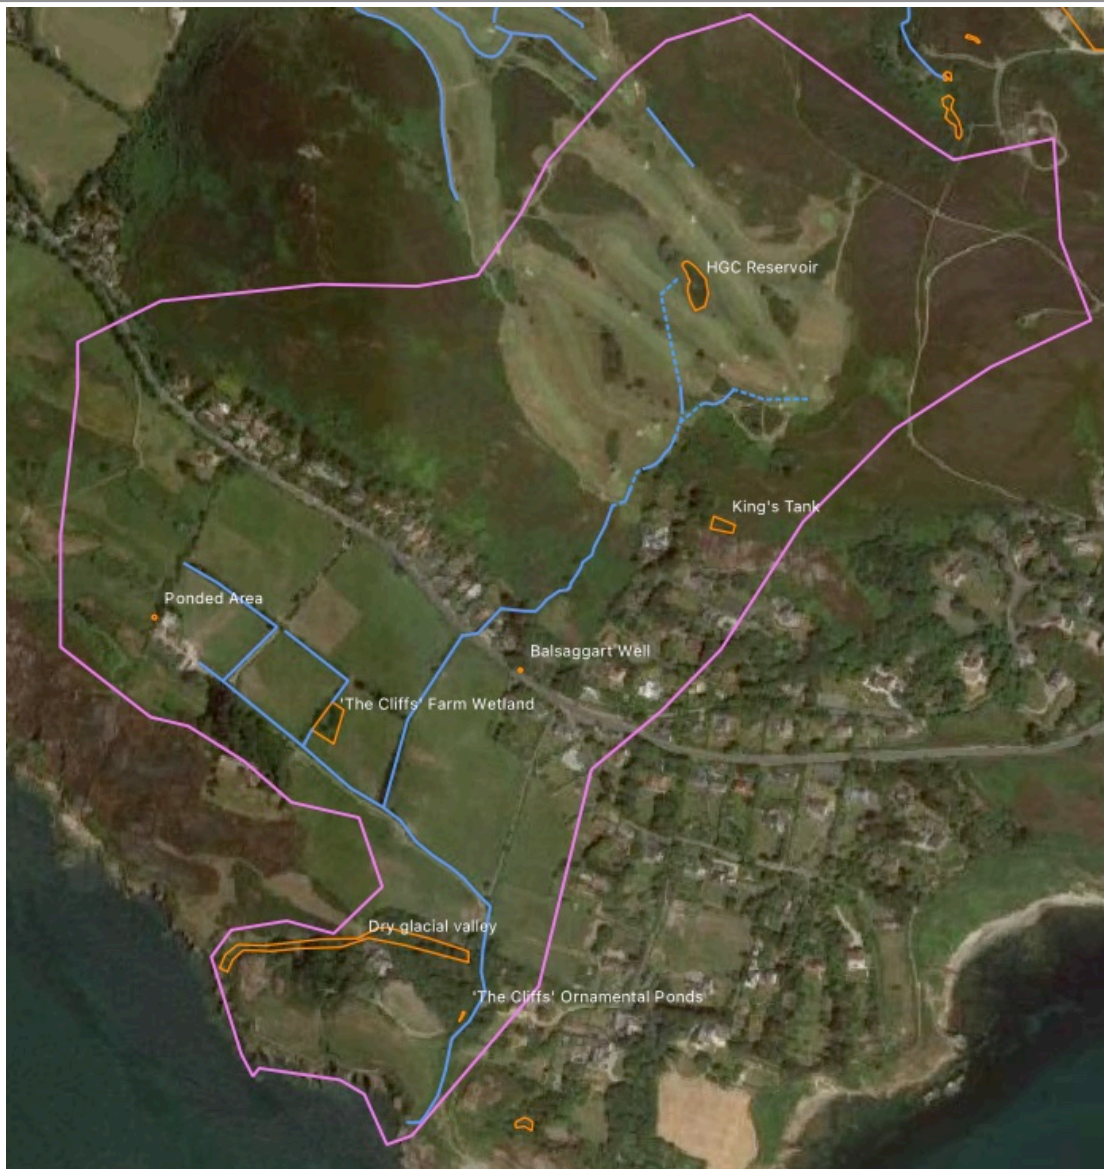
Site 8A - Balsaggart Stream

Channel Dimensions	<p>For reference the upper catchment refers to raised grounds north of Carrickbrack Road; the mid-catchment refers to farmlands; the lower catchment refers to lands between the farmed area and the outfall. Lands in the mid and lower catchments are referred to as 'The Cliffs'.</p> <p>Upper catchment: narrow, steep natural mountain stream with bedrock bed. Bed width 0.3 m, bank height 0.2 m.</p> <p>Mid catchment: flat to moderate, open channel with silty, weedy bed. Bed width 1 m, bank height 1.5 m, bank top width 3 m.</p> <p>Lower catchment: constructed channel 0.5 m wide base, 0.4 m high side walls, gravel bed, flow 15 l/s. Changes to a natural channel with heavy scrub on approach to outfall.</p>
Surveyed Water Levels	<p>Upper catchment = 110 - 121 mOD</p> <p>Mid-catchment = 36 - 42 mOD</p> <p>Lower catchment = 7.6 - 34 mOD</p>
Gradient	Low (mid-catchment) to steep (upper catchment)
