Wetland Study Phase I Howth Co. Dublin

Final Report

prepared for Fingal County Council

Project No.	Rev.	Author	Reviewed By	Approved By	Issue Date
200100	13	AF	KMOC	ACr	09/03/2021

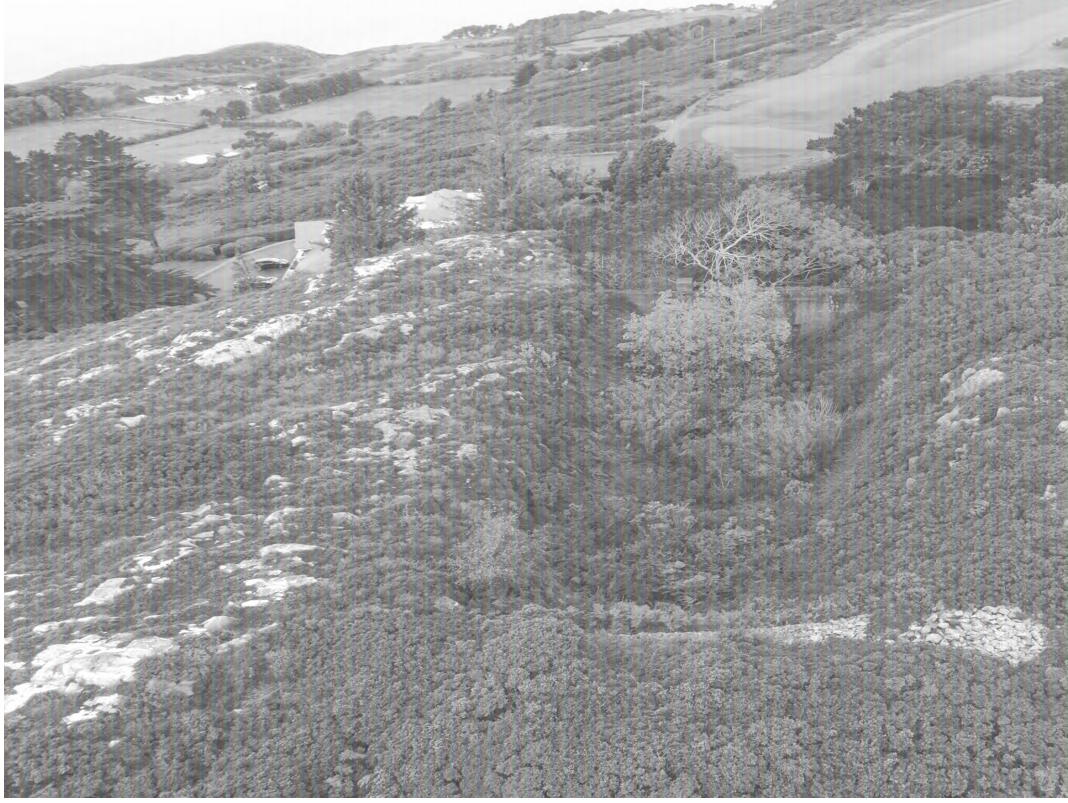
Site 8C - Kings Tank

Bedrock	Cambrian: Quartzite (Elsinore)	Proximity of Structural Fault	1 km northwest
Subsoil	None	Soil	Shallow acidic podzol (peaty) topsoil
Exposures	Quartzite exposed across area		
SW Catchment	Balsagart	Upgradient catchment	0.3 ha
Water Levels	Appears dry but floor inaccessible unconfirmed.		
Depth	7 m below surrounding bedrock ridge		
Inflows	Small raised bedrock valley which extends 75 - 100 m east. Rainfall on surrounding impermeable bedrock collected in narrow valley channel and flows westwards into 'tank'.		
Drainage Pattern	King's Tank is shown on all historical maps and is assumed to have been developed to collect and store potable water for local residents/farms. The tank base is approximately 7 m below the surrounding bedrock plateau. The western end of the valley appears to have deepened by excavation and a 7 m high concrete wall cast to impound water. The eastern side of the excavation is steep and has been reinforced in places with dry stone walling. Water collected in a narrow valley channel to the east enters the eastern side of the excavation.

Outflows	Flow/level control sluice valve at the base of the dam wall.		
Hydrochemistry			
Issues			
Measures	<p>Conduct botanical survey on tank floor.</p> <p>Explore feasibility of raising outlet of King's Tank to impound a small amount of water. May not be sensible given there is a new residence immediately downgradient of dam wall.</p> <p>Preserve as evidence of local water engineering heritage.</p>

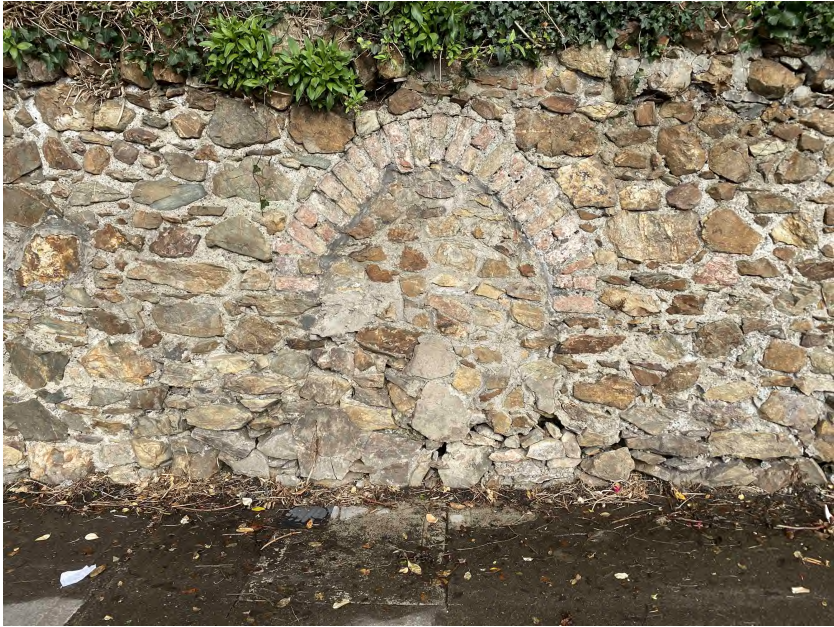
Site 8D - Balsaggart Well

Bedrock	Cambrian greywacke (Hippy Hole)	Proximity of Structural Fault	1 km northwest
Subsoil	Quartzite till	Soil	Shallow, well-drained acidic mineral
Exposures	Cambrian bedrock exposed on raised ground and stream bed to north.		
SW Catchment	Balsaggart Well	Upgradient catchment	Extends 500 - 800 m north towards Kings Tank.
Drainage Pattern	The well chamber is clearly marked by a gothic shaped arch in the stone wall. The well chamber has been blocked up with stone on various occasions. It is unclear if the chamber remains in situ behind the stone wall. Cement grout around the lower stones has been eroded away, possibly by groundwater discharge and many of the stones are loosely resting in place.

Water Levels	Inaccessible		
Depth	n/a		
Inflows	Water in the well likely comes from rainfall infiltrating through overburden and flowing on top of the impermeable bedrock.		
Outflows	Water emerging from behind stone wall and draining to road gulley suggests flow path still active.		
Hydrochemistry	n/a		
Issues	Well chamber opening has been closed with constructed stone wall.		
Measures	Worthy of further discussion from a heritage perspective but not of ecological importance.

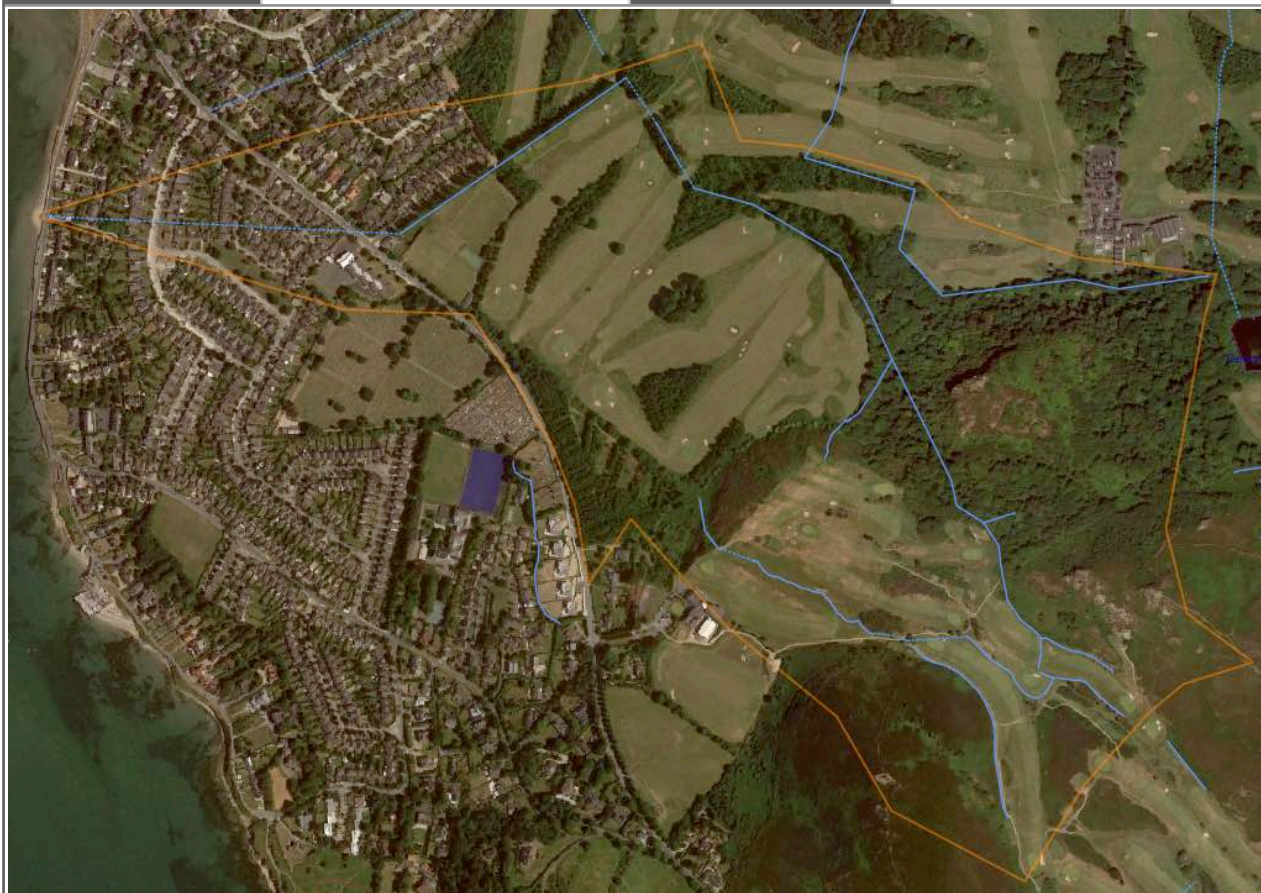
Site 9A - Carrickbrack Stream

Bedrock	Cambrian Quartzite & mudstone (Drumleck)	Proximity of Structural Fault	Southwest-northeast crosses catchment
Subsoil	Quartzite till	Soil	Shallow well-drained acidic mineral
Exposures	Southern and western faces of Dun Hill; northern and eastern faces of Shielmartin		
Channel Length	2,250 m	Catchment to Outfall	98 ha
Channel Dimensions	Upper catchment drained by open arterial drainage channels on northern and southern perimeter of HGC (western area), these are up to 1 m deep. Middle catchment drained by open channels through wooded areas on Deerpark Golf Course. Lower catchment west of Carrickbrack Road drained by stormwater network.		
Water Levels	Typically 1 m below ground level in open channels.		
Gradient	Moderate through HGC, steepening through the wooded area between HGC and Deerpark. Gradient flattens out through much of Deerpark and alongside Howth Celtic soccer pitch.		
Primary Inflows	Diffuse flows from upper catchment, rainfall-runoff generated on hardstanding in lower catchments.

Drainage Description	Fed by diffuse runoff from Dun Hill and Shielmartin which is collected in open arterial drains. These channels flow through a steep wooded area where channels are unmaintained. Through Deerpark there is a mixture of open channels through wooded areas and subsurface culverts crossing fairways. Waters enter stormwater network upon meeting Carrickbrack Road.		
Proportion Culverted	30%, mostly below Carrickbrack Road.		
Outfall	Coastline along Strand Road		
Pressures	Arterial drainage. Future development in Deerpark estate is likely to alter current drainage regime.		
Measures	Regular inspection of stream banks to ensure structural stability. Consider commissioning a small project to assist groundsmen at Howth Demesne to develop a current drainage map.

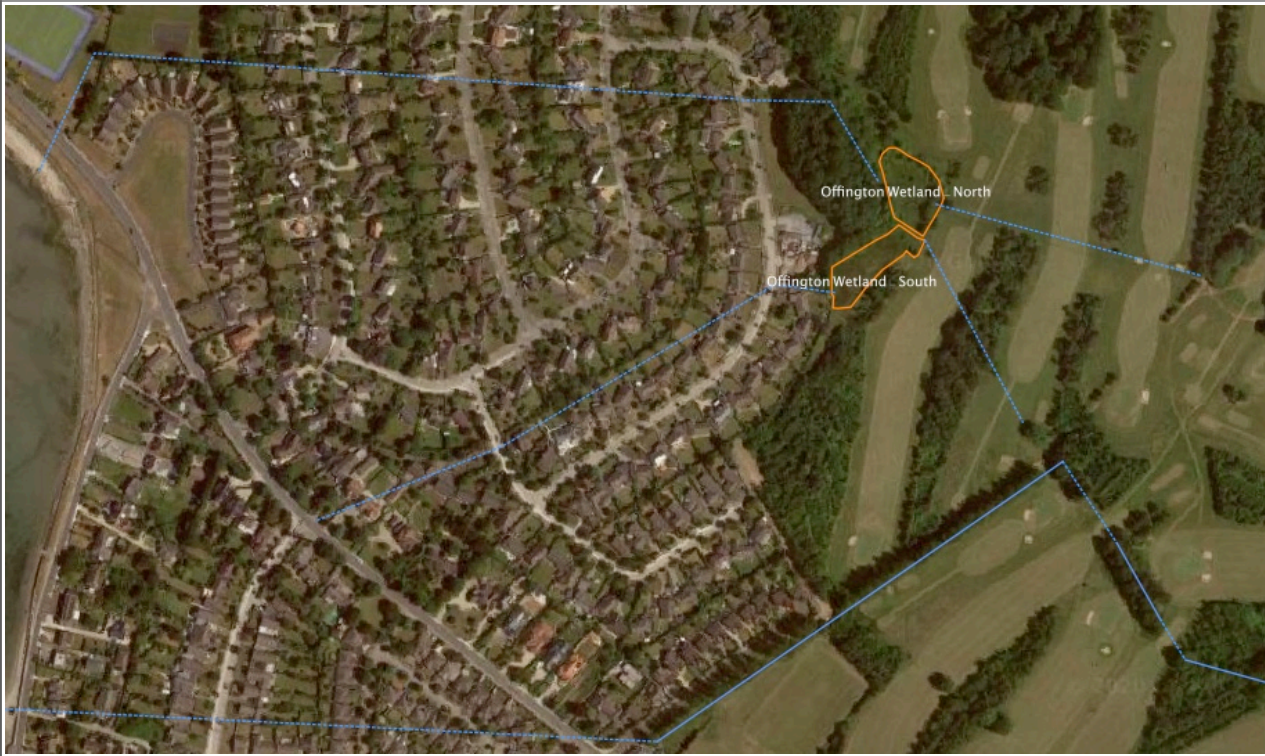
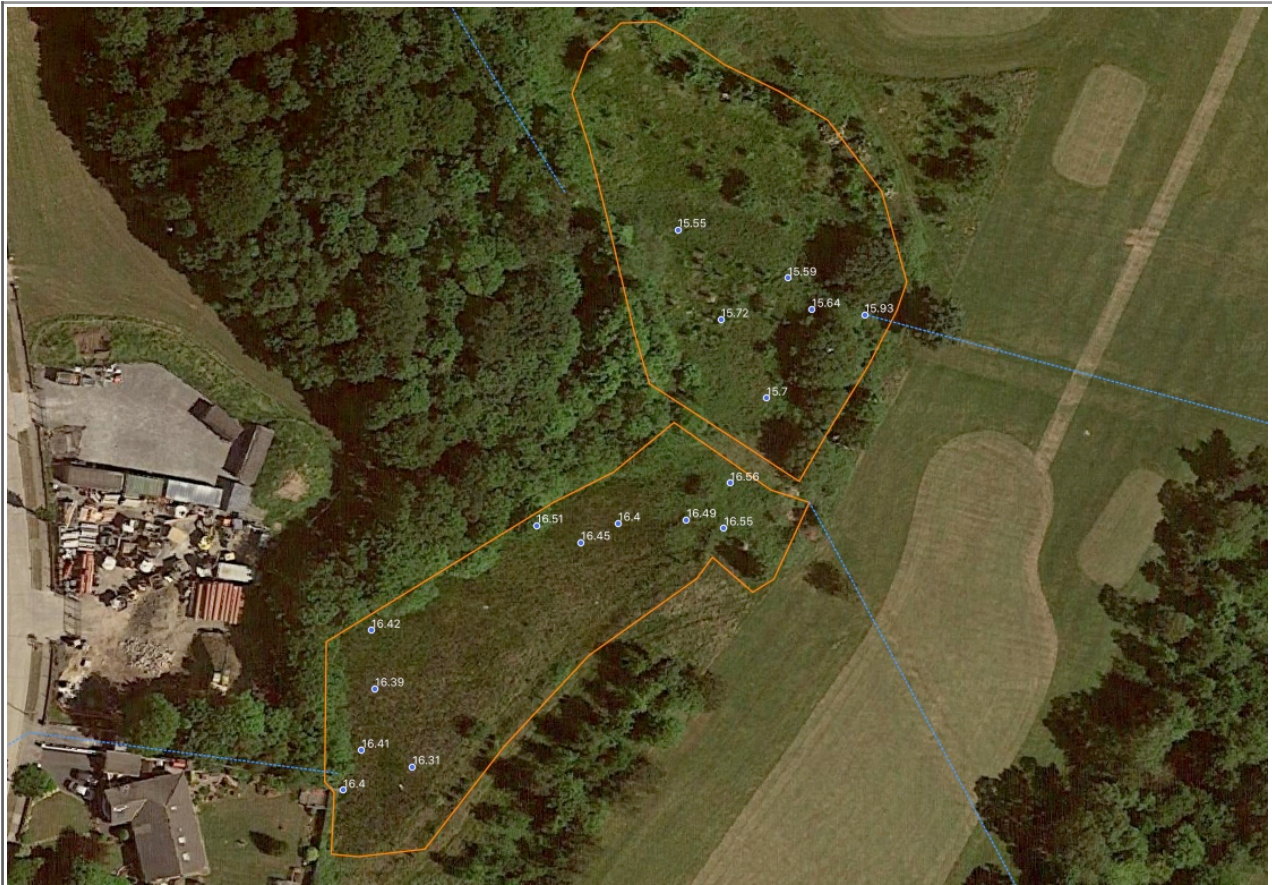
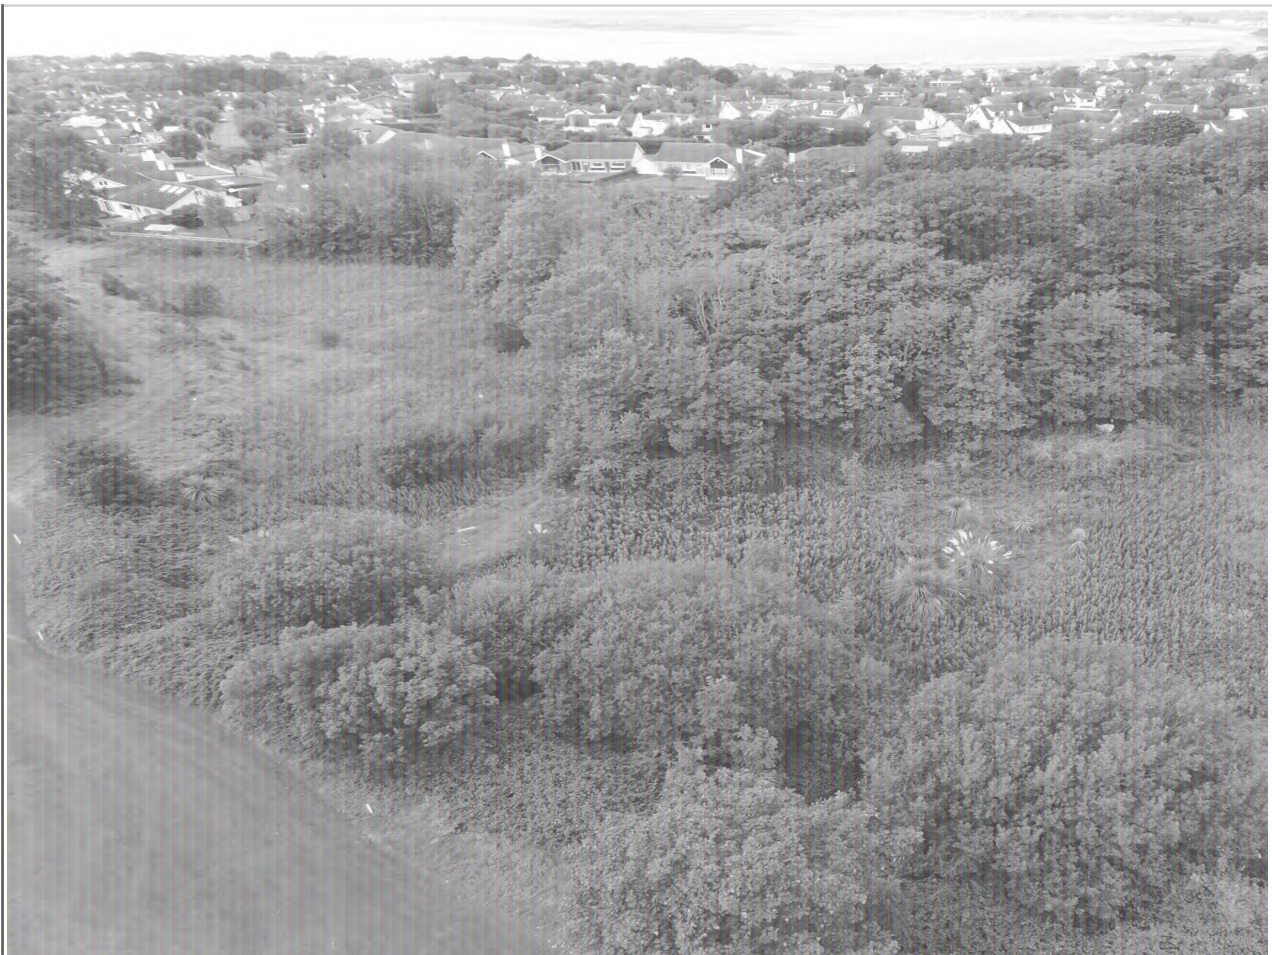
Site 10A - Offington Wetland

SW Catchment	Mains stormwater network	Upgradient catchment	Estimated 10 ha (combined) to the east and within Deerpark Golf Course
Historical Drainage Pattern	<p>Cassini maps show a convergence of drainage channels at this location though flow directions and connectivity of same are unclear.</p> <p>The ponds were installed 20-30 years ago to restrict people freely entering the golf course from Offington Lawn residential area. The ponds subsequently and inadvertently attracted young children as a play area. Resulting from this, combined with health and safety concerns, the pond inlet and outlet levels were adjusted to ensure submerged depth was never greater than 300 mm. The ponds are unlined so there is some uncertainty around their ability to retain water across the entire base.</p>		
Water Levels	<p>Northern pond = 15.55 - 15.72 mOD (sloping south to north)</p> <p>Southern pond = 16.17 - 16.55 mOD (sloping north to south)</p>

Water Depth	<p>Northern pond = 90 - 180 mm</p> <p>Southern pond = 60 - 230 mm</p>		
Current Inflows	<p>Northern pond: Single discrete inflow from a 225 mm concrete pipe (IL = 15.98 mOD) on the eastern edge of the northern pond. This pipe is an outfall from the subsurface drainage network. Flow emanating from this pipe was estimated as 1.5 l/s (heavy rainfall preceding 3 days). Assumed zero inflow during prolonged dry weather.</p> <p>The ponds are separated by a raised embankment (bank top = 16.75 - 18.1 mOD).</p> <p>Southern pond: Not clearly identified but southward flow observed through a lowered point at the eastern end of the embankment. Aerial photography suggests a linear subsurface drain outfalls to this point. The southern pond seems to have had some infilling on the eastern side which is raised relative to the western half.</p>		
Current Drainage Pattern	<p>It initially appeared during survey that flow from the northern pond inlet travelled south through the northern pond, across an overflow in the embankment, through the southern pond towards an outfall at its southern end. However, surveyed levels suggest that the ponds may not be connected and that the lowered eastern end of the embankment facilitates a separate inflow. Hence it seems more plausible each pond has its own independent inflow and outflow. Local stormwater network map would help to confirm this.</p>

Current Outflows	<p>Water levels in the northern pond suggest an outflow at the northwestern corner though this was not observed.</p> <p>Outflow from southern pond is presumed to be at the base of a concrete wall abutting the southwest corner, though the outlet itself was not observed (assumed at the time to be submerged).</p> <p>Alterations to golf course drainage (subsurface and surface channels) and alterations of local mains stormwater network, including recent Offington flood alleviation scheme make it difficult to confirm catchments, inflow and outflow routes.</p>

Pressures	<p>Lack of knowledge around variation in winter/summer hydrological regime.</p> <p>Disruption to contributing catchment and water quality as a result of likely future development works.</p>
Measures	<p>Inflow and outflow locations require further clarification. Remove vegetation around inlets and outlets. Reveal and clean outlet structure(s) of any blockages. Confirm any other drainage inflows.</p> <p>Contributing catchments require further clarification. Confirm catchments to inflows via more detailed walkover survey of Deer Park drainage network.</p> <p>Sample inflow water quality to assign baseline conditions. Include parameters to assess use of fertiliser, pesticide, herbicide. Discuss recommended protocol for use of same with groundsmen. Consider this approach also with groundsmen at Sutton GC and Howth GC. All groundsmen encountered were open to liaising with local authority for assistance to develop/support enhanced biodiversity areas on their courses.</p> <p>Ecologist to decide on a target water depth for northern pond. Grade pond base and adjust inlet and outlet inverts accordingly, if possible/required.</p> <p>Investigate consequence of outlet becoming blocked (may require a relief overflow to stormwater network).</p> <p>Include inspection of inlet and outlet as part of inspection programme.</p> <p>Provide statutory protective measures as catchment/drainage infrastructure/pond layout may be manipulated as part of future development works which would disrupt regime.</p> <p>Consider flow and level monitoring for minimum one year to assist understanding of winter/summer flow regimes and minimum and maximum water depths.</p>

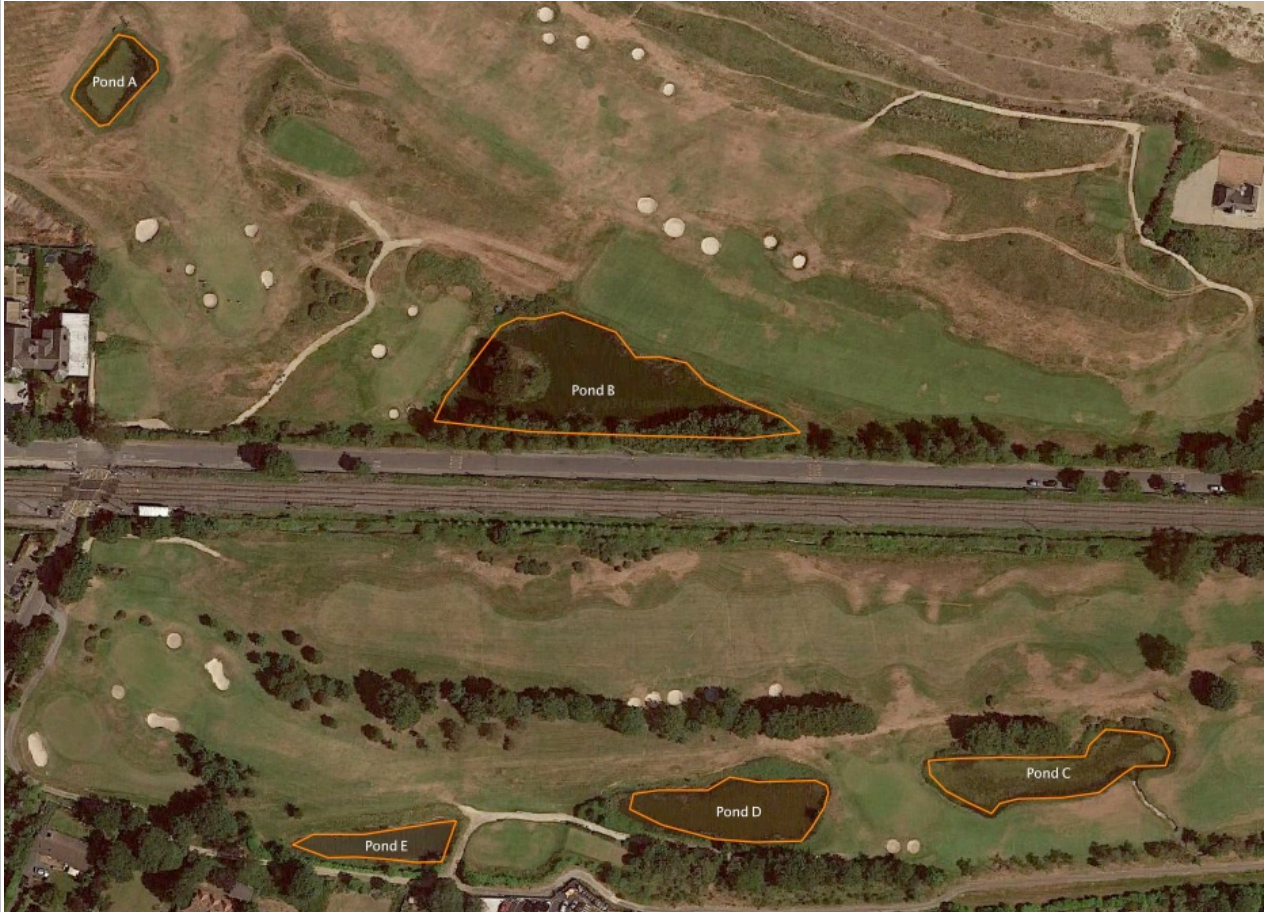
Site 11A - Pond A

Bedrock	Limestone/Shale (Tober Colleen)	Proximity of Structural Fault	1 km southeast
Subsoil	Windblown sands and dunes	Soil	Windblown sediments
Exposures	Dunes viewed from Burrow beach		
SW Catchment	n/a (coastal)	Upgradient catchment	N/a
Water Levels	1.23 mOD		
Depth	c. 1 m		
Inflows	Surrounding subsurface drainage network. Groundwater.		
Drainage Pattern	Previously used as an irrigation supply, this practice ceased due to the small pond size and susceptibility to saline intrusion.		
Outflows	Equilibrium with groundwater. In the case of high water levels excess water is pumped to the western estuary.		
Hydrochemistry	C = 528 µS/cm; T = 11.7 °C; pH = 7.8*; ORP = 277 mV; DO = 72%*.		
Issues	None		
Measures	None

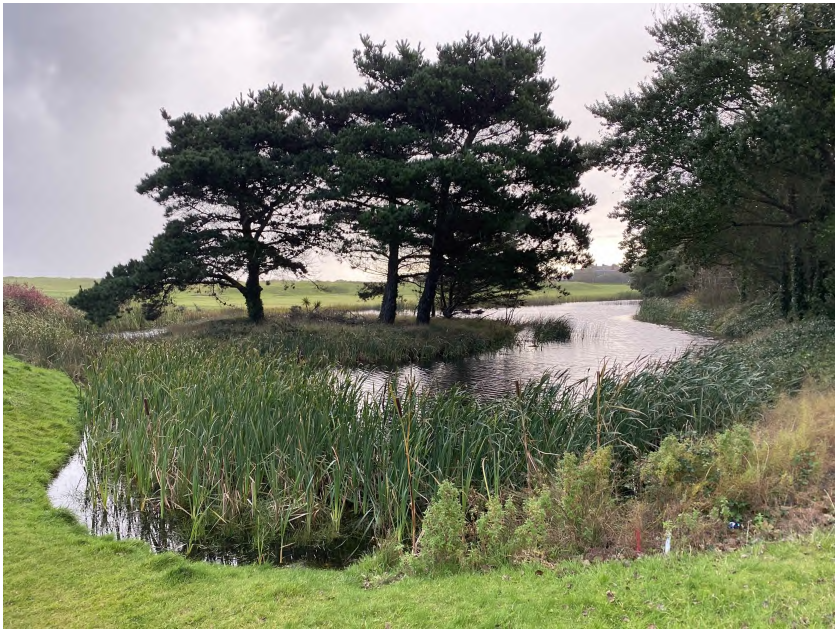
Site 11B - Pond B

Bedrock	Limestone/Shale (Tober Colleen)	Proximity of Structural Fault	1 km southeast
Subsoil	Marine beach sands / till	Soil	Windblown sediments
Exposures	Dunes viewed from Burrow beach		
SW Catchment	n/a (coastal)	Upgradient catchment	
Water Levels	1.34 mOD		
Depth	2.5 - 3 m		
Inflows	Surrounding subsurface drainage network. Groundwater flow from south.		
Drainage Pattern	Used as primary irrigation supply for northern course during prolonged dry weather. In the case of high water levels excess water is pumped to the western estuary.		
Outflows	In the case of water levels rising to inundate surrounding fairways excess water is pumped to the western estuary. Maximum drawdown during pumping is 1.8 m to ensure pond does not dry out.

Hydrochemistry			
Issues	<p>Finite volume as an irrigation supply. Minimum pond water depth of 1.0 m maintained to prevent pond substrate drying out. When water levels approach minimum depth irrigation is restricted to tees and greens.</p> <p>Liquid seaweed fertiliser is used, 2 m buffer applied to ponds.</p> <p>Weedkiller used sparingly, 2 m buffer applied to ponds.</p> <p>Some algal bloom can occur during warm, dry conditions which suggest nutrient input. Algacide used sparingly.</p> <p>Previous attempts to source groundwater irrigation supply from bedrock aquifer proved unsuccessful. Reportedly moderate-high yielding well < 500 m from golf course abstracting from Waulsortian limestones.</p>		
Measures	Consider sluice-controlled gravity-fed pipe to release excess water to sea. The sluice could be automated to function only when tidal levels permit.

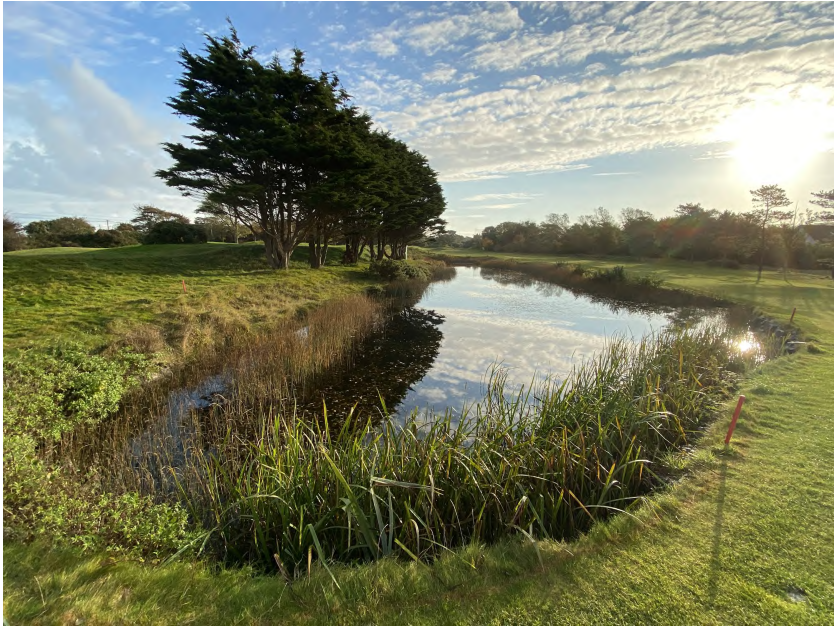
Site 11C - Pond C

Bedrock	Limestone/Shale (Tober Colleen)	Proximity of Structural Fault	800m southeast
Subsoil	Marine beach sands / till	Soil	Windblown sediments
Exposures	Dunes viewed from Burrow beach		
SW Catchment	n/a (coastal)	Upgradient catchment	
Water Levels	1.27 mOD		
Depth	Estimated 2 m		
Inflows	Surrounding subsurface drainage network. Groundwater.		
Drainage Pattern	<p>Ponds C, D and E are aligned along the route of a historical drainage channel shown on 25" OSI maps.</p> <p>Pond C and Pond D are connected via a subsurface pipe installed 2 m below the intervening green. A recently installed concrete channel at the eastern end of Pond C becomes active when pond water levels exceed 1.26 mOD. A 30 mm pipe (IL = 1.37 mOD) at the southeastern end of the channel acts as an overflow outlet. This reportedly transmits excess water to a flood relief pipe recently installed by the local authority along the right of way south of the ponds.</p> <p>Pond C was emptied and cleaned to facilitate installation of the flood relief channel. While empty groundwater inflow was observed as spring seeps emanating between till and sand lenses exposed on the southern bank. Eels have been observed in Ponds C, D and E.</p>

Outflows	Concrete channel		
Hydrochemistry	C = 627 µS/cm; T = 12.9 °C; pH = 8.0*; ORP = 270 mV; DO = 67%*.		
Issues	None		
Measures	None

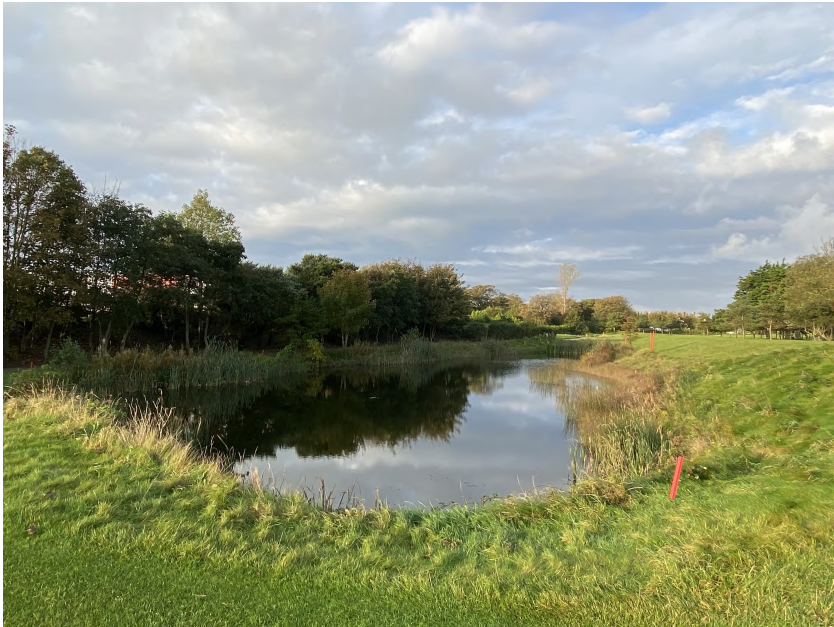
Site 11D - Pond D

Bedrock	Limestone/Shale (Tober Colleen)	Proximity of Structural Fault	800 m southeast
Subsoil	Marine beach sands / till	Soil	Windblown sediments
Exposures	Dunes viewed from Burrow beach		
SW Catchment	n/a (coastal)	Upgradient catchment	
Water Levels	1.27 mOD		
Depth	Estimated 2 m.		
Inflows	Surrounding subsurface drainage network. Groundwater.		
Drainage Pattern	As per Pond C, facilitated by subsurface connector pipe		
Outflows	As per Pond C.		
Hydrochemistry	C = 824 µS/cm; T = 12.4 °C; pH = 8.2*; ORP = 284 mV; DO = 78%*.		
Issues	Water contained in Pond D reportedly went a blood red colour on one occasion in recent years with malodour detected. Source of the colour suggests presence of metals in the area which may have precipitated out of solution upon recent oxidisation. Literature makes reference to a midden (ancient rubbish dump) at Sutton and construction of a recent flood relief pipe may have disturbed content. though any connection between the two is merely hypothesis.

Measures	Surface water quality monitoring.

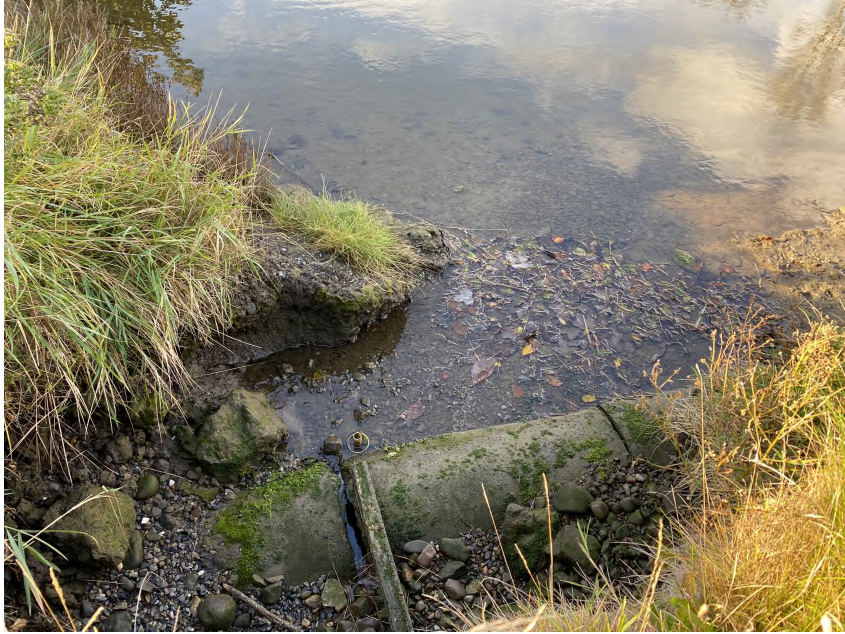
Site 11E - Pond E

Bedrock	Limestone/Shale (Tober Colleen)	Proximity of Structural Fault	800 m southeast
Subsoil	Marine beach sands / till	Soil	Windblown sediments
Exposures	Dunes viewed from Burrow beach		
SW Catchment	n/a (coastal)	Upgradient catchment	
Water Levels	1.22 mOD		
Depth	Estimated 2 m		
Inflows	Surrounding subsurface drainage network. Groundwater. Estuarine waters observed entering the pond via 300 mm pipe.		
Drainage Pattern	Conductivity levels clearly show that the westernmost pond is in continuity with saline waters. A 300 mm pipe at the eastern end of this pond provides direct connectivity with the estuary to the west. A sluice flap is in place at the pipe outlet but may have failed. This pond reportedly contains mullet which heron have been seen feeding on.

Outflows	Estuarine pipe		
Hydrochemistry	C = 25,149 µS/cm; T = 12.4 °C; pH = 8.3*; ORP = 251 mV; DO = 110%*.		
Issues	Inflow of estuarine waters on a rising tide. The different hydrochemistry in this pond relative to the interconnected Ponds C and E provides a unique habitat. Currently there are no plans to repair the sluice flap.		
Measures	None.
